Church of St Dunstan, Wenden Lofts

LB at Risk
Church of Dunstan, Wenden Lofts

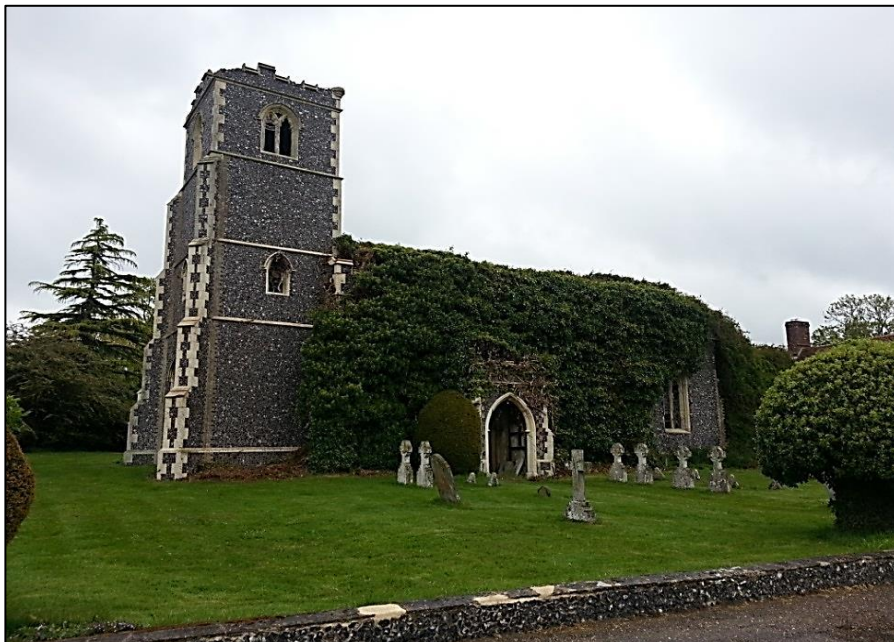
An overgrown and ruinous shell. Consolidation work to fabric required.

Condition Very bad

- Vegetation to be removed
- Vulnerable areas of structure to be propped and supported
- Openings to be secured as necessary.
