# Arkesden Conservation Area Appraisal and Management Proposals, 2012

**1.1** This appraisal has been produced by Officers of Uttlesford District Council to assess the current condition of the Arkesden Conservation Area, to identify where improvements can be made and to advise of any boundary changes that are appropriate. The document is in draft form and will be subject to public consultation and agreement by District Council Members.

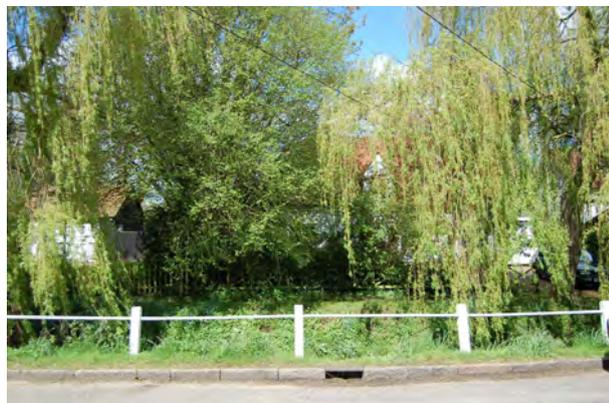
Picture 1.3 20th century railings along Wicken Water, whilst of little historic or architectural note, add considerably to the quality of the Conservation Area

**1.45** The 20th century railings supported on concrete posts, many painted white, bordering Wicken Water and on the access bridges are a feature of Arkesden. Whilst not being of particular architectural and historic interest they do contribute to the quality of the street scene. They are generally in good condition but some are in need of minor repair or painting. It is very important that this feature is kept in good condition and painted on a regular basis because should railings or posts become shabby the visual qualities of the centre of the Conservation Area would be eroded.

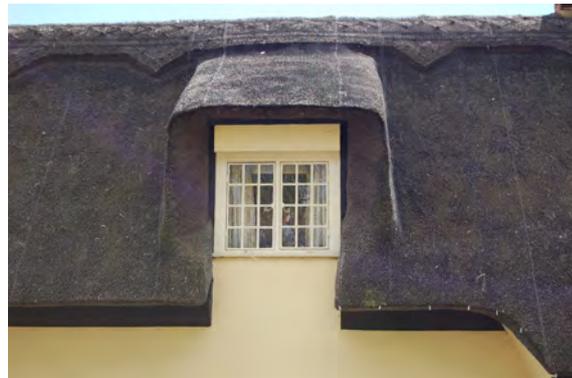
Picture 1.10 A narrow dormer pierces the thatch

**1.76** Roofscapes provide a rich variety of architectural detail, form and shape. Interest is drawn from the single or multiple red brick chimney stacks, some of very elaborate shape. On low 1 ½ storey cottages dormer windows penetrate the roofline where they typically provide contour and interest. On grander buildings smaller pitched roof dormers are typically narrow openings sometimes partly concealed behind a parapet.

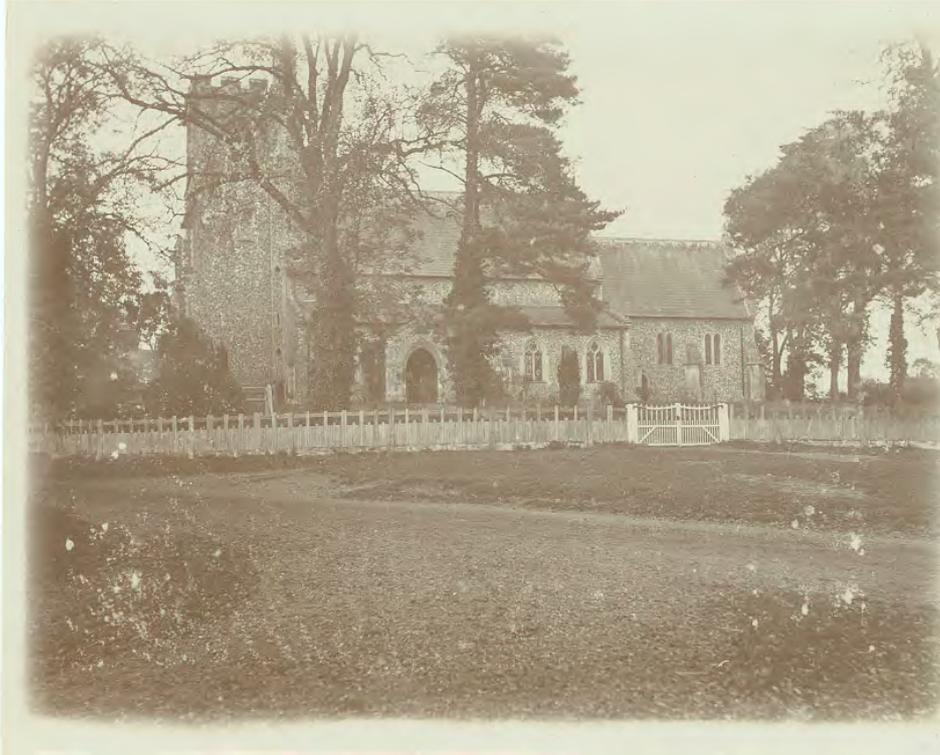
Picture 1.12 St Mary's Church in the late 19th century (Reproduced courtesy of Saffron Walden Museum)

**1.94** St Mary's Church. Grade II\*, properly called Church of St Mary the Virgin. Using local materials to their full potential, the walls are of flint rubble with stone dressings, the roof now in slate. Chancel and nave originally date from c.1250 to which north south aisles were added in the 1380s. The west tower was rebuilt in about the middle of the 15th century and a south porch added. The north aisle was largely rebuilt early in the 16th century according to an inscription said to have formerly been in the north wall. Some medieval windows tracery remains as does a 12th century square tapering font. Traces of a Norman tower found in 1855 when the present west tower was built. At that time, according to Bettley and Pevsner further renovations were carried out to the clerestory, chancel arch and hammerbeam roof<sup>(18)</sup>. Inside there are a number of important monuments including a 15th century effigy of a priest (thought to be John Croxby, Vicar here 1435-56), in the north wall of the chancel and the late 16th century monumental tomb of Richard Cutte and his wife now "crudely repainted"<sup>(19)</sup>. Other tablets and inscriptions are to the Birch Wolfe family of nearby Wood Hall. There is also a military brass of 1439.

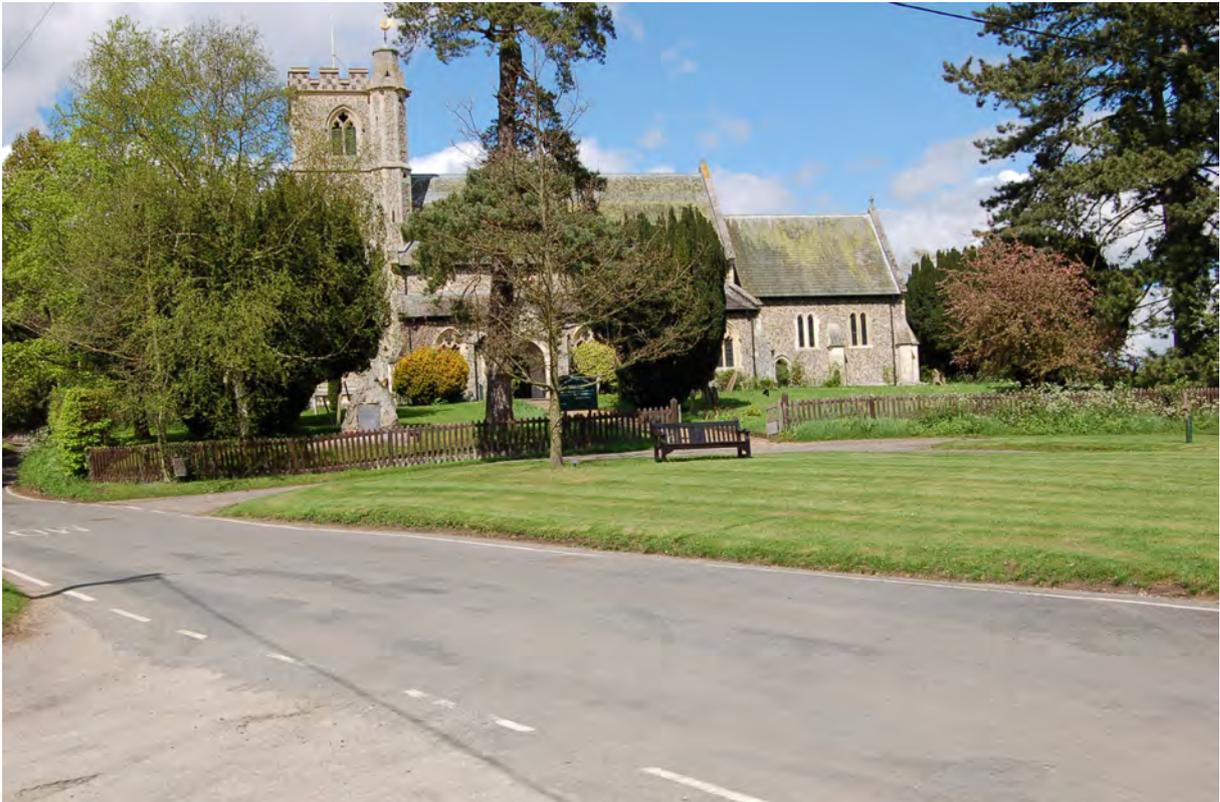
Picture 1.13 St Mary's church in 2012

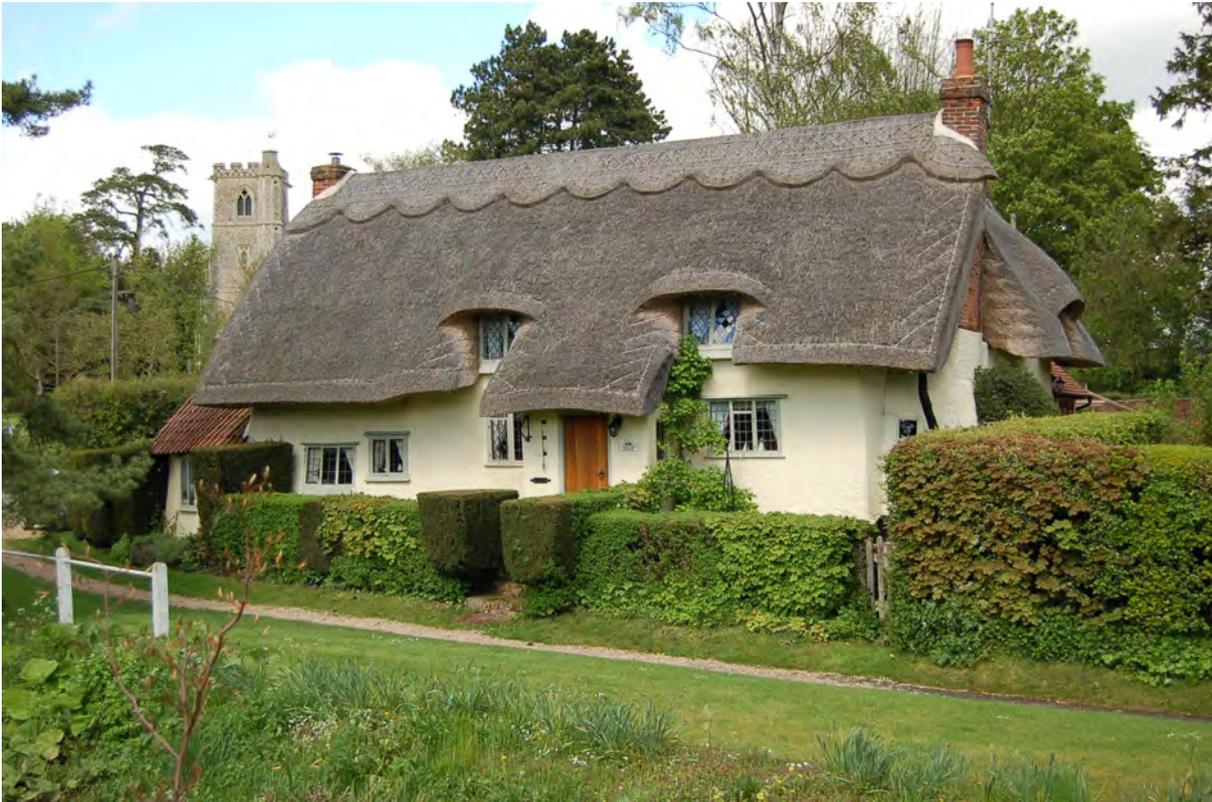
Picture 1.14 A quintessential English village scene; the thatched Watts Folly sits on the banks of Wicken Water with the west tower of St Mary's Church rising through the trees behind

**1.96** Lower down on the bank of Wicken Water sits Watts Folly (Grade II), a typical 17th century timber-framed and plastered house on an L shaped plan, originally two cottages until 1936. One storey and attics, modern casement windows with leaded lights. Roof thatched, with 2 dormers on the south front and one dormer on the east side. At the east end there is a large external chimney stack.

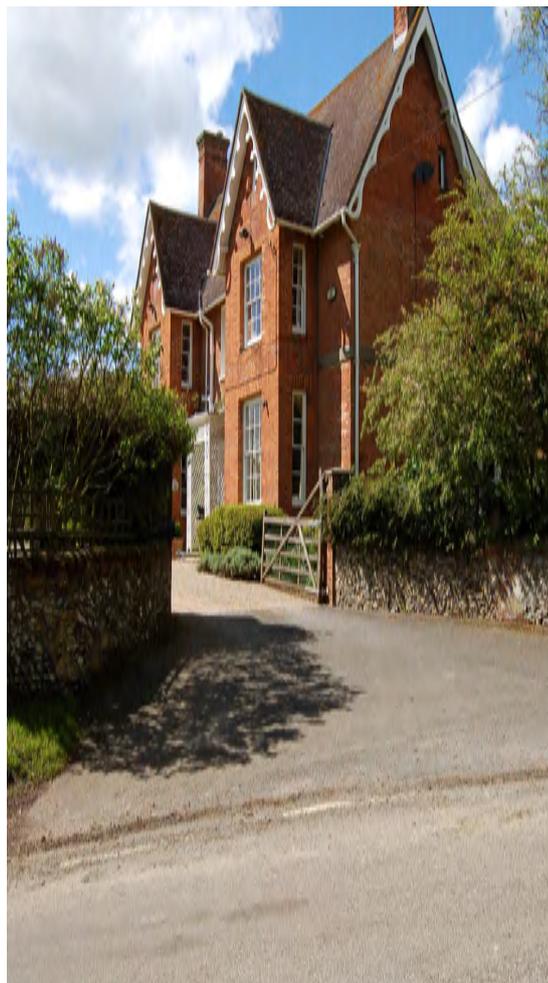
**1.103** The Old Vicarage. A tall elegant and prominent building, 19th century in appearance although it may have earlier origins, largely unaltered, two and a half stories, constructed of red brick with central pedimented porch. Original windows and slate roof of steep pitch with carved barge boards, two tall chimney stacks at west and east ends. Two projecting bays, the front elevation punctuated by two, then one, then two vertical hung sashes of 16 panes each, side lights and small upper story single lights. A single storey extension was added in the early 20th century. The living was a discharged vicarage, yearly to a value of £230 in 1874, having been formerly 'endowed with a portion of the great tithes, which were commuted for land and a corn-rent, under the inclosure (sic) act, in 1814'<sup>(20)</sup>. Throughout the 19th century the residence was in the gift of the Birch Wolfes of Wood Hall. The relative wealth of the living may account for the size and quality of the building. An Article 4 Direction to provide protection for windows and selected architectural detailing may be appropriate subject to further consideration and notification.

Picture 1.15 The Old Vicarage; an unlisted building of very high quality

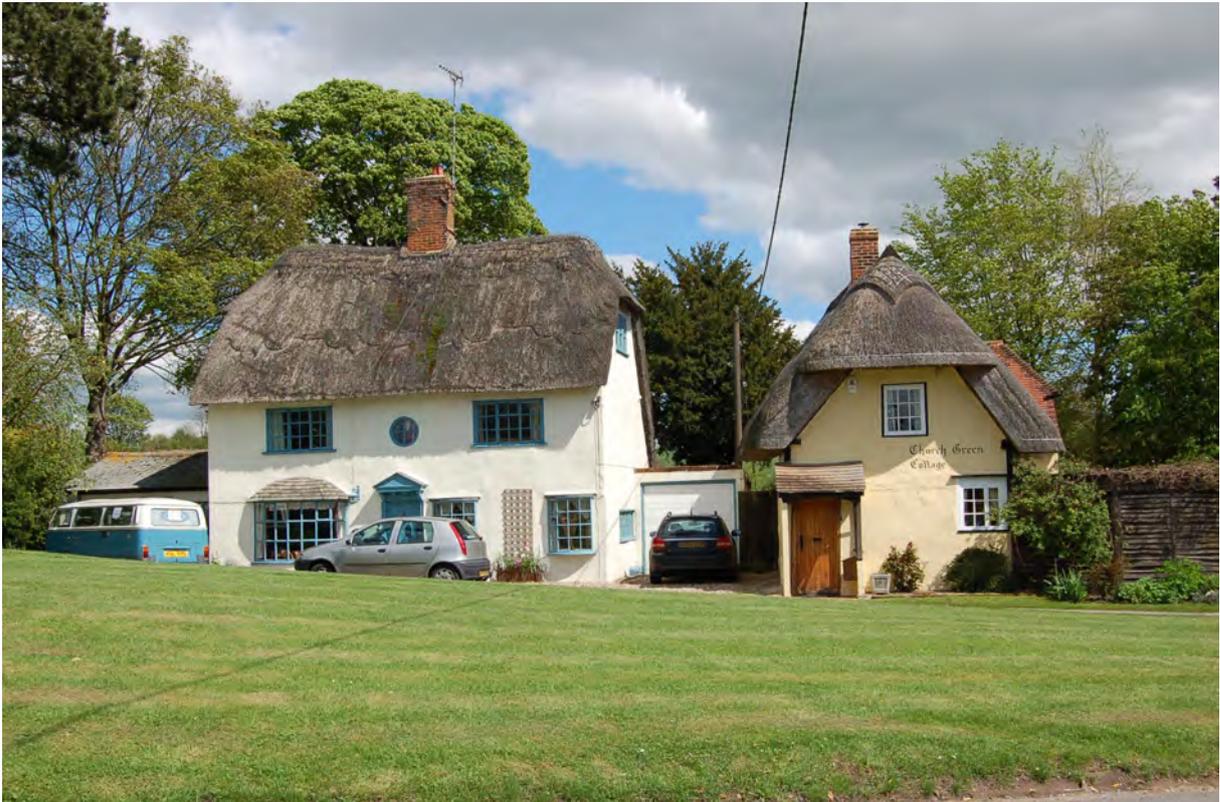
Picture 1.16 A very English scene - Dove Cottage (left) and Church Green Cottage (right) front onto Church Green and are set in scale by mature trees in the background. The presence of utility poles detracts from the quality of this view

**1.111 Elements that are out of character with the Conservation Area.** A number of utility poles and their overhead services detract from the quality of the streetscene. It is considered appropriate to draw attention to the level of visual damage, particularly where these services intrude in proximity to Listed Buildings. It is recognised that in the current economic climate it may be difficult to achieve any real improvements, though, it will still be worth while exploring the potential for the under grounding of services with the utility companies should the opportunity arise.

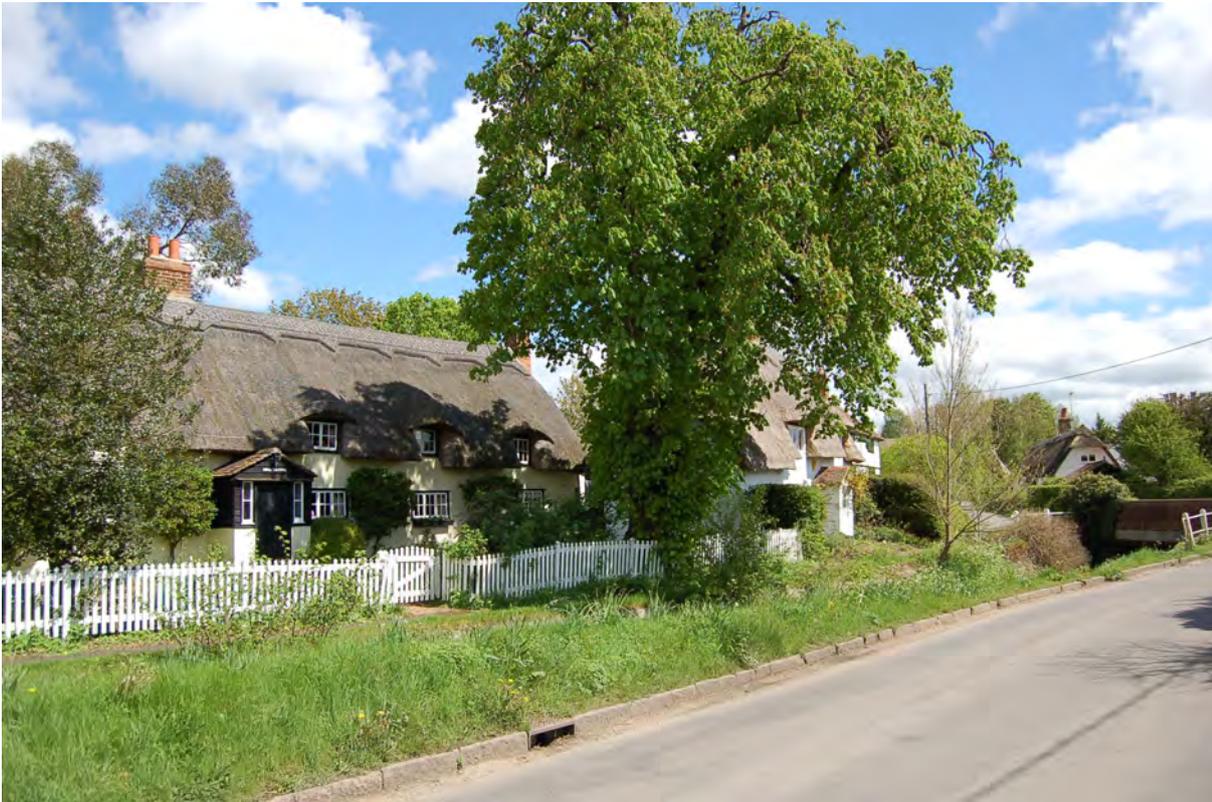
Picture 1.17 Long Thatches and Ivy Cottage sit back from the road across Wicken Water

**1.128** Long Thatches is was originally a run of three 17th century timber-framed and plastered cottages, but was renovated in the 20th century to form one tenement. It is one storey with attics, small casement windows. Roof thatched, with 5 dormers; one central and 2 end chimney stacks. Adjacent is Ivy Cottage, recorded in the English Heritage listing entry as Barnford Cottage, of similar date and construction to Long Thatches. Much renovated in the 20th century now with modern casement windows, thatched, half hipped, with 2 dormers.

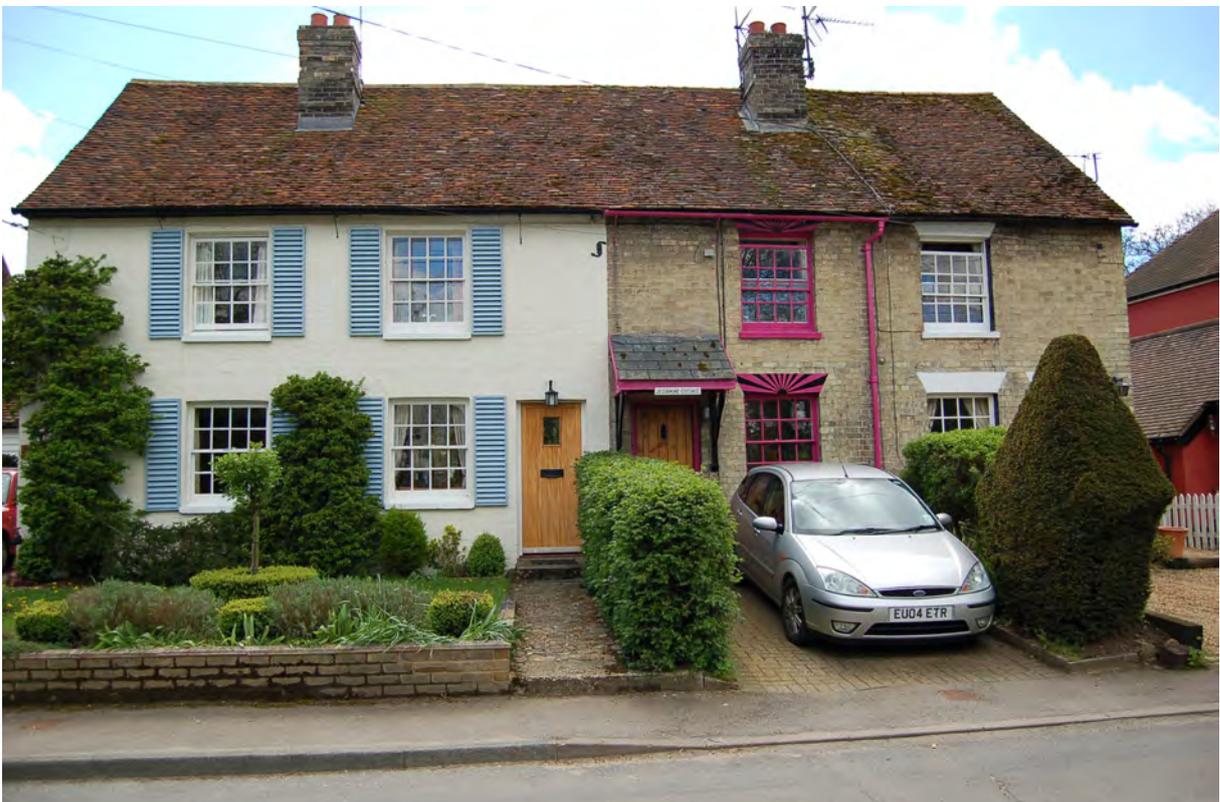
**1.134** Rose Cottage, Jessamine Cottage and Brick Cottage on Wicken Road comprise a pleasing run of three (originally four) related terraced cottages dating from the 19th century. They are shown on the 1877 Ordnance Survey mapping as such. Constructed of yellow-white gault brick, tiled roofs, two chimney stacks with a range of eight double hung vertical sashes of 16 panes each under cast lintels. Front doors are 20th century replacements and Jessamine Cottage has a porch. Article 4 Directions to provide protection for windows and selected architectural detailing may be appropriate subject to further consideration and notification.

Picture 1.18 Rose Cottage, Jessamine Cottage and Brick Cottage on Wicken Road comprise a pleasing group of non-listed buildings worthy of note

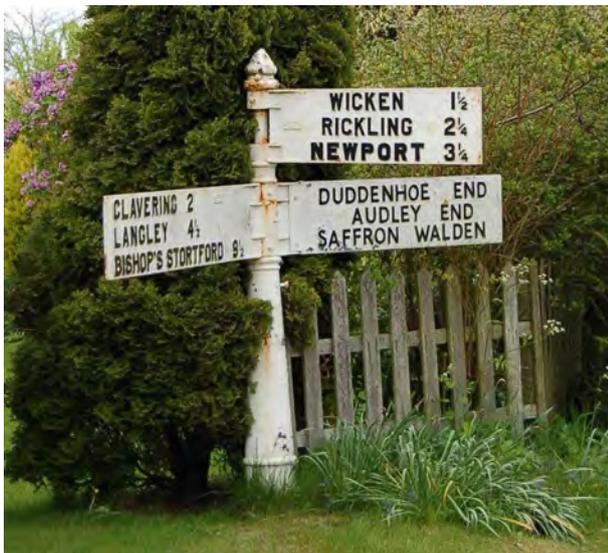
Picture 1.19 Cast iron signpost manufactured by the Maldon Ironworks in 1934. Junction of Wicken Road and Clatterbury Lane

**1.139** At the junction of Wicken Road and Clatterbury Lane can be found a cast iron circular section tapered signpost with conical finial. Dating from 1934, this was originally manufactured by Maldon Iron Works. There are three 10½-inch arms of which one is a replacement casting without mileages<sup>(21)</sup>. This is now in need of some repainting.

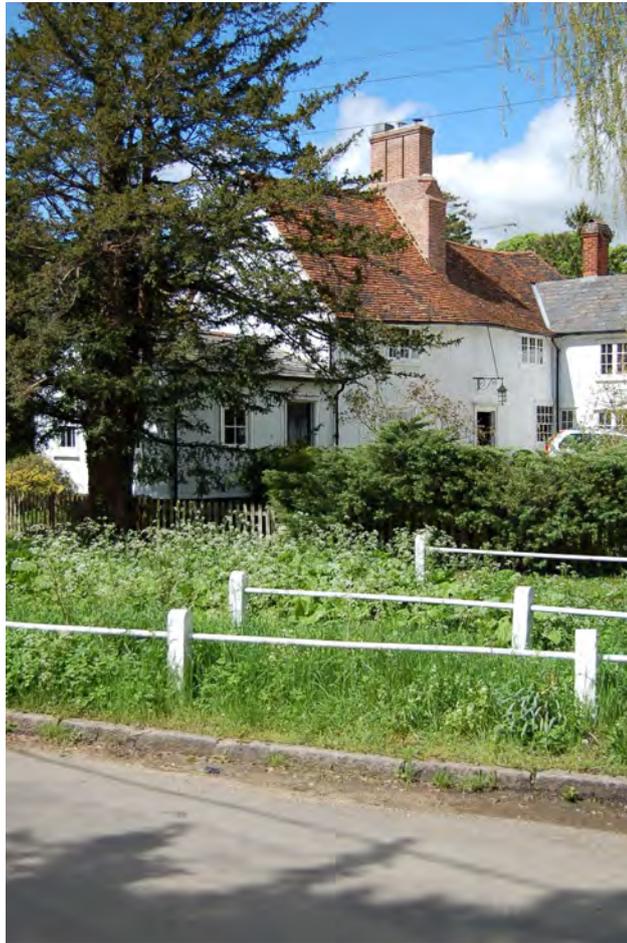
Picture 1.20 Distinctive railings, wide banks and rough cut granite setts edging the road all combine to add to the quality environment in front of the former Green Man Inn

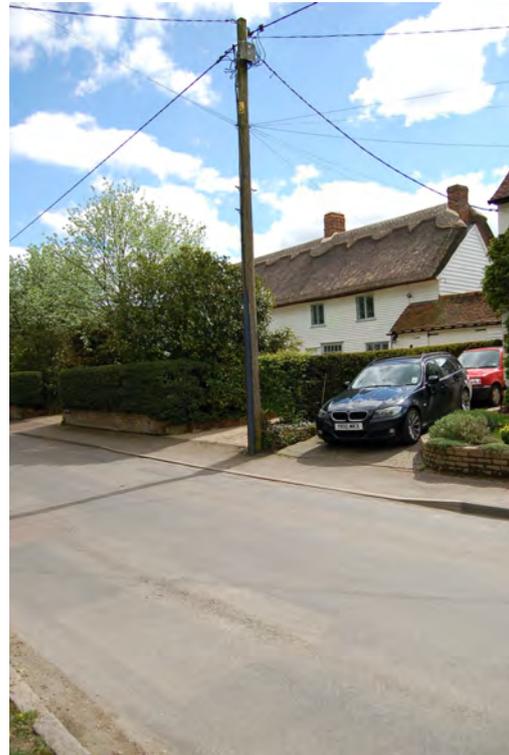
Picture 1.21 Utility poles intrude into the streetscene in Wicken Road

**1.143 Elements that are out of character with the Conservation Area.** Utility poles throughout the Conservation Area; as noted above, opportunities to reduce the image of these intrusive features should be explored.
