Great Chesterford Conservation Area Appraisal and Management Proposals, Approved April 2007

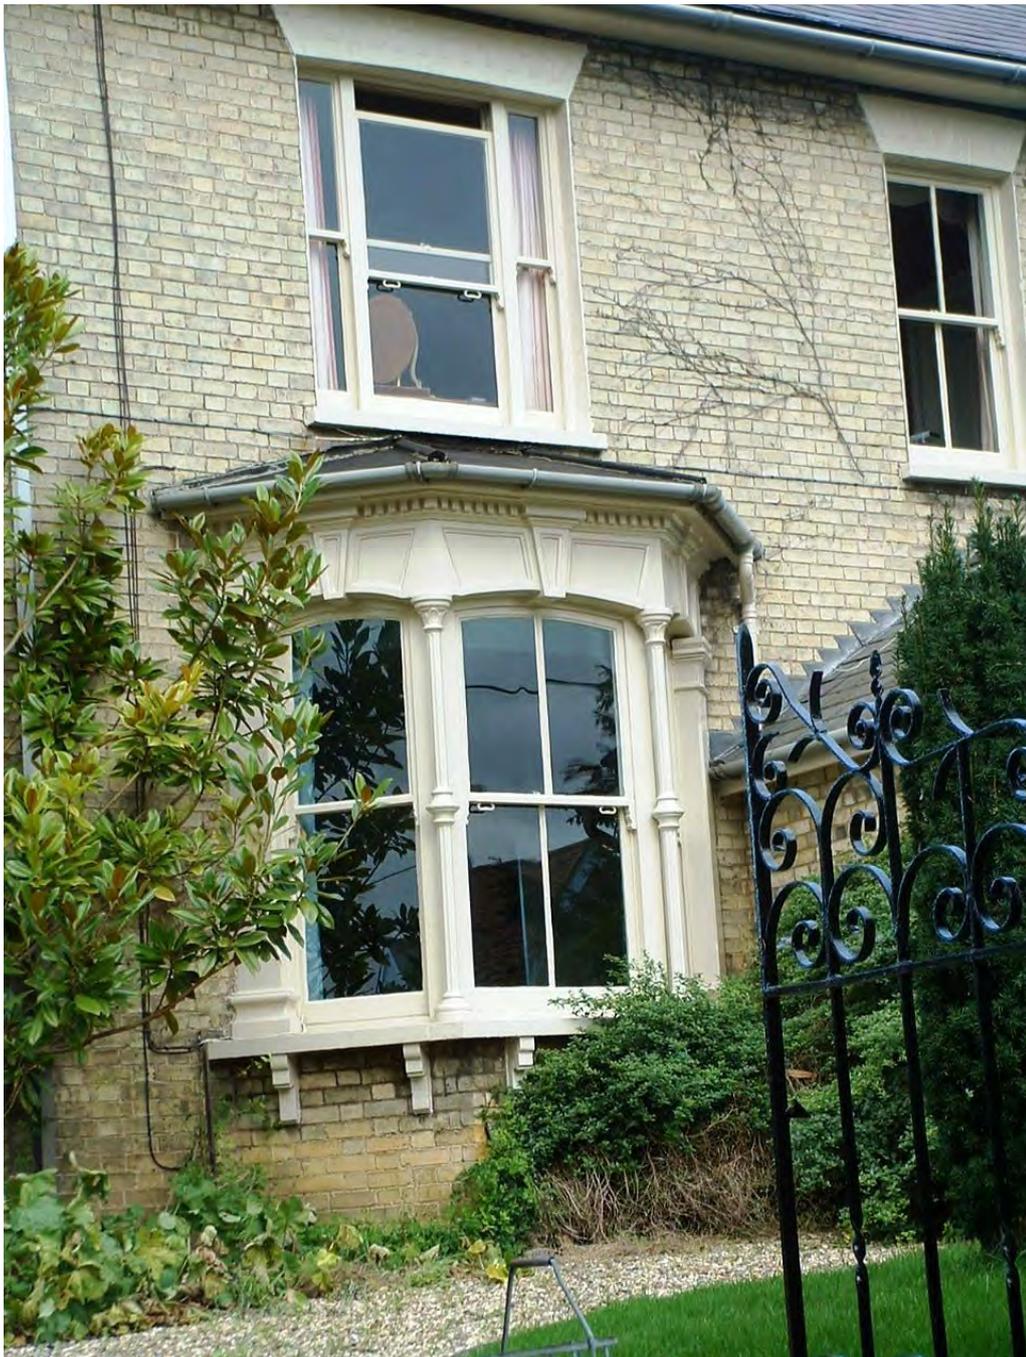
Picture 1.3 Distinctive C19 window

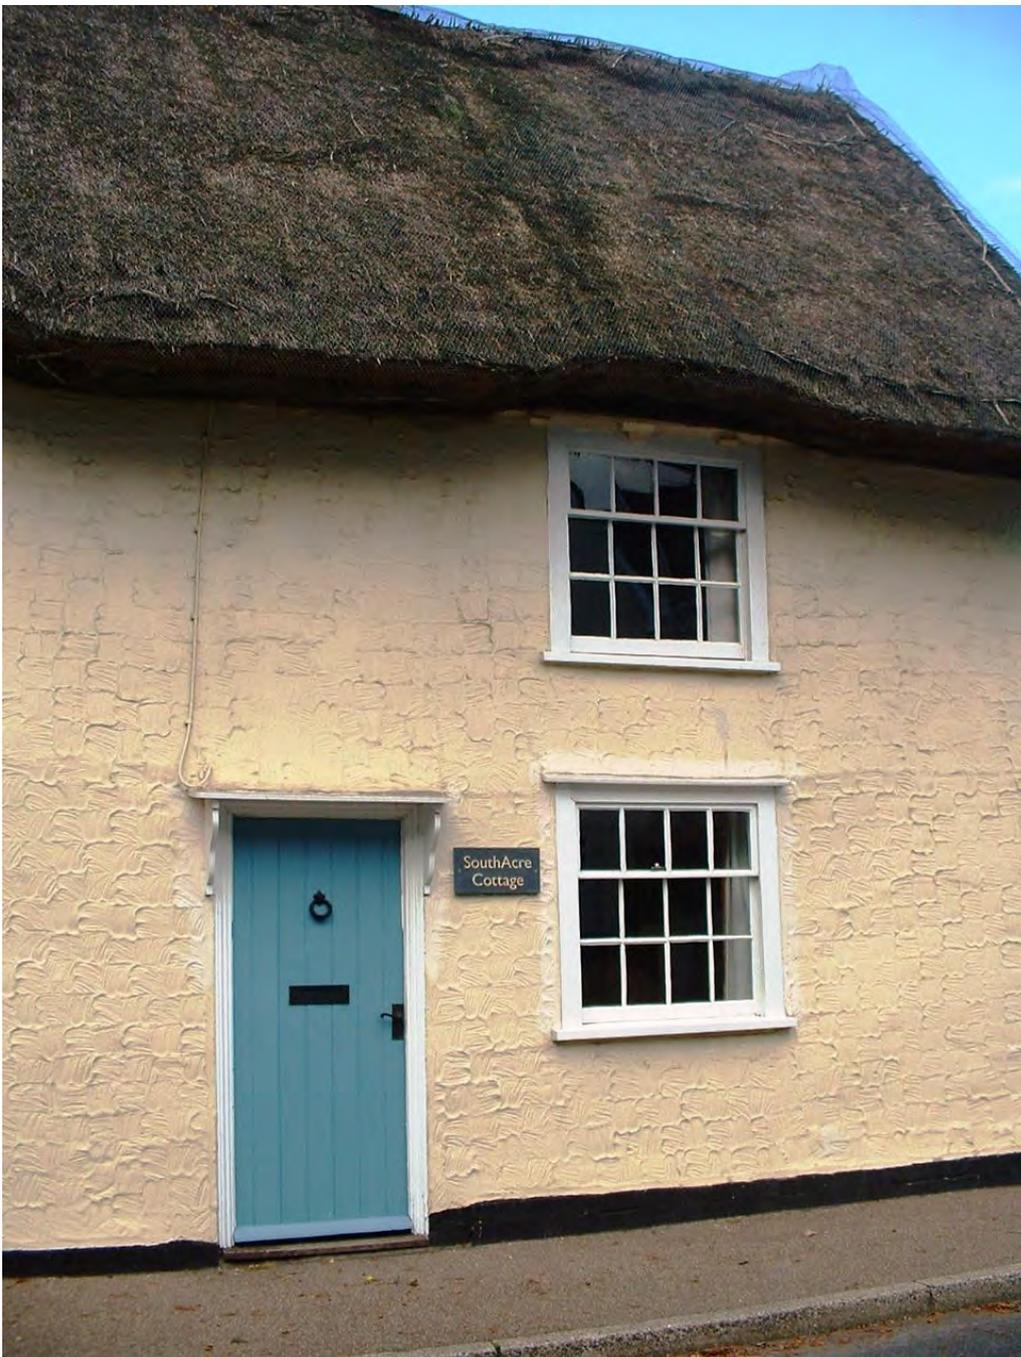
Picture 1.4 South Acre Cottage

1.59 On the north side Chesterford House, a grand imposing brick house with tiled roof, dating from the 18th century set in large grounds and enclosed by a wall, is in complete contrast with the diminutive timber framed plastered and thatched property nearby, known as South Acre Cottage. Further to the west, Saffron House, hidden away behind a brick and flint wall, dating from the 17th century and formerly the Three Horseshoes Public House, stands at right angles to the road and is characterised with a jettied upper storey. Nearby the Old White Horse, with remains of ironwork that once supported the pub sign is of similar age but directly abuts the pavement. Each has some quality features and detailing from the period, but both perform different roles in enhancing and adding to the special character of this part of the village.

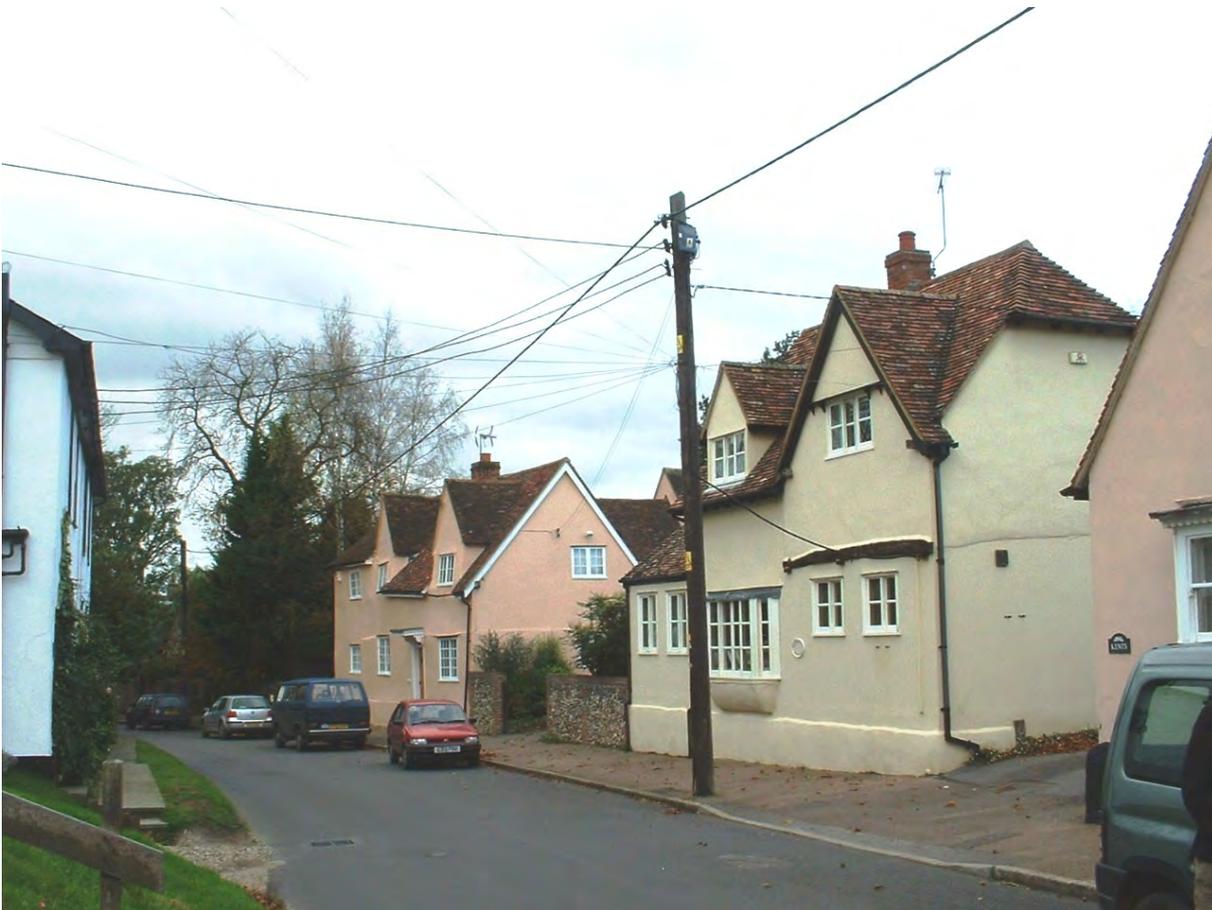
Picture 1.6 Overhead whires, detracting element in the street scene

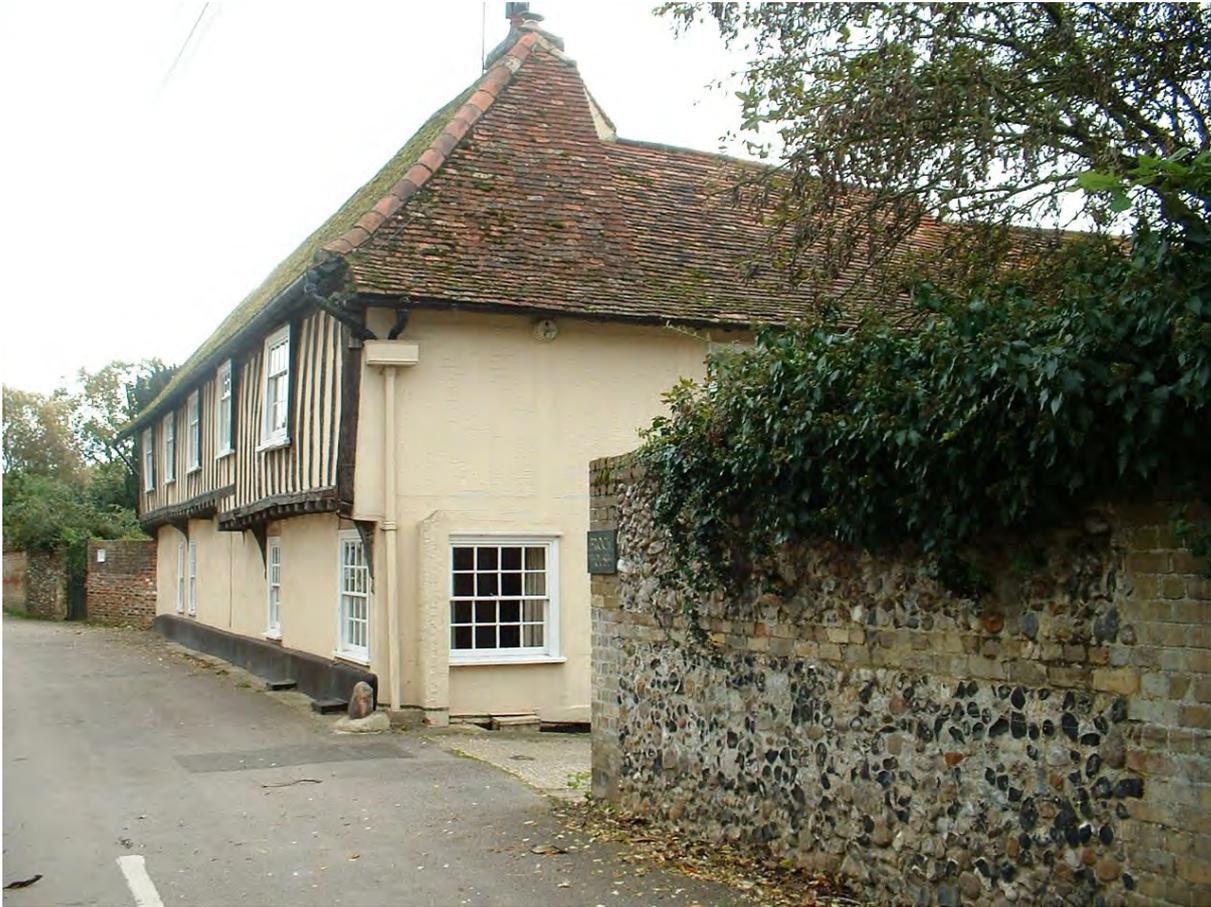
Picture 1.9 Brock House

1.80 Individually listed buildings. The oldest, dating from the 16/17th century are located on Manor Lane and Carmel Street. Both Manor Farm itself together with the magnificent exposed timber framed Brock House and its distinctive jettied upper storey are particularly fine. Most properties from this period are tiled, although several on Manor Lane and Carmel Street that have thatched roofs that provides diversity of roofing material. Elsewhere other 18/19th century properties provide further diversity with their slate and pan tiled roofs that can be seen on South Street and Carmel Street. Some of these are small whilst others, like the Primary School are very substantial and dominant in the street scene. The latter, built by N. J. Cottingham in 1849 is unusual with its knapped flint walls and steeply pitched roof with bands of fish-scale tiles surmounted by flint stacks with diagonally set brick shafts. Another distinctive building that adds character and diversity is the 19th century Congregational chapel on Carmel Street built in 1841.

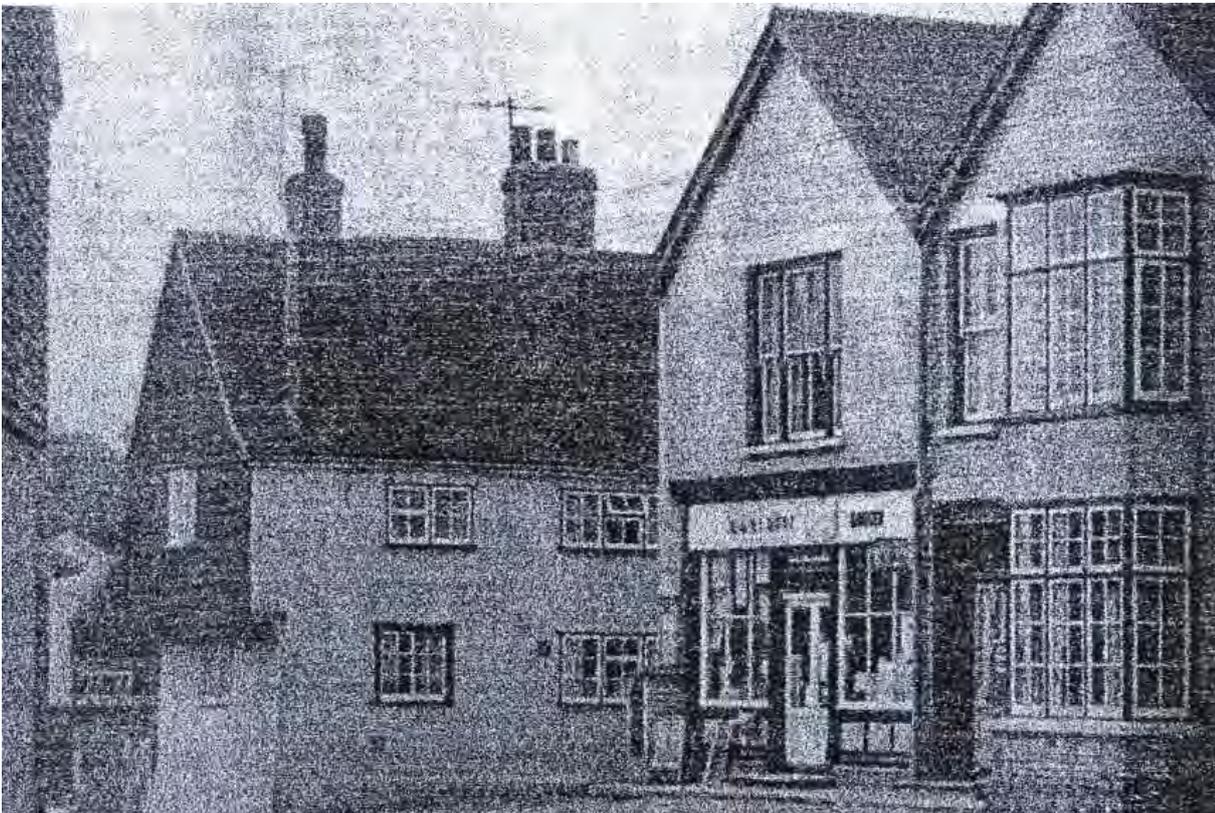
Picture 1.10 Historic view of Post Office building

1.85 The Post Office on School Street is a tall late 19/early 20th century building constructed in yellow brick with slate roof and simple bargeboards to front with chimneystacks. There are fine box and vertical sliding sash windows and an original large shop window on ground floor. The interesting door and doorframe contains the lettering 'Shelfords' etched in the glass.

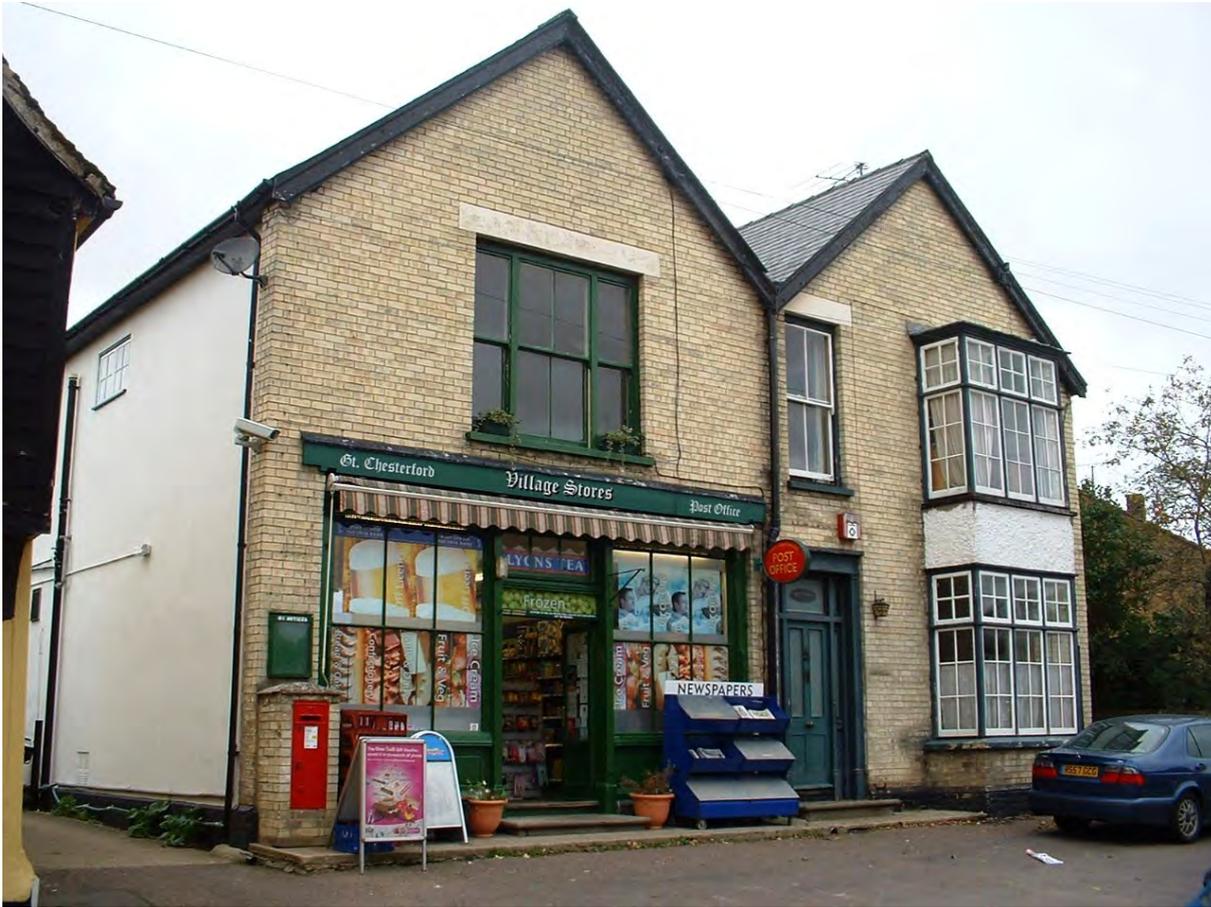
Picture 1.11 Little chnged present view of Post Office building

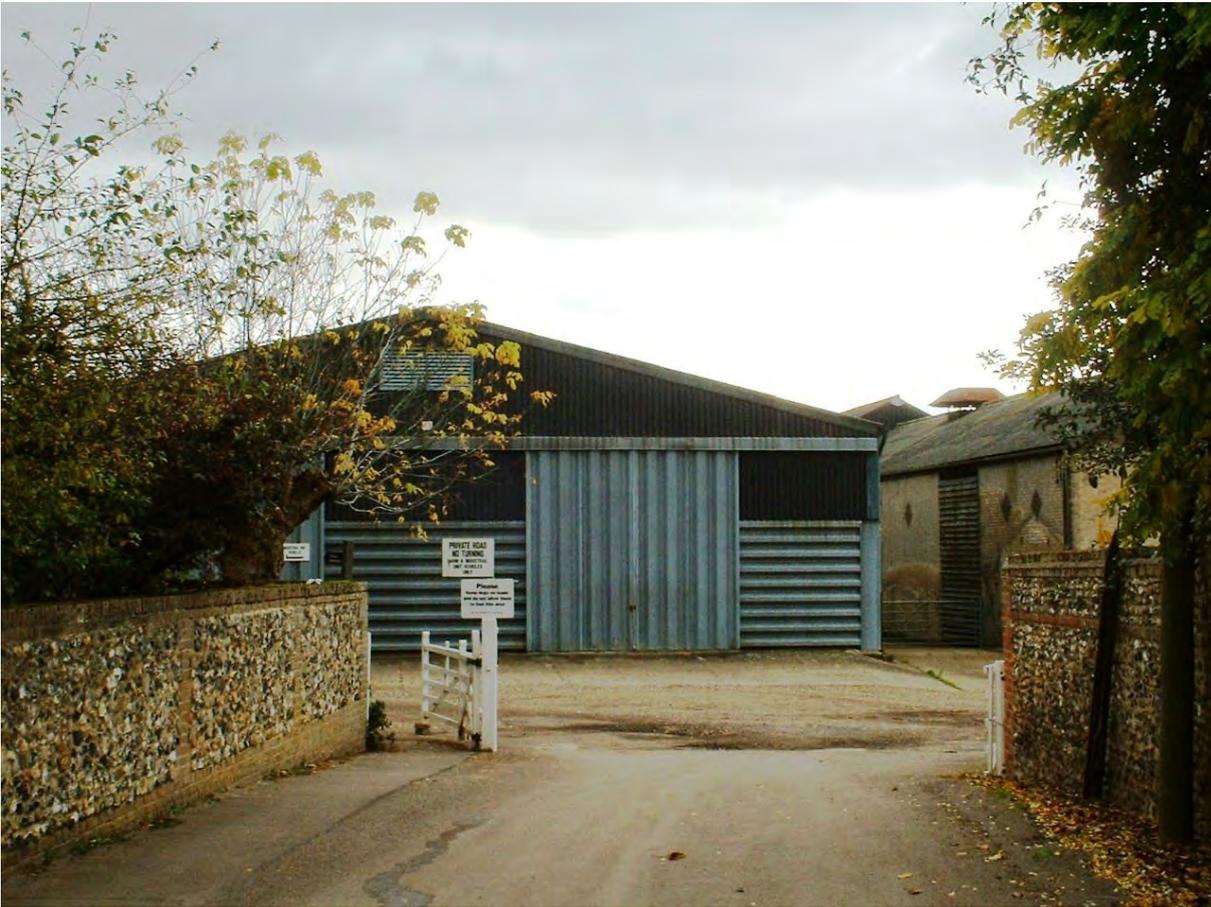
Picture 1.14 Detracting view along Manor Lane

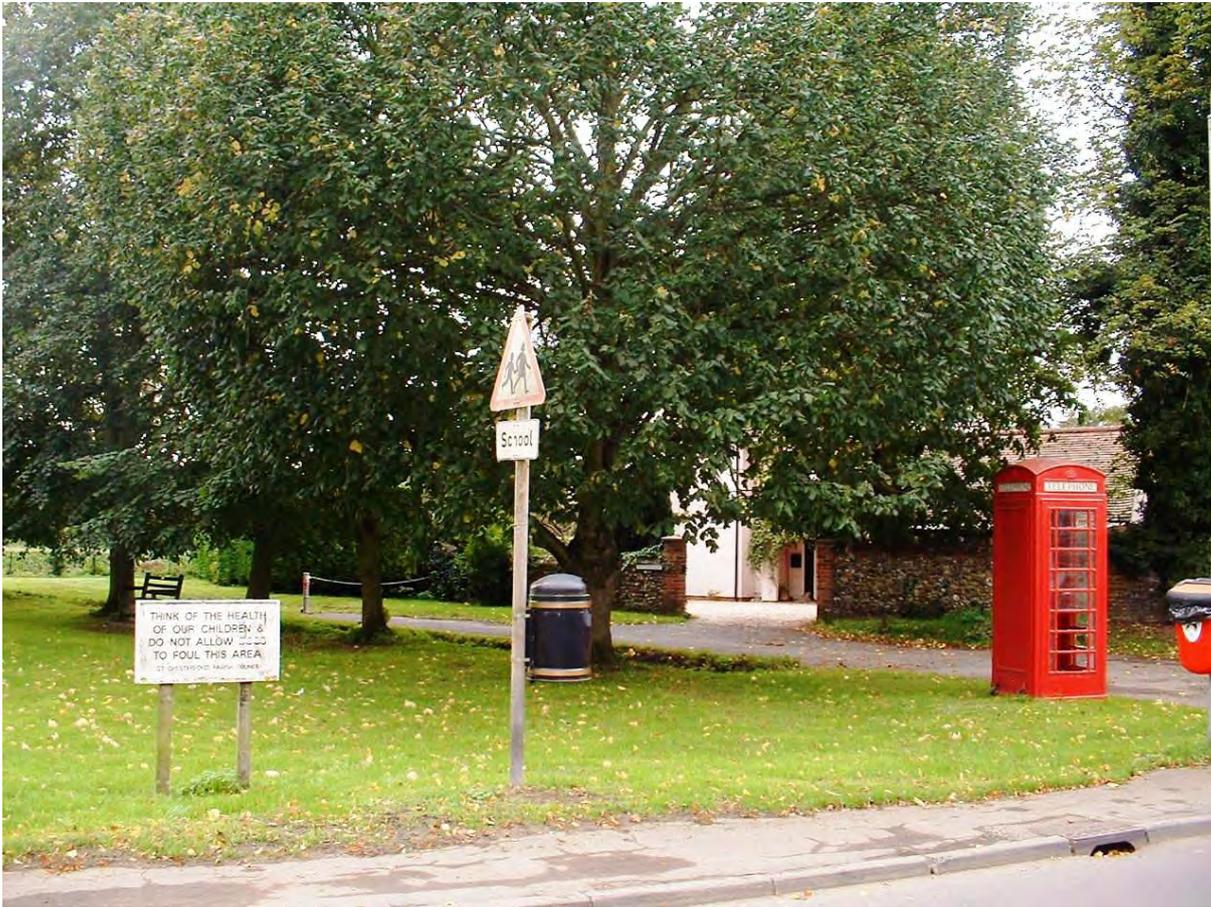
1.97 Horse River Green could be improved by removing a dominant sign on the frontage to South Street. As previously noted this green contains a number of trees. It is an area where the countryside comes into the village and as such tree species should reflect this. Should the opportunity arise to replace the several species of cherries, this would be beneficial.

Picture 1.15 House River Green, positive and negative aspects

1.98 The removal of the litterbin on the stump of the telegraph pole at Coronation Green would also be an advantage.

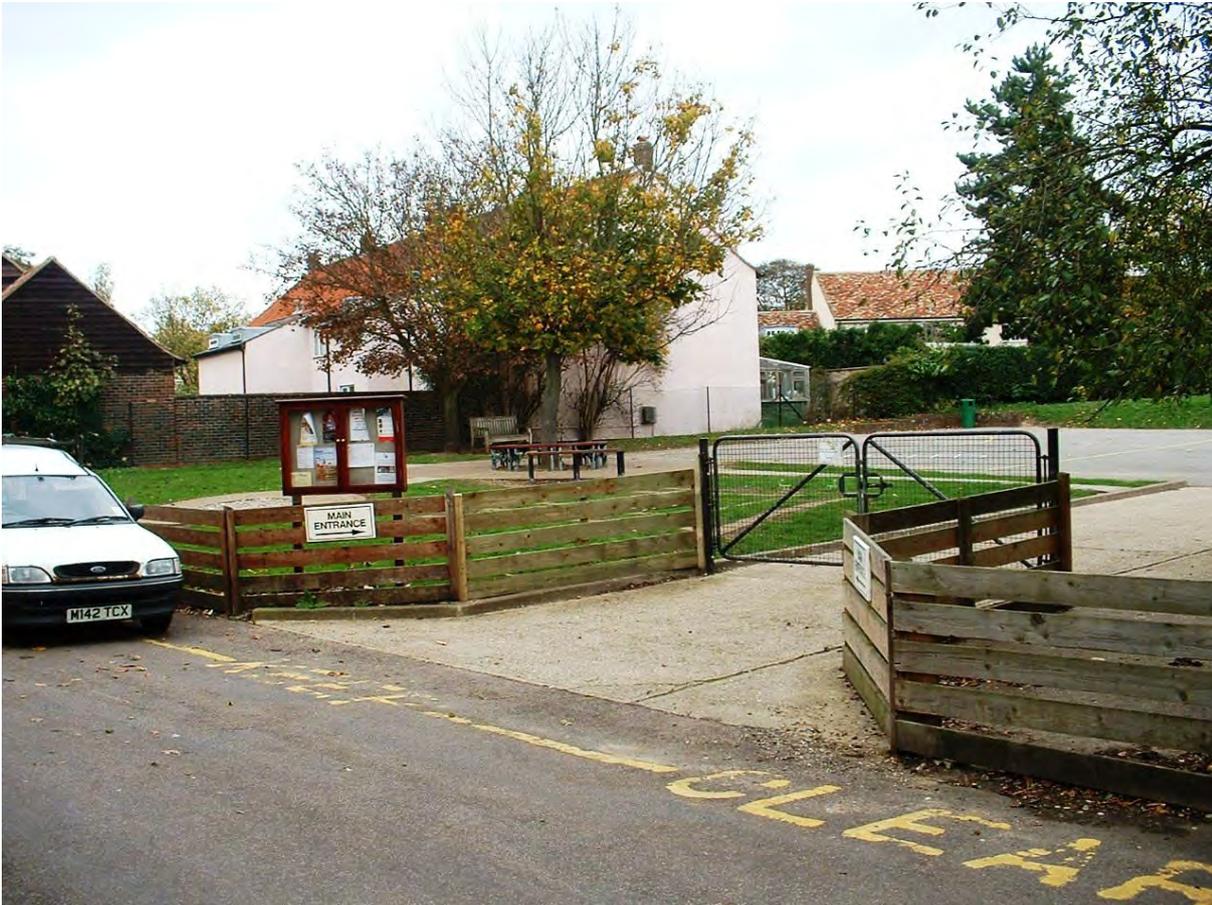
Picture 1.16 Detracting fencing at Primary School

Vandalised telephone box	Horse River Green	Liaise with owner to repair
Litterbin on stump of electricity pole	Coronation Green	Liaise with PC to seek removal
Fence to play ground	Primary school site School Street	Discuss potential for improvement with education authorities, prepare landscaping scheme if appropriate

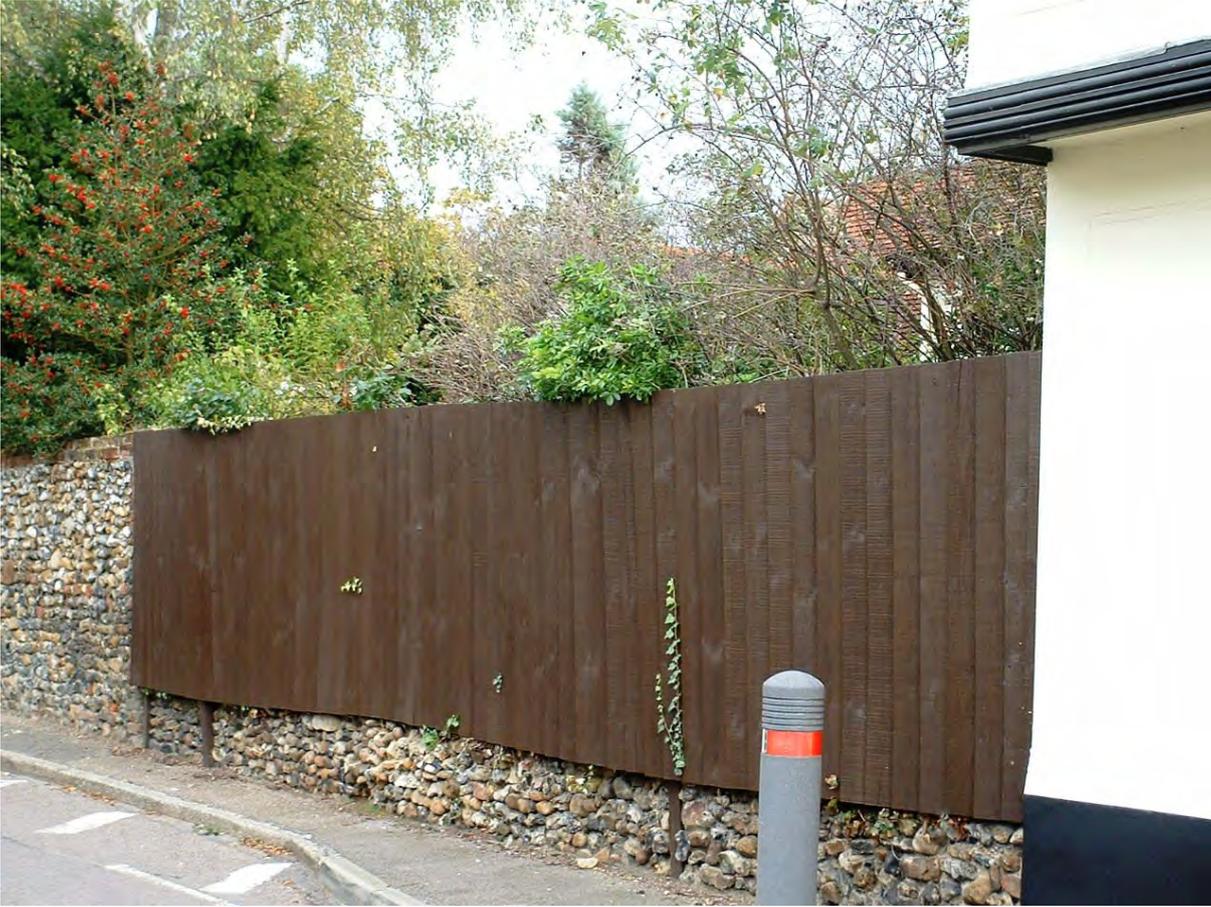
1.100 A replacement fence erected by a previous owner where a wall previously existed, forms part of the boundary to Carmelstead on Carmel Street and is ugly. It would be most beneficial if this could be replaced by rebuilding the wall.

Picture 1.17 Detracting fencing to curtilage of listed building

Element identified	Location	Proposed next step
Replacement fence	Carmelstead Carmel Street	Establish status and discuss potential for improvement with owner
Modern garage	North of King's Granary	Liaise with owner, long term solution would be redevelopment of site that lies within the Development Limits
Changed priorities signage	Newmarket Road	Liaise with ECC to achieve removal
Timber fence	Crown House Church Street	Establish status and discuss potential for improvement with owner
Gap in important wall	Boundary between church and Bishop's House	Discuss repair with owner
Ivy growth	Churchyard trees	Discuss removal with church
Crash barrier	B1383 beyond the Conservation Area	Discuss with Essex County Council
Poles and signs	Grassed area junction Newmarket Road/Carmen Street	Discuss removal/rationalisation with public utility company and ECC
Speed reduction plan	Principally High Street, possibly elsewhere	Discuss with PC and local District and County Members and pursue options vigorously with ECC

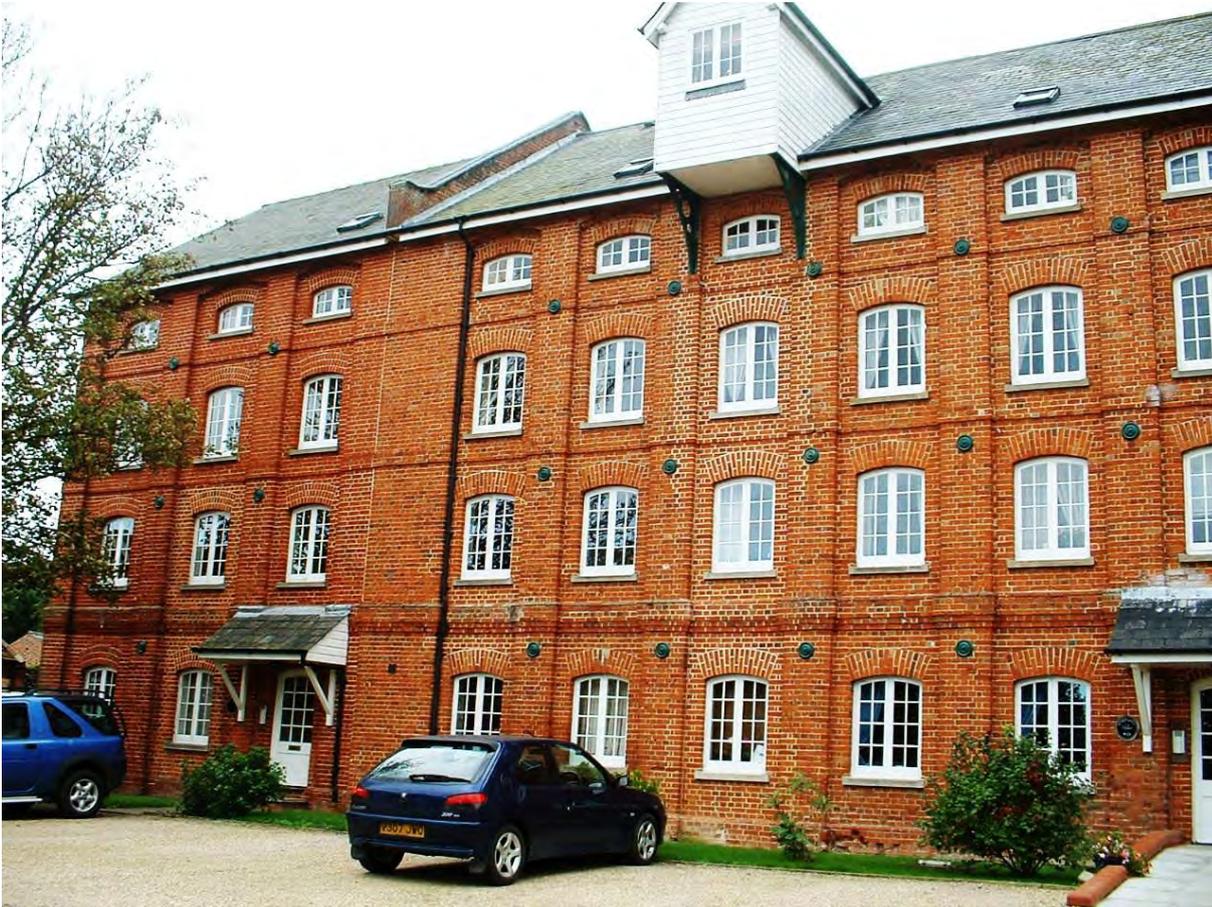
Picture 1.19 Kings Mill converted to flats

1.109 Separately identified building in the curtilage of a listed building. King's Mill, within the curtilage of Mill House is a dominant 4-storey slate roof building that has successfully been converted to flats. It is built of red and gault brick constructed in English bond with some decorative banding. The basic form, structure and detailing such as window openings remain largely intact. Its bulk and general form and some original features make a positive contribution to this part of the village. This structure dates from the early/mid 19th century, and appears on the 1877 OS map. It has now been successfully converted to flats and is a landmark building in the village, visible from many vantage points.

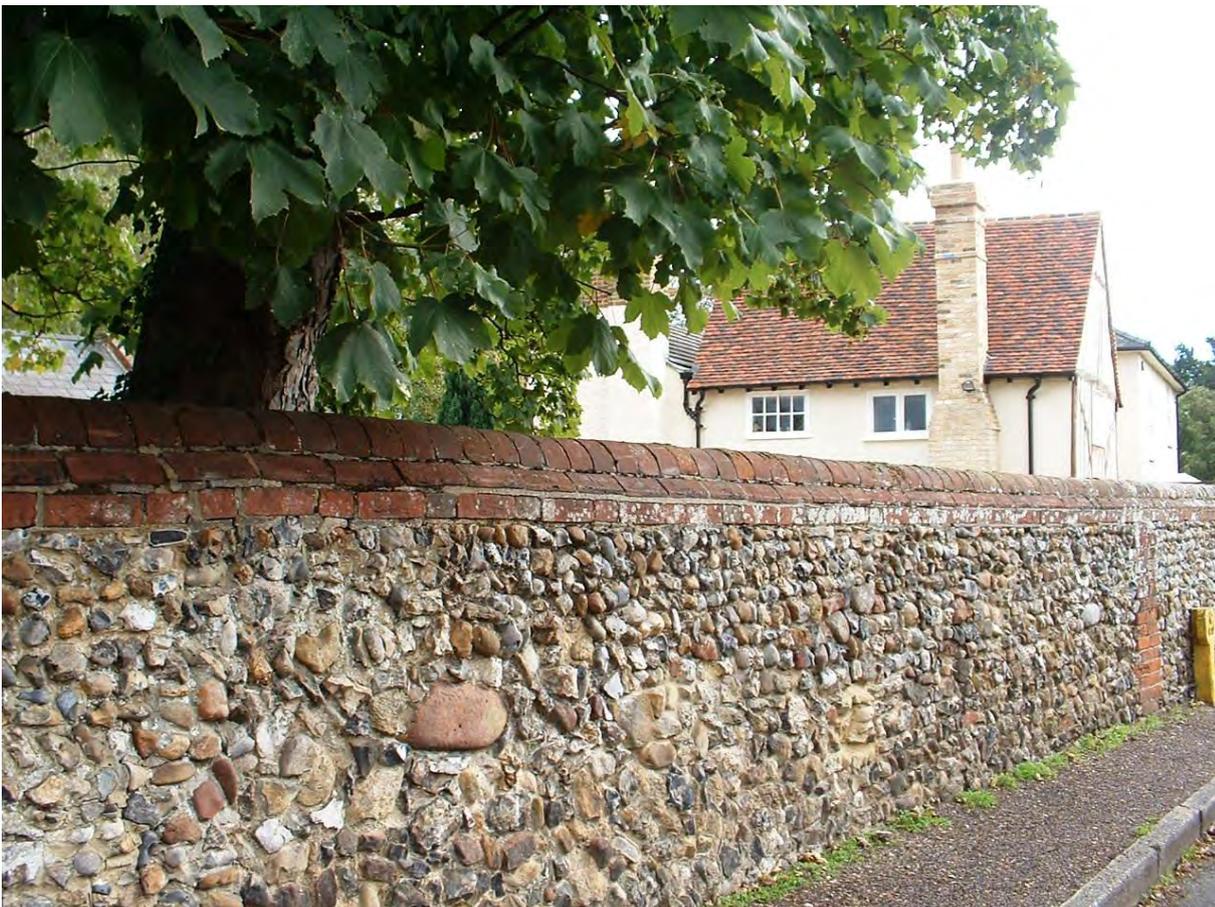
Figure 1.2 Curtilage wall to listed building, The Dalles

1.128 The Delles appears as a mid 19th century house with external render and painted brickwork for the most part with slate and tiled roof. However the jettied exposed timber frame at the north western end dating from the 17th century indicates further remains of timber framing that can only be observed from inside. It is set in extensive grounds, the landscaping of which is evident on the 1877 Ordnance Survey map. 19th century detailing includes bay windows with original decorative slate roofs, remains of quality rainwater goods and decorative central bargeboard to rear and a decorative red and gault brick chimneystack. There are two ranges of brick and flint outbuildings with slate roofs that although modified, remain visually attractive.

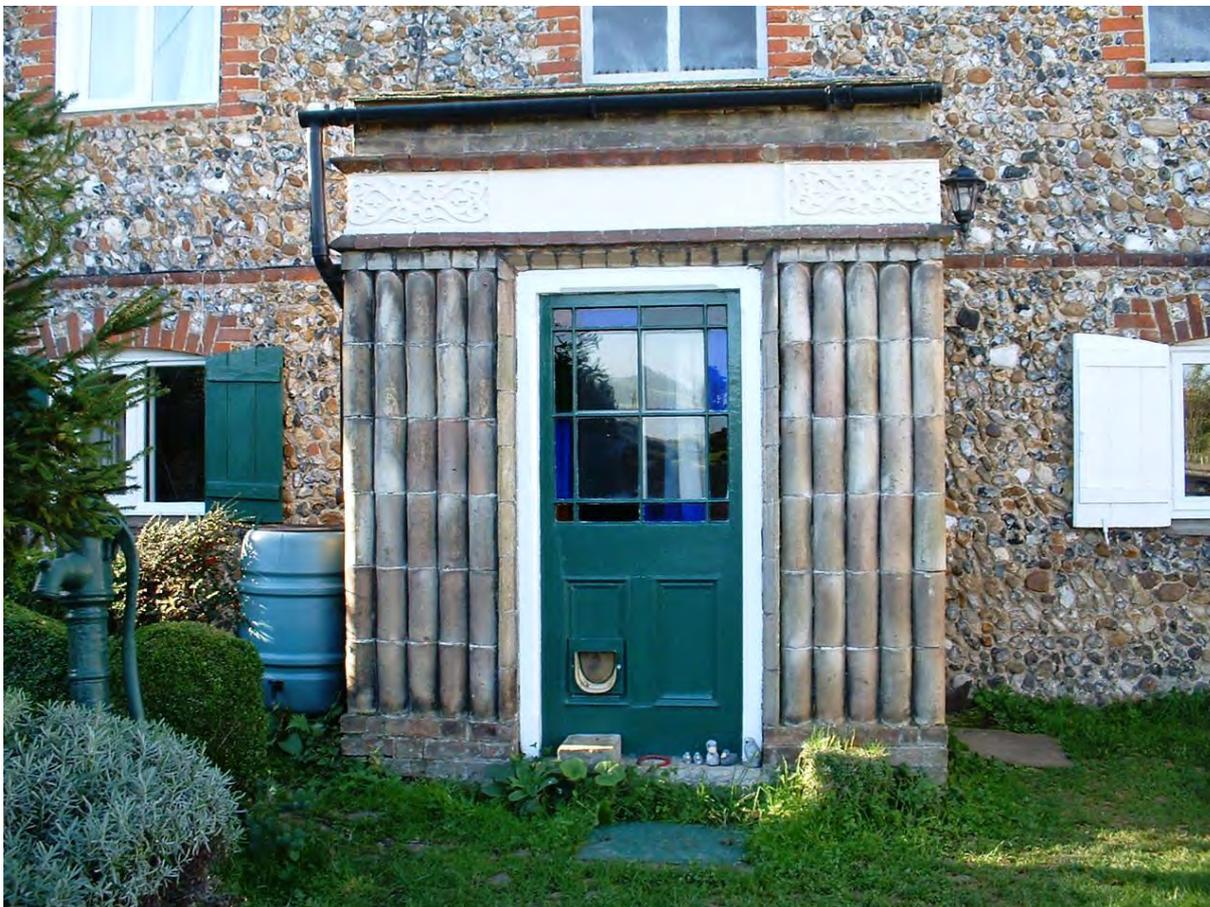
1.131 Flint Cottage, Newmarket Road, is a mid 19th century property constructed of brick and flint displaying a number of original and unusual features. Its elevation to Newmarket Road is 2 storeys with original railing to pavement. The rear elevation is three storeys and whilst the timber windows have been replaced the overall form and shape is most distinctive. Three windows have been sealed, probably in the late 19th century. Some original shutters remain. Interesting internal details include a vaulted cellar with two chutes, one for delivering coal from the Newmarket Road. The wall to Carmen Street is dated 1874. A washroom in part constructed of clunch, contains interesting roof timbers and a stone sink in original position. This building is also characterised by decorative pargetting and remains of an oval plaque that once contained an inscription. A most peculiar feature is the decorative rear porch, best described as a folly, being decorated in part with land drain sections aligned vertically to provide a most unusual and distinctive feature.

Figure 1.3 Most unusual porch to Flint Cottage

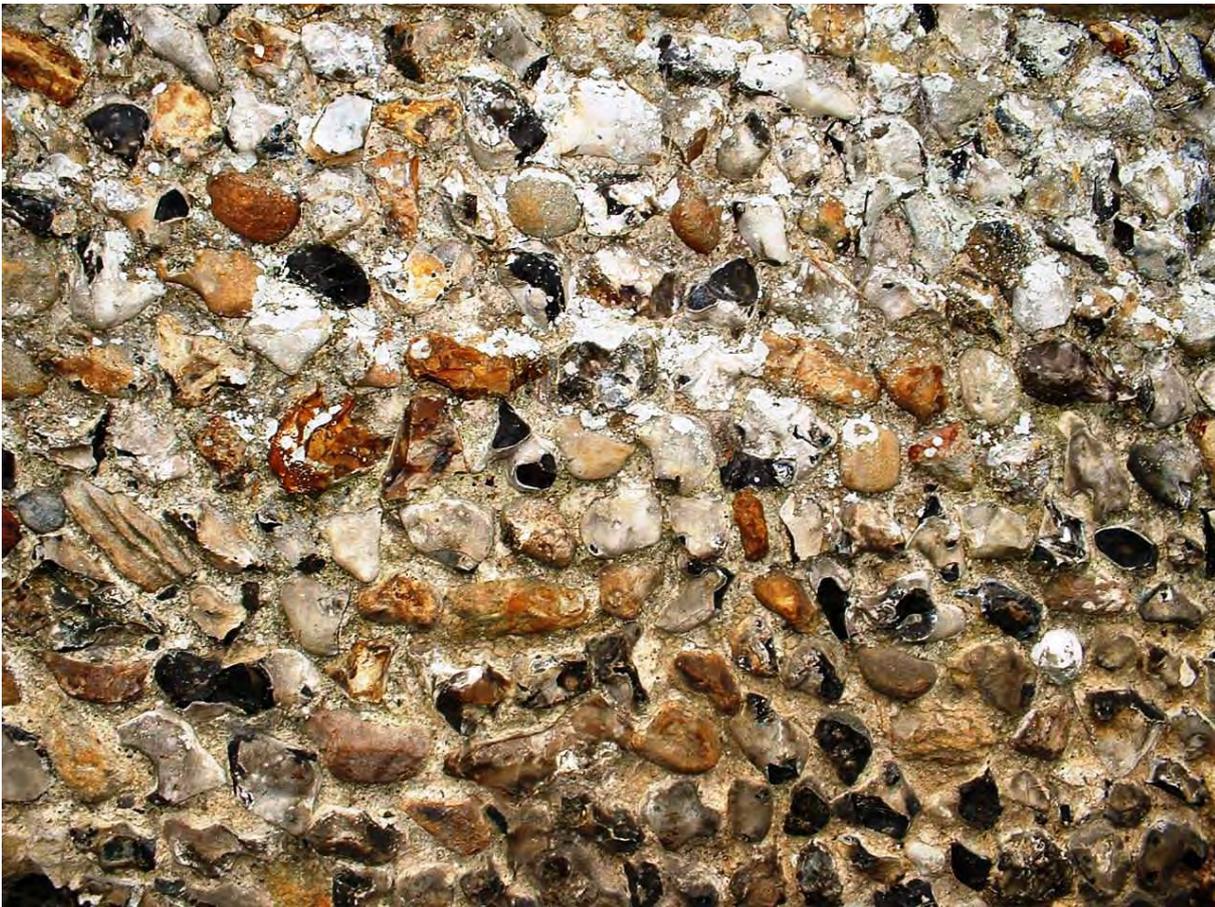
Figure 2.1 Fine exaple of flintwork

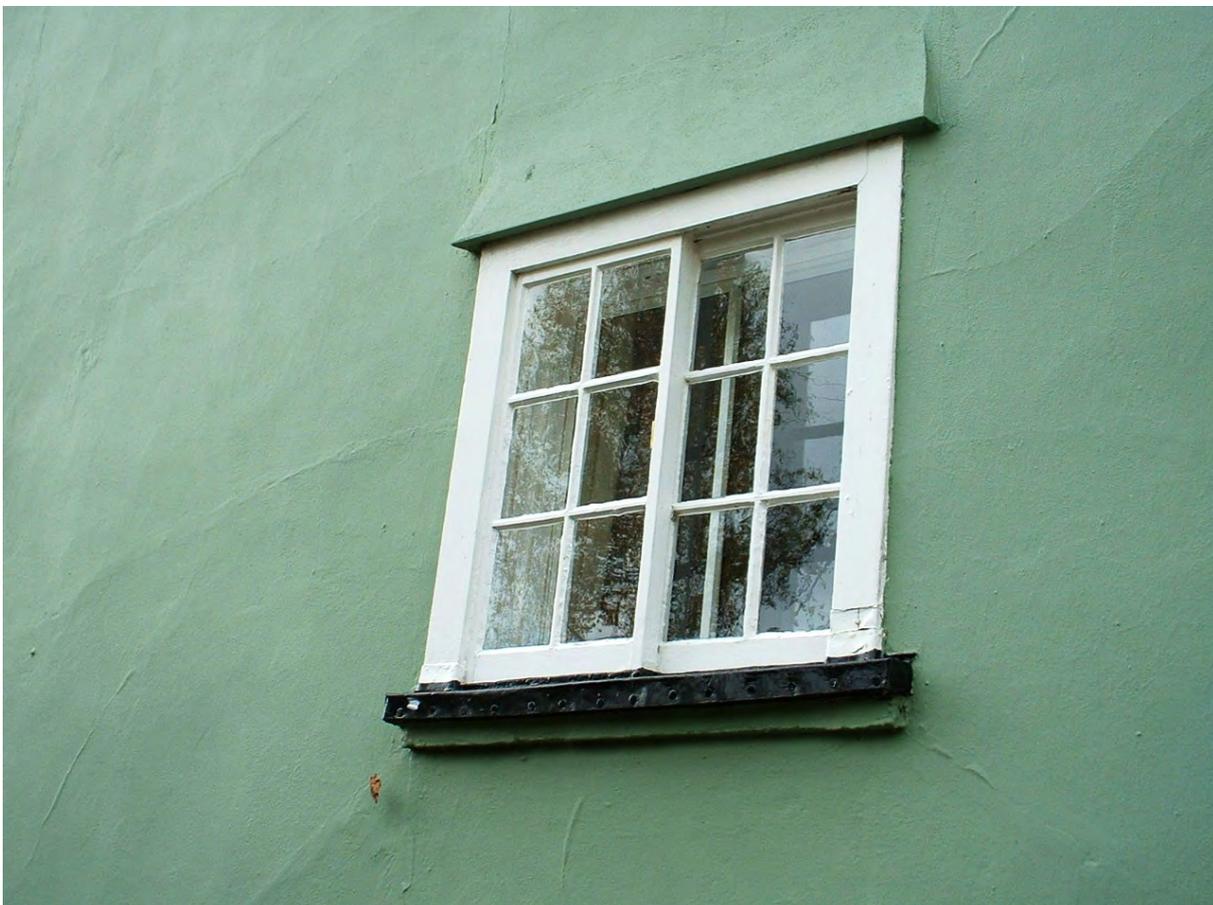
Figure 2.2 Quality horizontal sliding sash window

2.12 The council therefore proposes to make an Article 4(2) direction to remove the right to alter windows and doors and roofing materials on selected dwellings. In due course an Article 4(2) Direction will be drawn up and appropriate consultation will take place in due course.

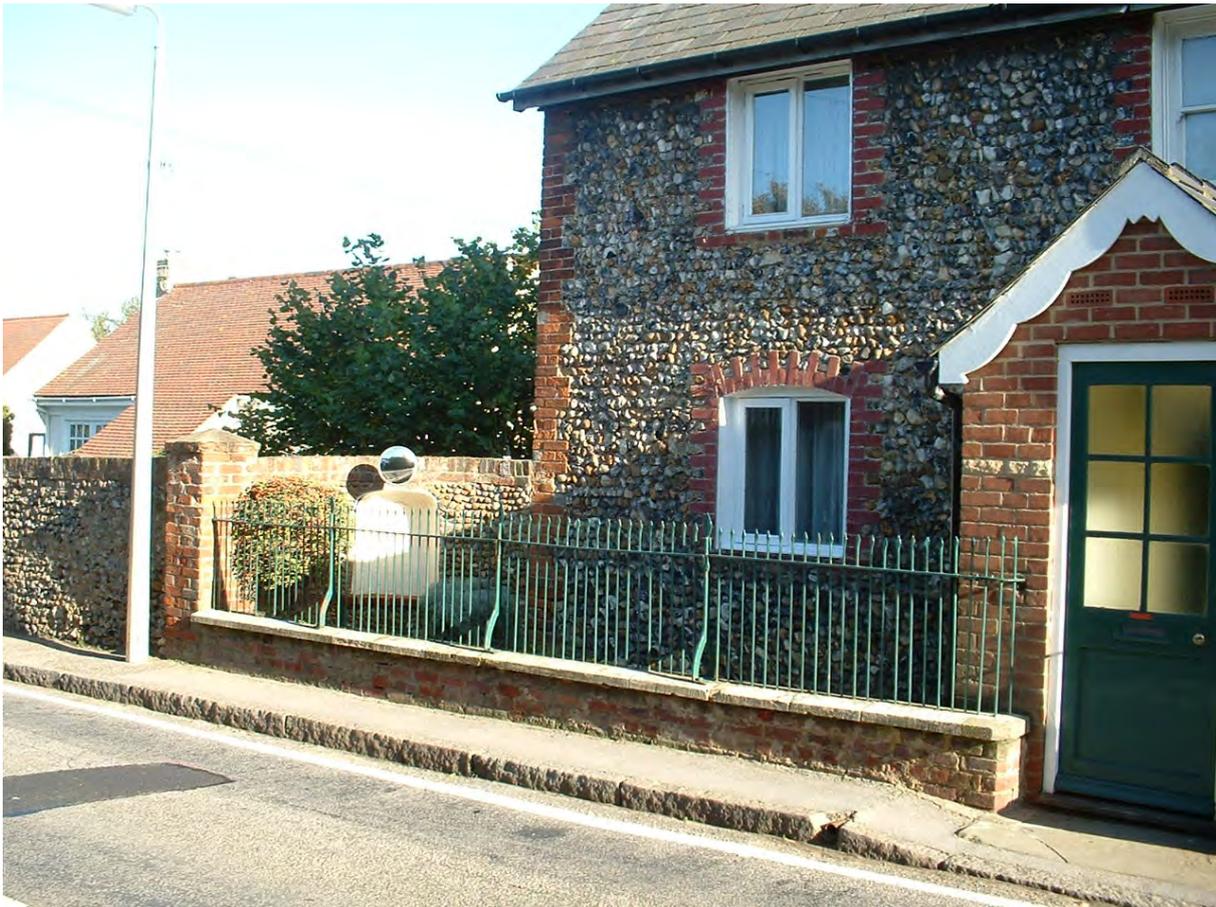
Figure 2.3 Distinctive railings to be protected

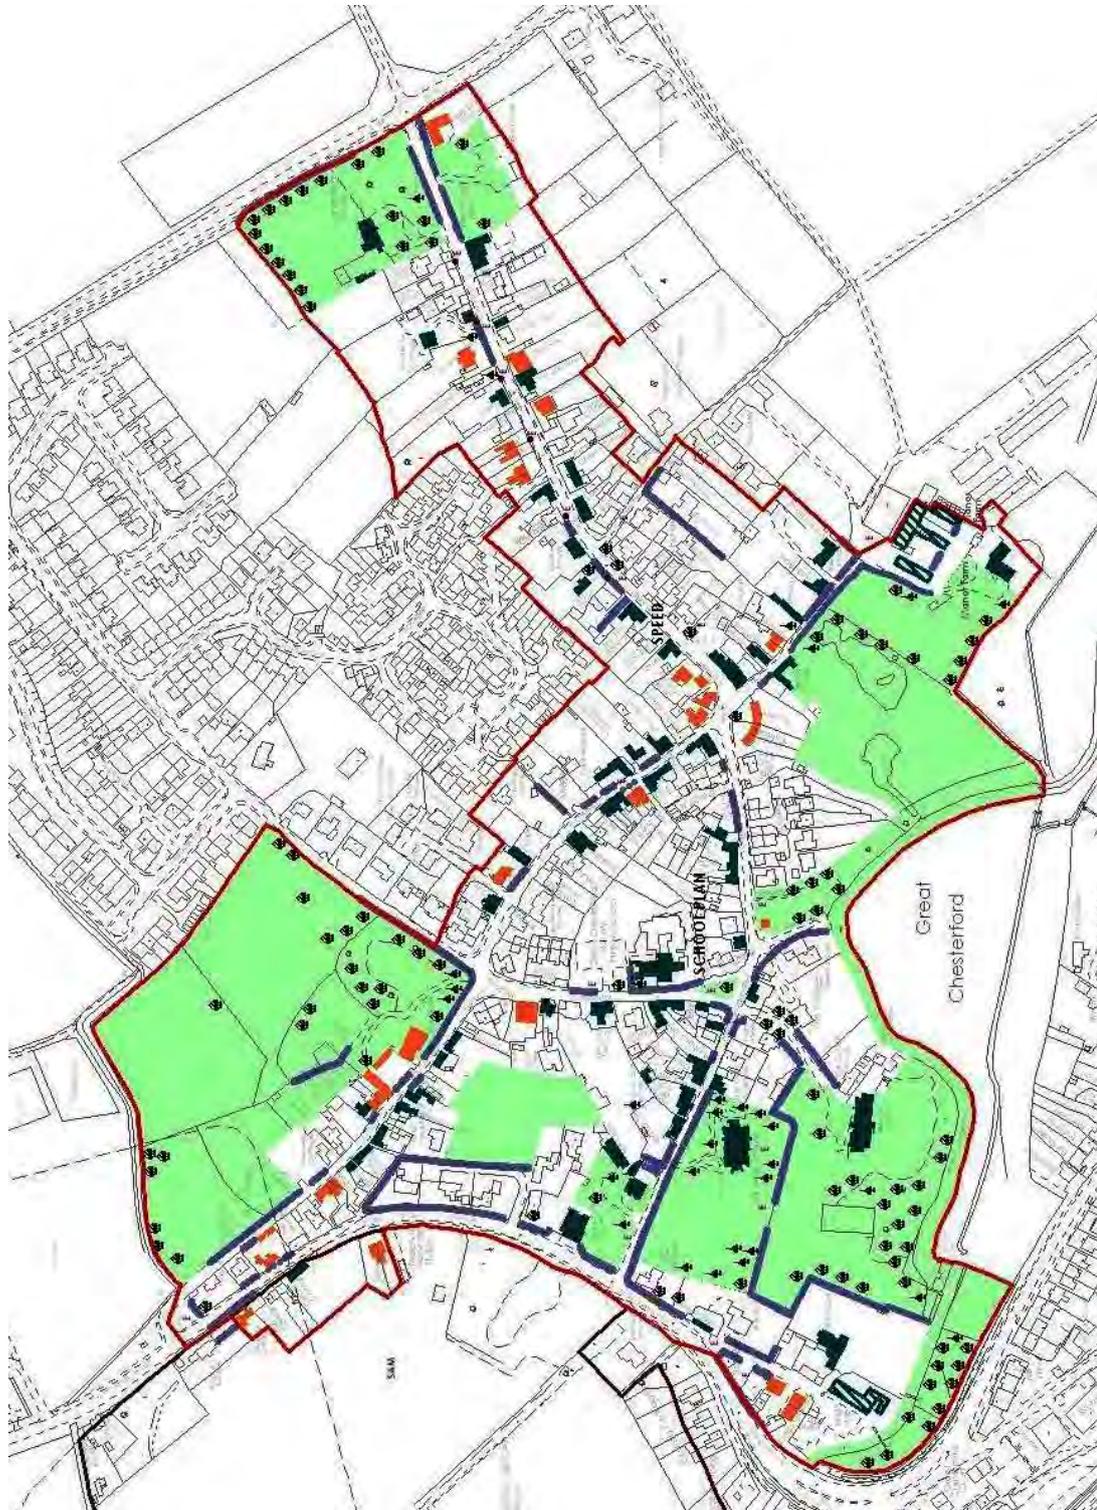
Figure 3.8 Mangement Plan

2.17 The general locations of trees that make a particular contribution to the conservation area are illustrated on Figure 8. Other trees also contribute to the quality of the street scenes. As noted in the appraisal all trees in the conservation area (subject to exceptions) are afforded protection, as owners have to notify the council if they wish to undertake works to them. Many trees have been made subject to Tree Preservation Orders.

2.20 The walls of quality are shown on Figure 8. Some are within curtilages of listed buildings where listed building consent will normally be refused for any proposal involving their demolition. Others are not in the curtilages of listed buildings and as such are unprotected. The council therefore proposes to introduce an Article 4 Direction to remove the right to remove selected walls and railings and appropriate consultation will take place in due course.
