Stansted Mountfitchet Conservation Area Appraisal and Management Proposals, Approved April 2007

Part 1 - Appraisal 1

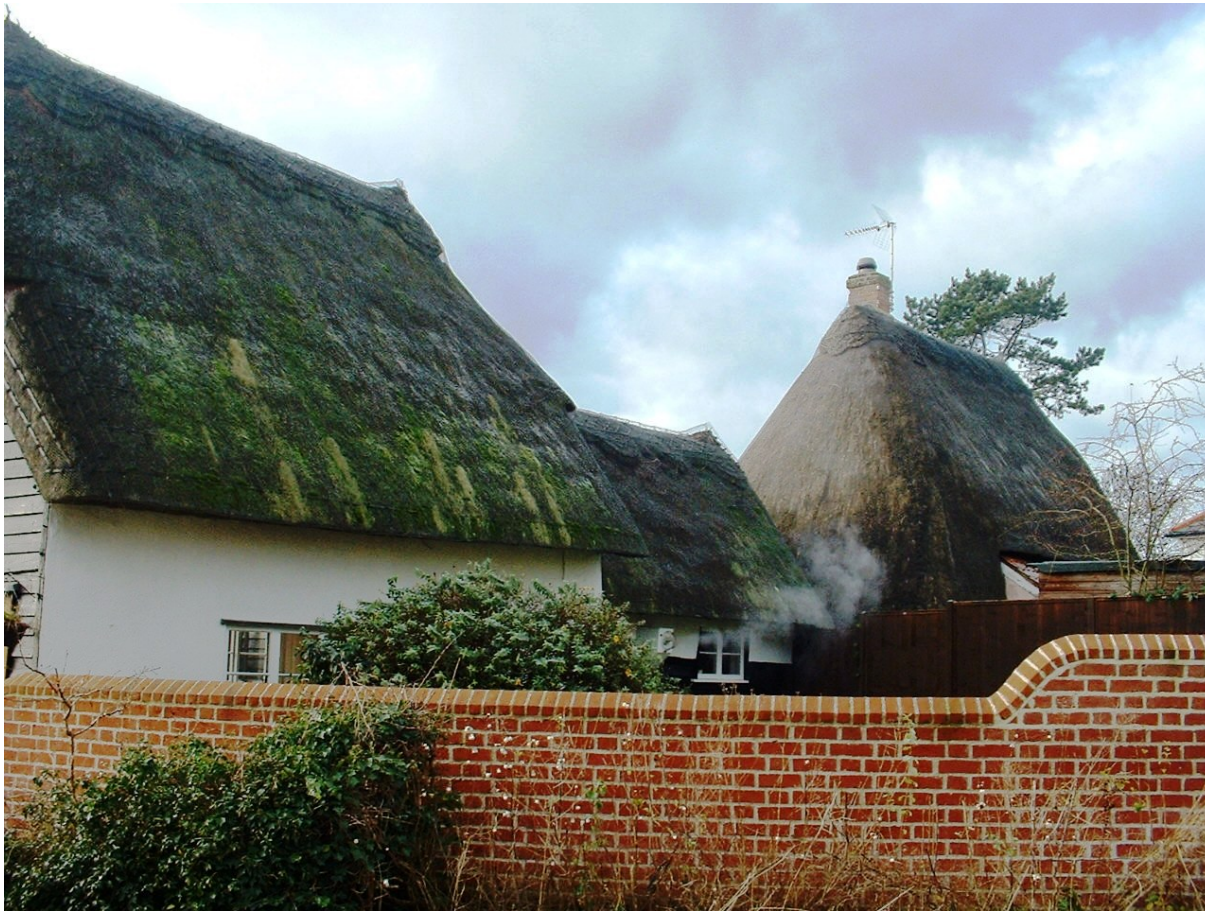
Picture 1.3 Thatched properties, Bentfield End

1.51 Many buildings abut the two streets whilst the wide range of 19th century terrace dwellings that provide significant historic interest from this period to the north side of Bentfield End Causeway, are set back a short distance parallel from it. The listed buildings and barns at Bentfield Place, successfully converted to residential and commercial uses, provide additional variation of architectural scale.

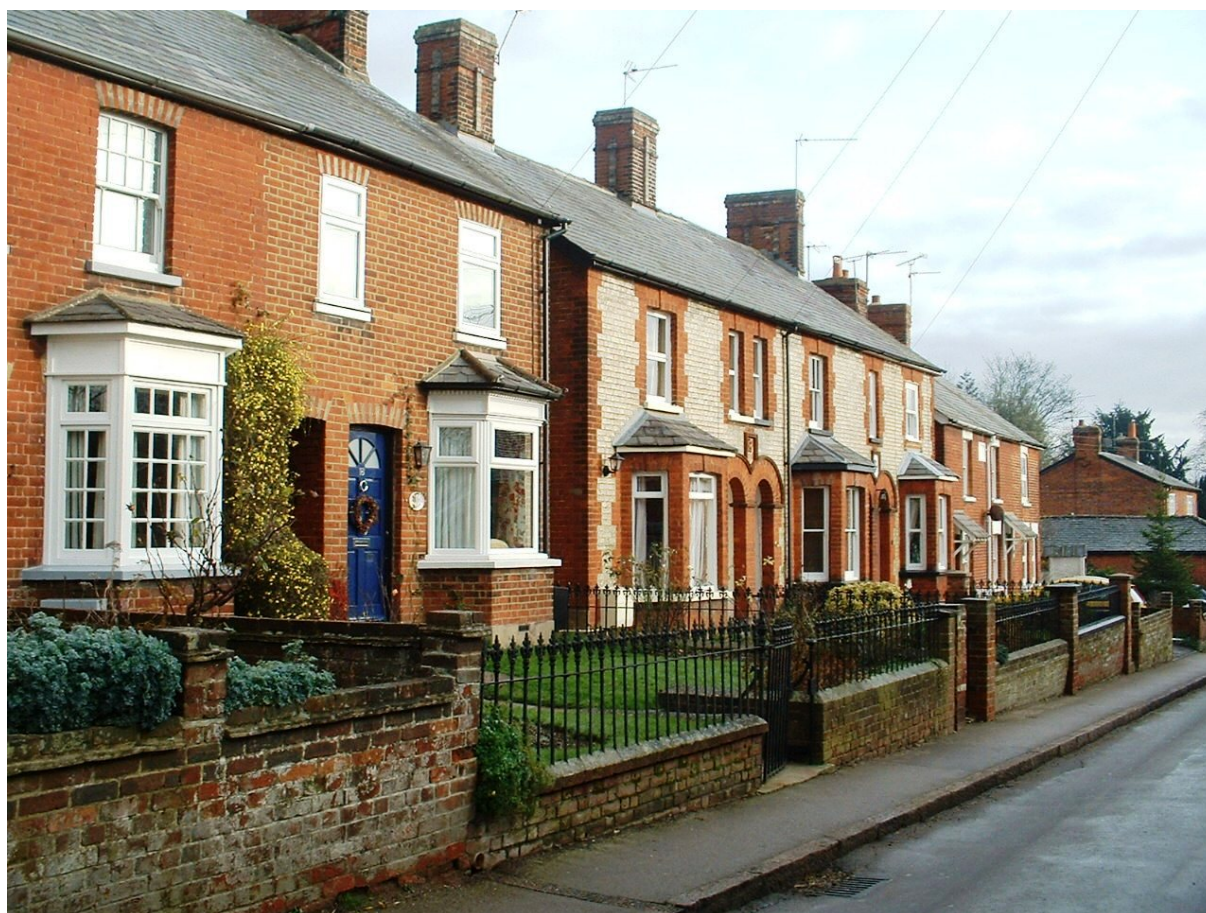
1.67 This whole range of 19th/20th century buildings are representative of a number of styles of the period, varying from simple to ornate. Although many windows have been replaced the overall impression is one of architectural rhythm representing an interesting range and development of 19th century terrace housing.

Picture 1.4 Range of C19 and C20 dwellings displaying simple architectural rhythm

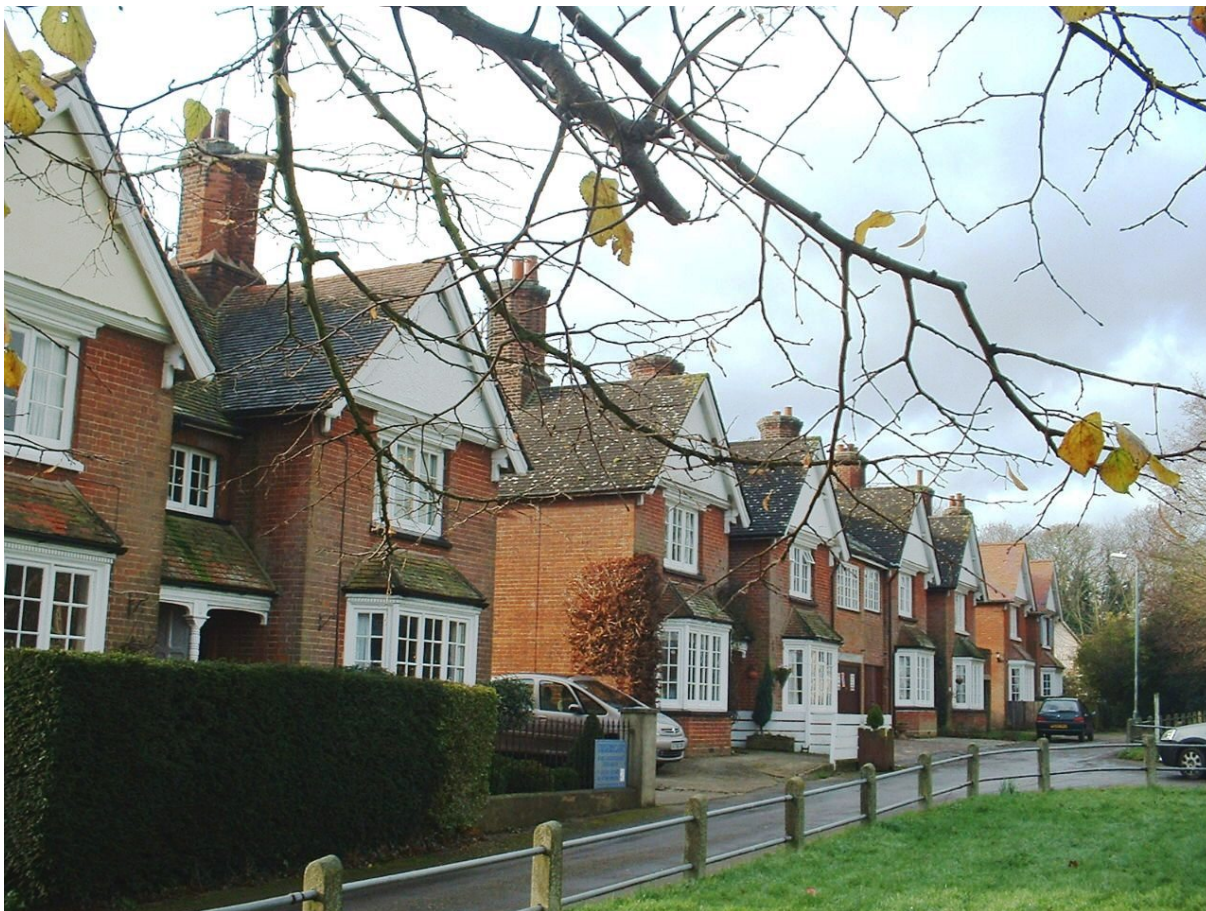
Picture 1.8 Recreation Ground. Fine unspoiled early C20 houses

1.105 Nos. 43 – 57. Fine groups of two storey early 20th century dwellings of brick construction with tiled roofs, mostly original. They are largely unaltered in nearly all respects, displaying unusual and distinctive chimneystack shafts, recessed doorways with wooden detailing, decorative bay windows with tiled roofs, original casements window ranges and simple bargeboards to front.

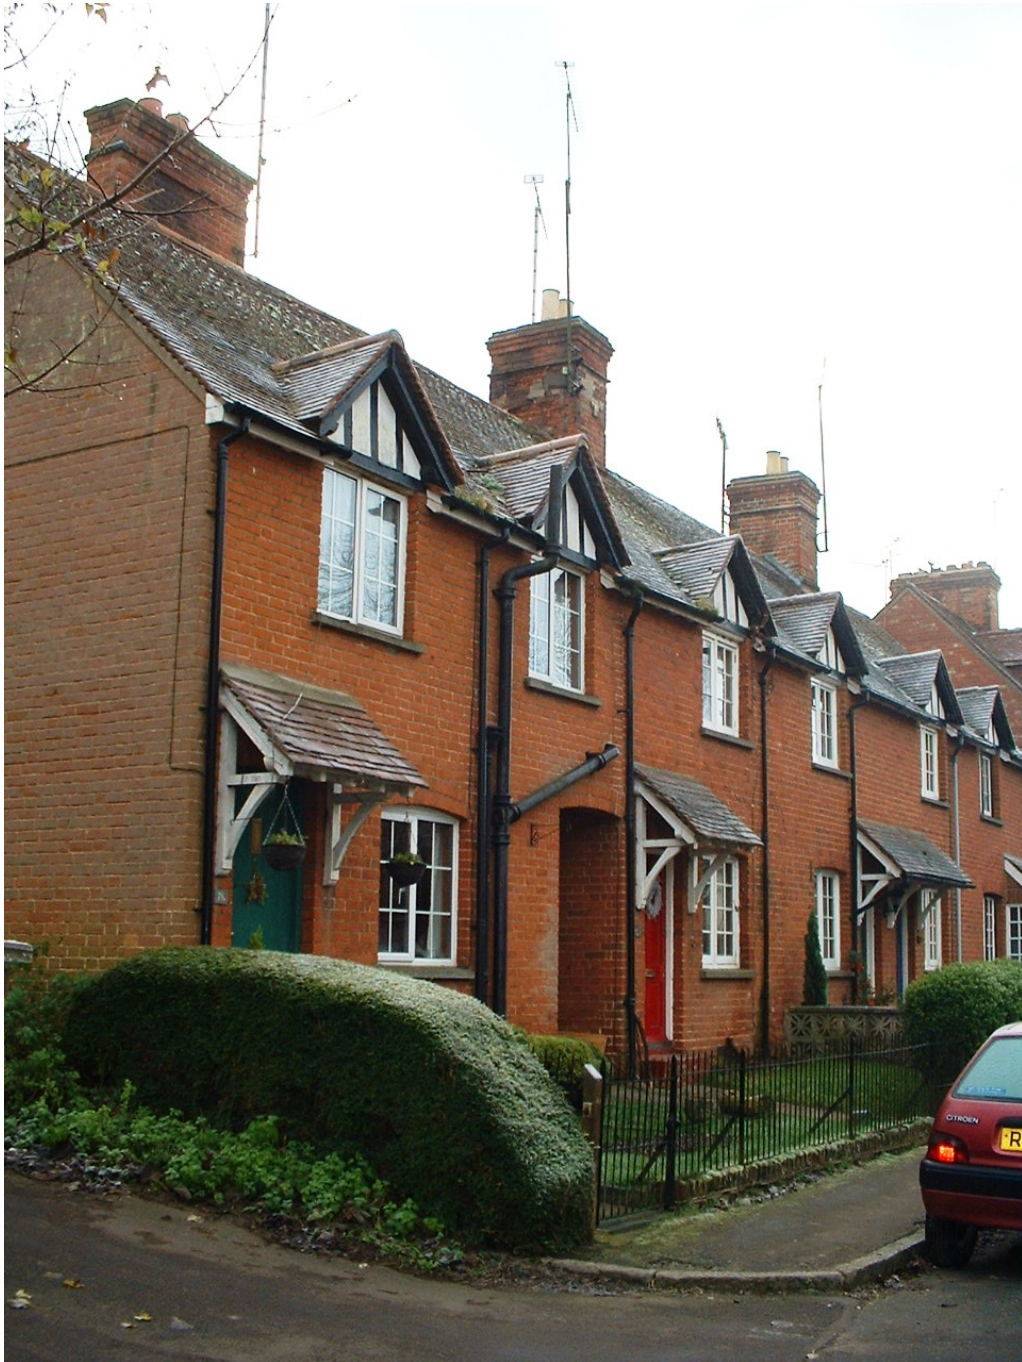
Picture 1.11 Late C19 cottages with original porches

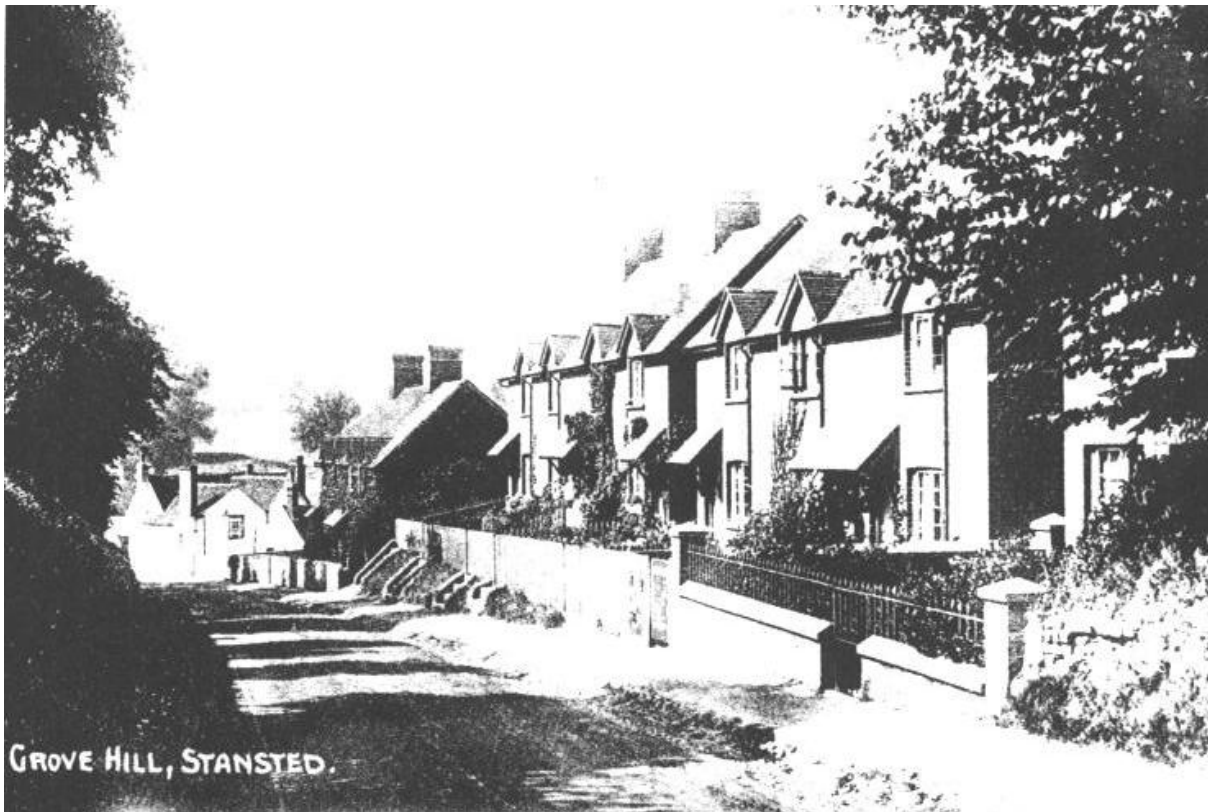
Picture 1.12 Grove Hill, circa 1914

1.148 Nos. 7 – 27. Three groups of late 19th century cottages of red brick construction with tiled roofs and original chimneystacks. Some original steps. Vertical wooden detailing to dormers. All original porches. A length of flint wall capped with half round brick defines curtilage of nos. 7 – 9. Despite large numbers of replacement windows, these cottages with their porches are very representative of the period and are an interesting element of the community's historic building stock.

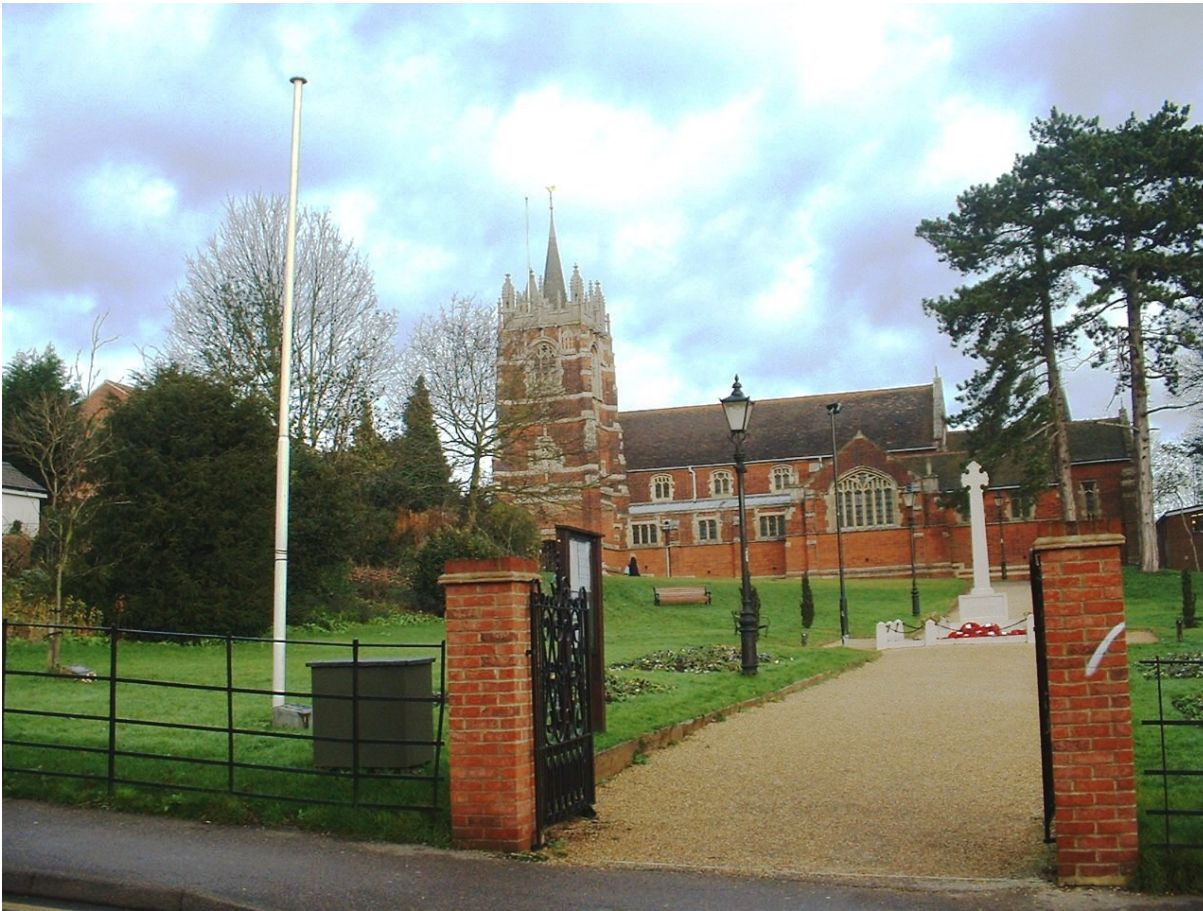
Picture 1.13 The War Memorial and St Johns Church

1.152 Important trees and open spaces. The war memorial site is an important open space the central feature of which is the memorial itself, constructed of white stone. Simple railings to the Chapel Hill street frontage enclose the site. Internally there are seats, flowerbeds and structure planting that lack overall cohesion. There is also a confusion of notices. It is considered that the site would benefit from rationalisation and the introduction of a greater sense of formality and planting, particularly on the eastern and western boundaries. It is considered that such an approach would increase the sense of dignity, necessary in such locations. The council would prepare such a landscaping scheme if requested. One solution would be to define the edges with yew hedging whilst maintaining the view of the church

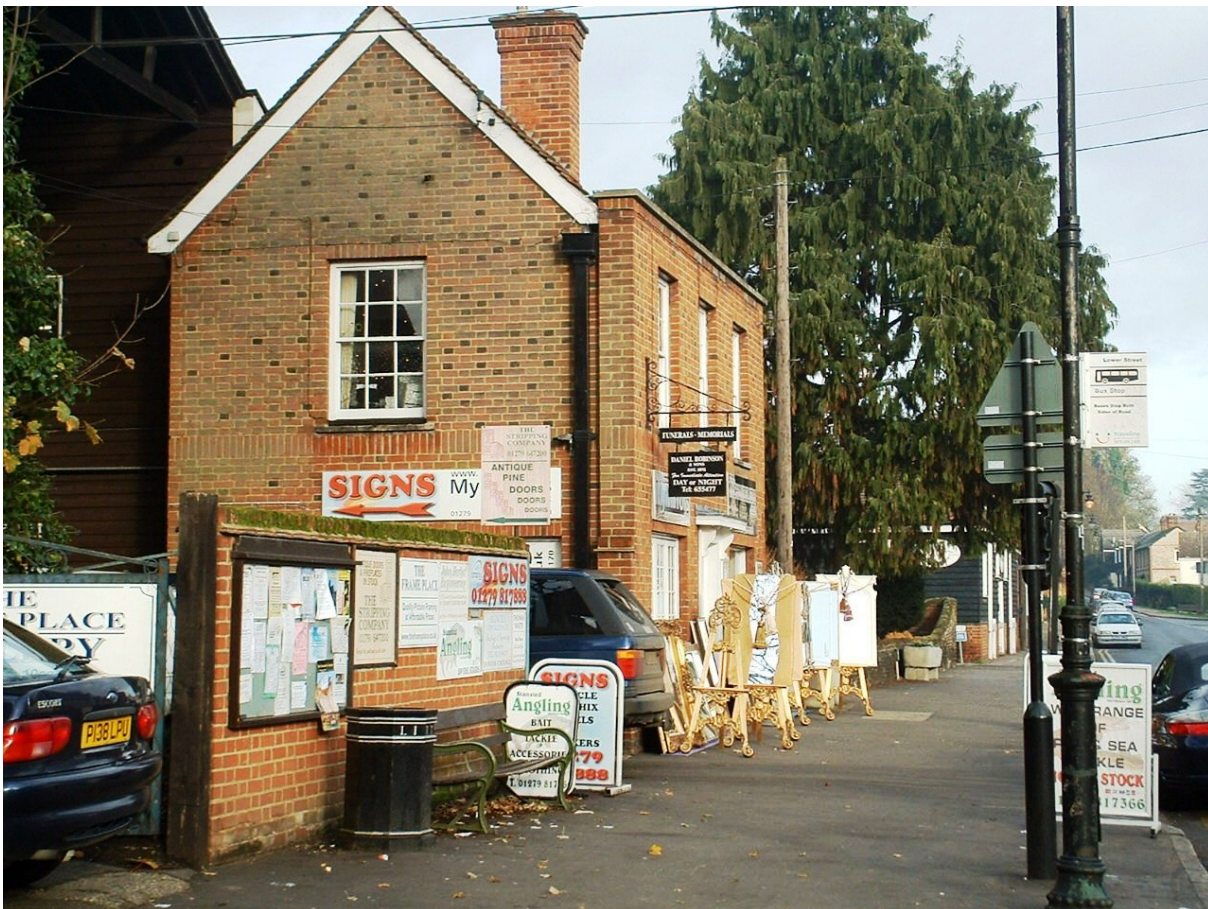
Picture 1.14 Detracting signs and clutter, Lower Street

1.162 Broken railings to the front of the Stansted Mountfitchet Social Club are in need of repair. Also in this area there is a profusion of signs and redundant pole in need of rationalisation and also a Telephone kiosk with royal crown in need of some glass replacement.

Detracting element	Location	Proposed action
Derelict building	Peter Kirk School site	Liaise with Essex CC to secure removal
Dilapidated fencing	As above	Liaise to seek replacement/ reduce impact
Approach steps and boundary	Stansted Free Church	Liaise with owner to seek improvements
Signs etc	Adjacent 27 Lower Street	Establish status and liaise with owners to reduce impact
Missing slates	Youth Centre, Lower Street	Liaise with Essex CC and seek necessary repairs
Broken railings and confusion of signs etc	Near Stansted Mountfitchet Social Club	Liaise with owners to repair railings and with others to reduce impact of signs etc and repair glass to telephone kiosk
Poor quality fencing	Grove Hill boundary of no.40 Lower Street	Liaise with owners to secure improvements
Poor quality fencing	Corner of Woodfields and Chapel Hill	As above

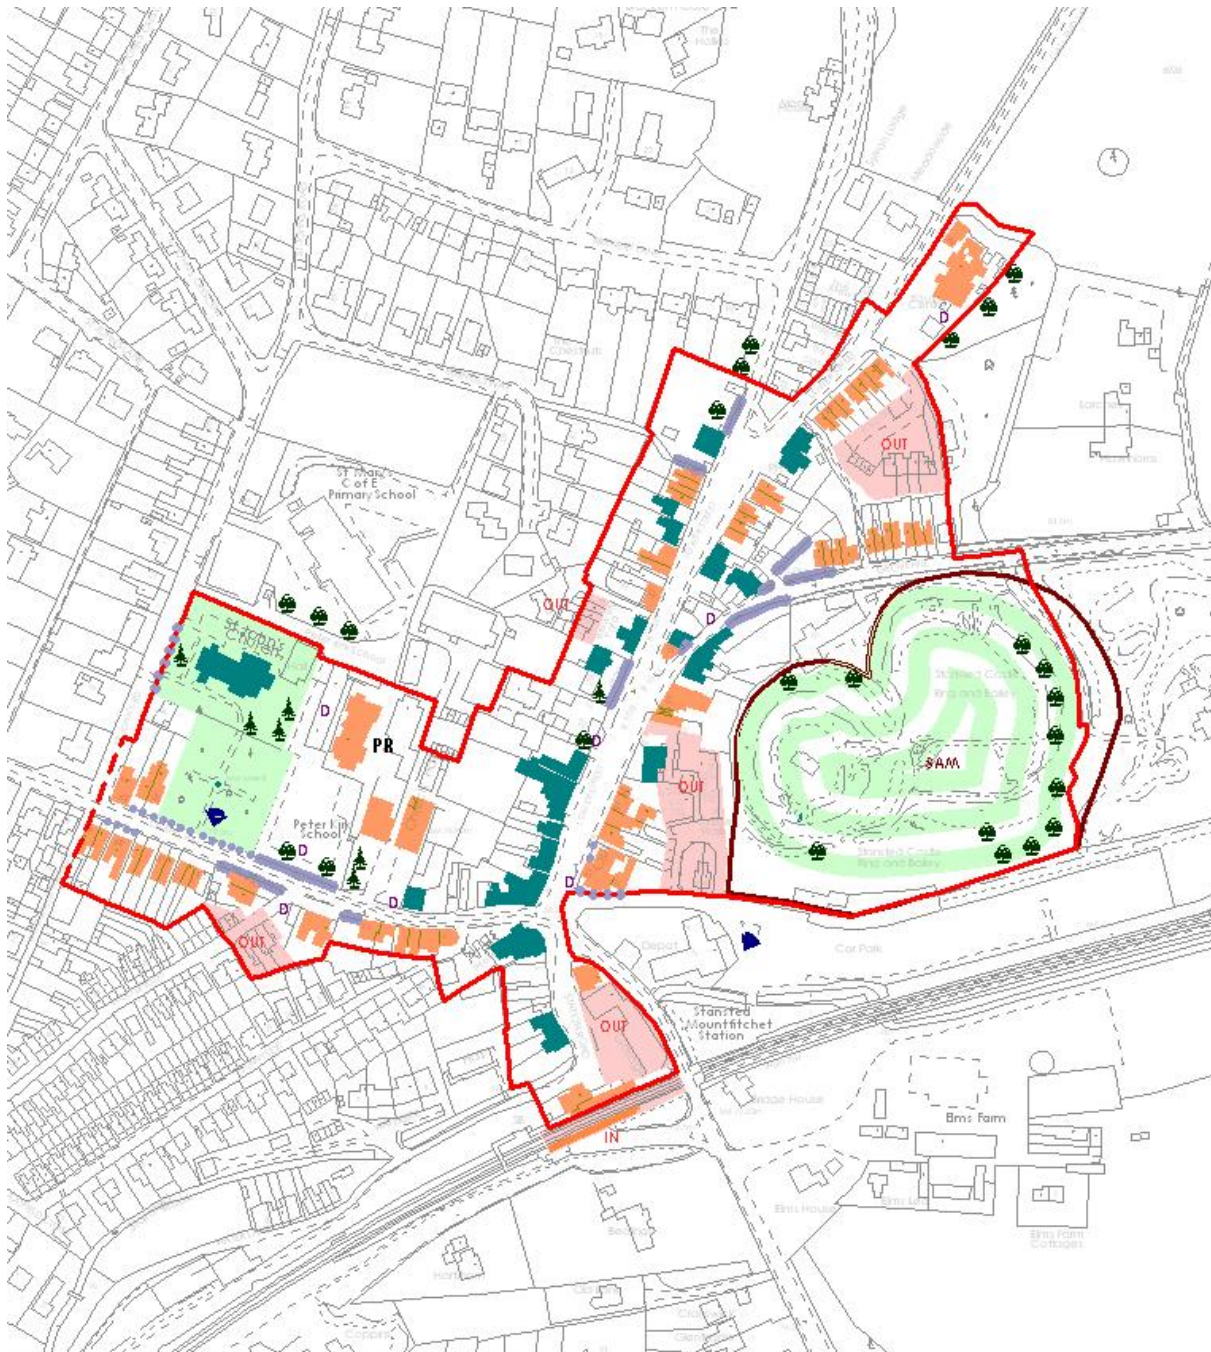
Fig.4 - Area 3

1.112 The details described below are shown on figure 4.

Figure 3.4 Area 3
