Great Hallingbury Conservation Area Appraisal and  
Management Proposals, Approved June 2014

**1.1** This appraisal has been produced by Officers of Uttlesford District Council to assess the current condition of the Great Hallingbury Conservation Area, to identify where improvements can be made and to advise of any boundary changes that are appropriate. The document is in draft form and will be subject to public consultation and agreement by District Council Members.

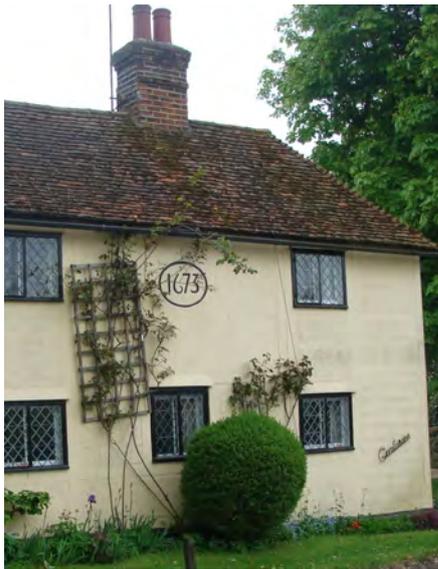
Picture 1.3 Pargetting, colour-washed plaster and simple detailing on Centuries in Church Road

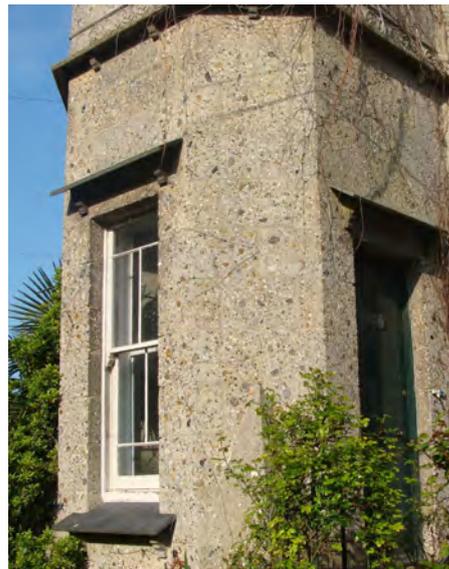
Picture 1.4 Glebe House constructed of concrete and exposed aggregate block detailing in the Scottish Baronial Style

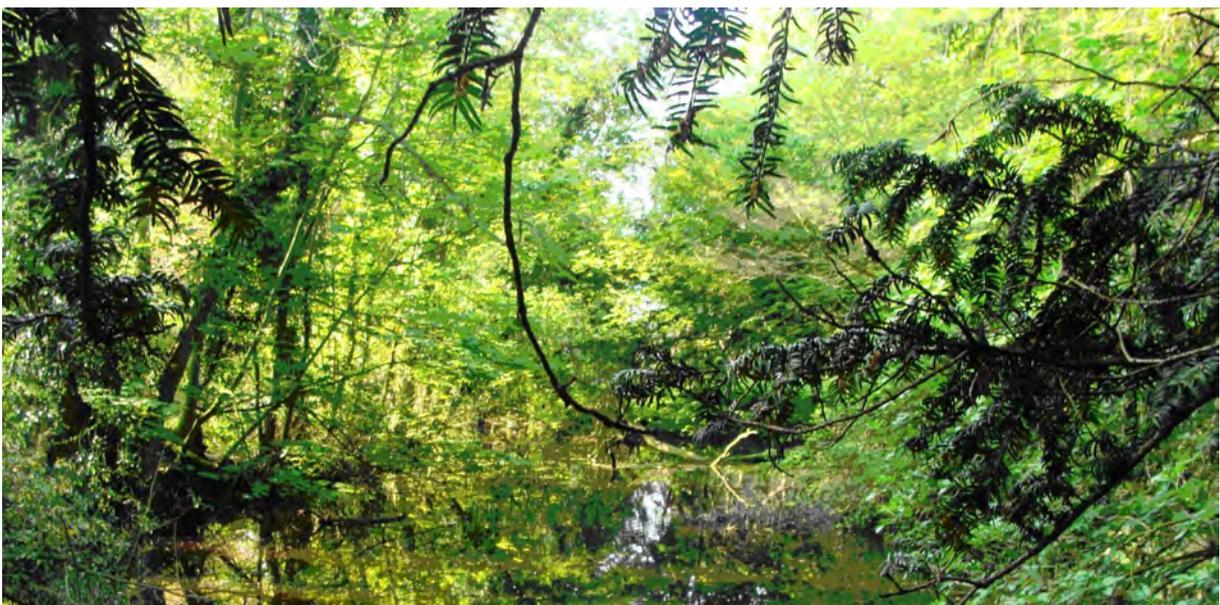
**1.59 Scheduled Ancient Monuments.** Moated site north of Glebe House. (The following description is an abbreviated version of the scheduling text). "*Around 6,000 moated sites are known in England...The majority of moated sites served as prestigious aristocratic and seigneurial residences with the provision of a moat intended as a status symbol rather than a practical military defence. The peak period during which moated sites were built was between about 1250 and 1350 and by far the greatest concentration lies in central and eastern parts of England. However, moated sites were built throughout the medieval period, are widely scattered throughout...*

**1.60** ... *The Old Rectory [Glebe House] moated site remains essentially undisturbed and will retain archaeological information relating to the occupation of the site. The water-filled ditches will retain environmental evidence pertaining to the economy of its inhabitants and the landscape in which they lived. The monument includes a moated site...immediately north of Glebe House... The monument includes a sub-rectangular moated site of which the eastern arm has been infilled but will survive as a buried feature. The remaining moat ditches describe a horseshoe shape ... A causeway 2.5m wide across the southern arm gives access to the island which has earthworks indicating the subsurface remains of earlier buildings on the site.*<sup>(6)</sup>.

Picture 1.7 Moated site north of Glebe House, a Scheduled Ancient Monument. Such homestead moats may have been more prestigious as opposed to having real military purpose

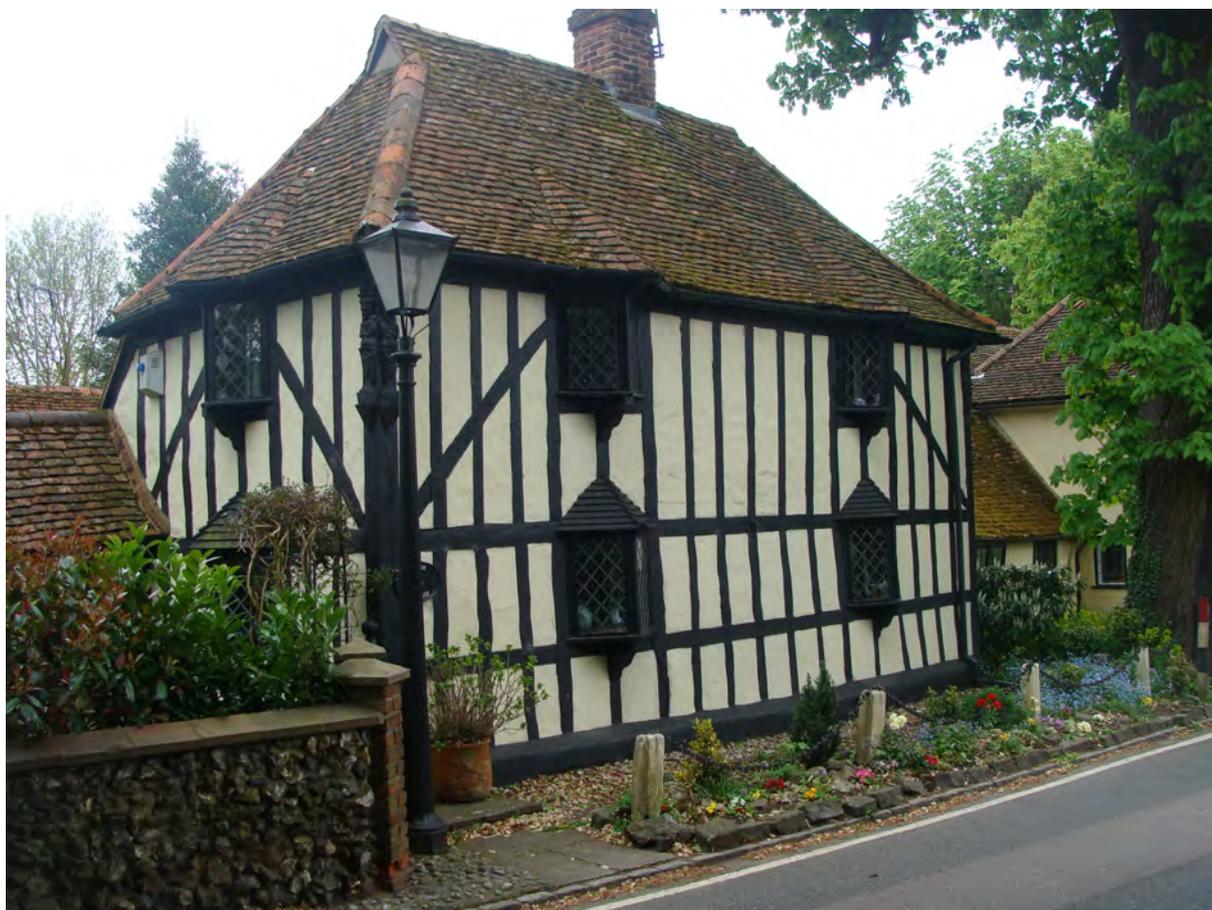
**1.65** Tudor Cottage, Church Road – Grade II. Early to mid 15th century. Hipped plain tile red roof with gablets. Exposed timber frame with plaster infill. 2 storeys with 2 range triangular oriel windows, leaded diamond panes on shaped brackets. Carved figures added to corner posts under eaves. Central red brick square chimney stack.

Picture 1.8 Tudor Cottage, a Listed Building dating from the 15th century, prominent in the street scene

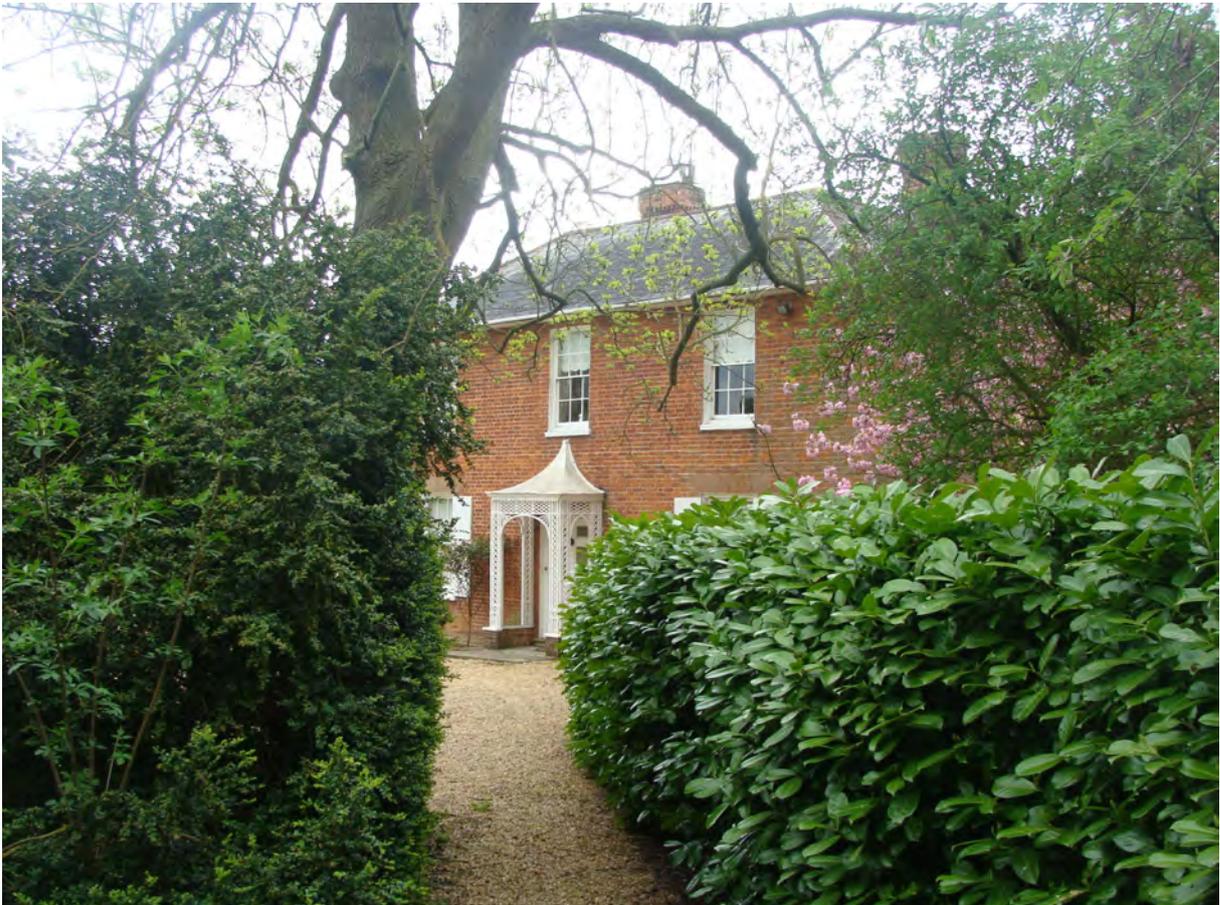
**1.66** The Hall, Church Road – Grade II. House. Early 19th century front, red brick with hipped grey slate roof. Brick dated 1813. Timber framed and plastered 16th and 17th century ranges at rear. Fine metal tent porch supported by ornamental pillars with matching frieze. 2 red brick chimney stacks. Homestead moat.

Picture 1.9 The Hall viewed from the churchyard

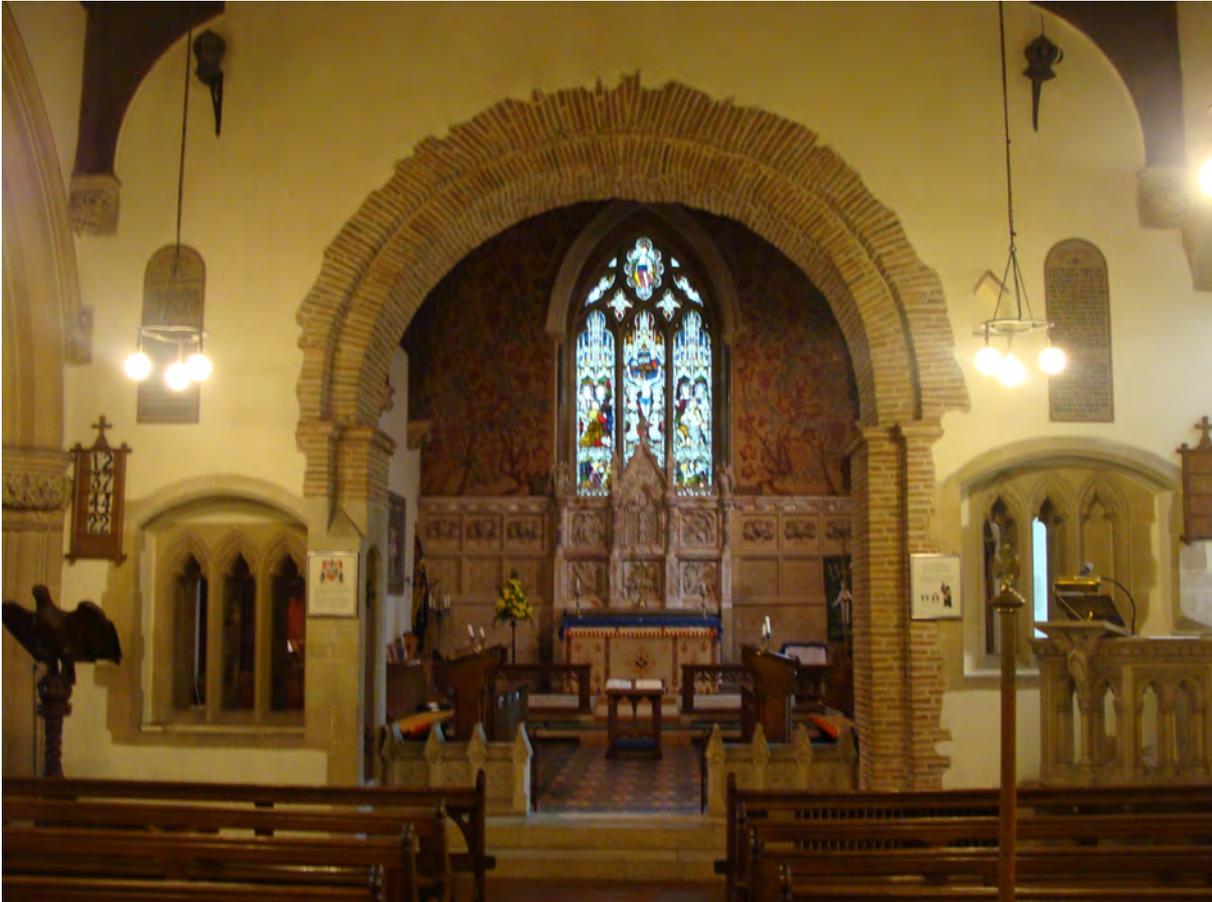
the main feature is the complete early Norman chancel arch built entirely of Roman bricks. The Victorian arcade is of circular piers with richly carved foliage capitals. There is a late 11th century window in the south west wall of Roman brick.

Picture 1.10 The early Norman chancel arch in St Giles church built entirely of Roman bricks

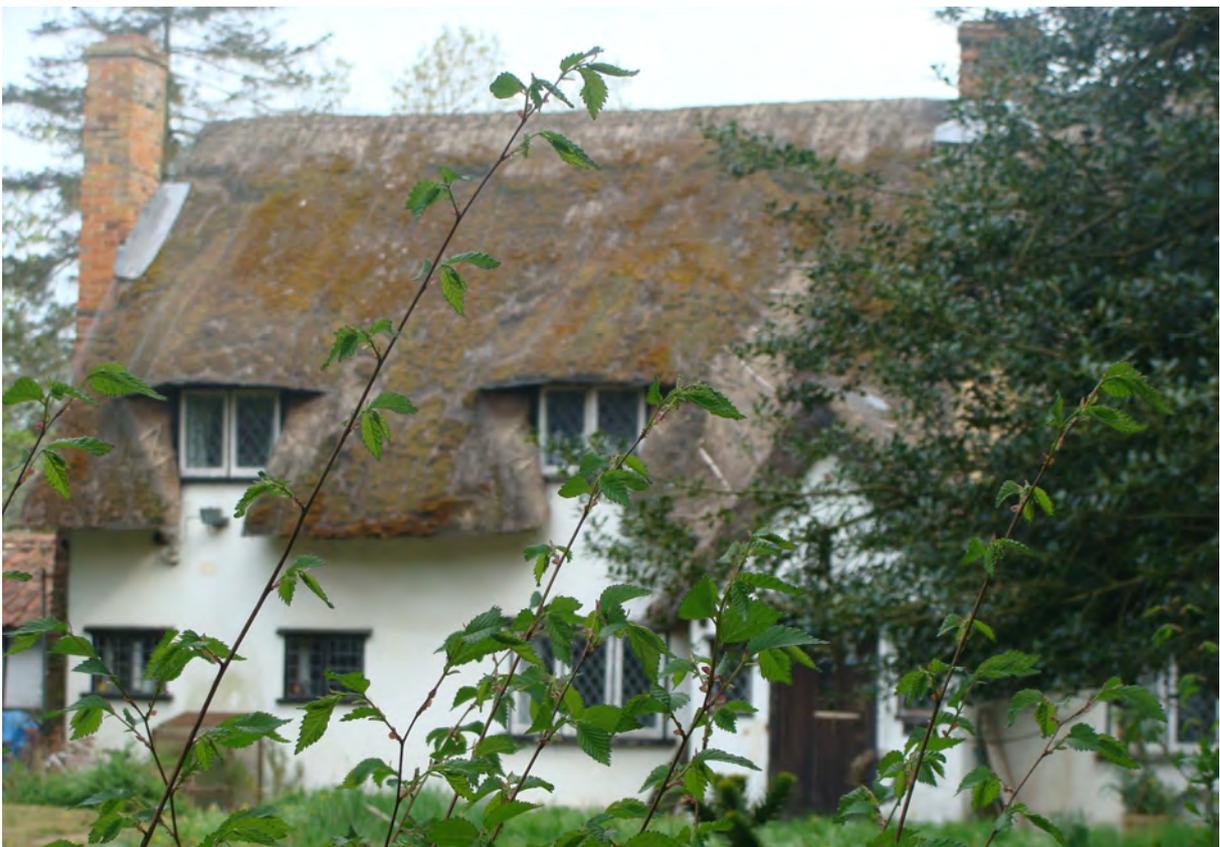
**1.72** Nos. 18 and 19 Church Lane – Grade II. (Now called Hunters End) Cottage 16th -17th century. Thatched roof, timber framed and plastered. 1 storey and attic with curved dormers and a single storey gabled wing. 2 red brick chimney stacks. *The thatched roof is in need of repair, particularly the ridge which is a particularly vulnerable element of a thatched roof. This is the only thatched property in the Conservation Area, a fact which emphasises the need to retain it.*

Picture 1.12 Hunters End. The only thatched property in the Conservation Area whose ridge is particularly in need of repair/ replacement

Other actions
Necessary repairs to pedestrian access gates to churchyard were noted in the original survey. Repairs have recently been completed and the gates now re-hung
Undertake minor repairs and restoration to Houblon tomb in churchyard
Seek owner's co-operation to secure necessary repairs to deteriorating thatched roof at Hunters Lodge

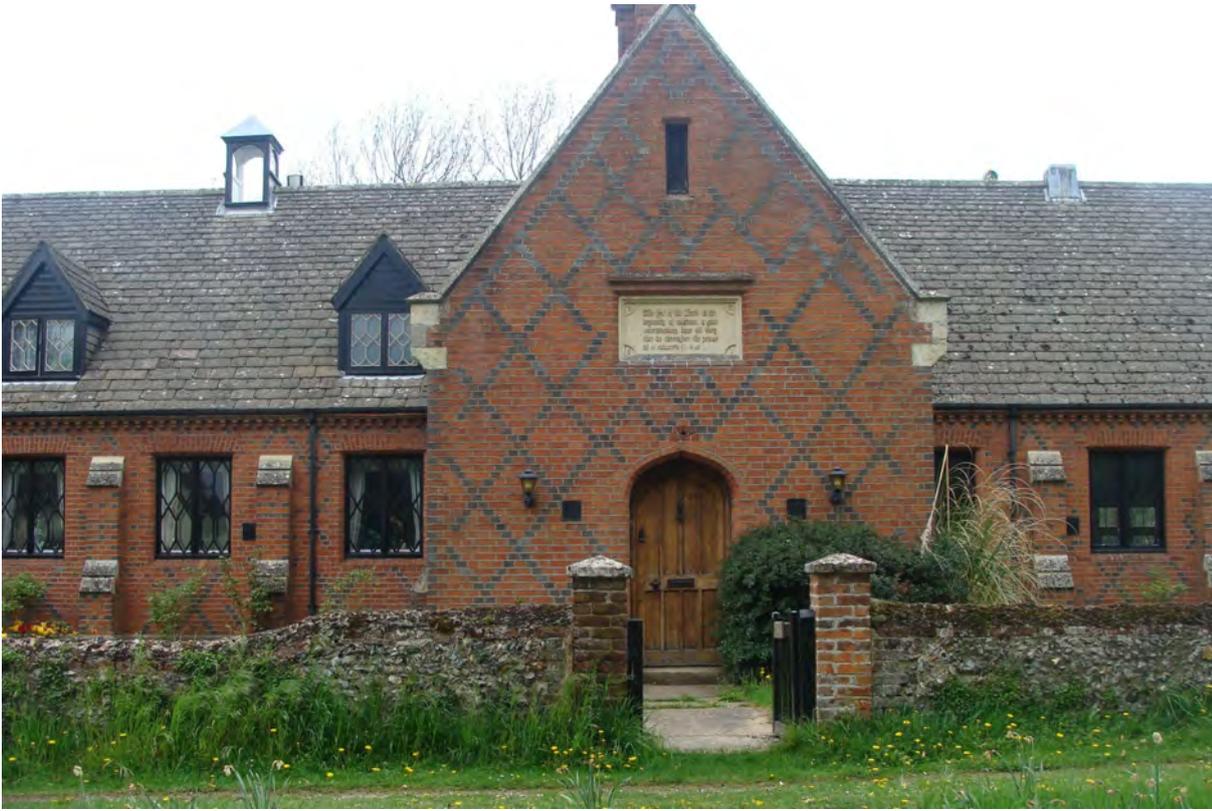
**1.73** Church of England Primary School (*now residential*) – Grade II. Circa 1848 a single storey village school built of red brick with black diaper pattern of headers, in a restrained Jacobean style. A carefully detailed school design for this period.

Picture 1.13 The former school building now converted to residential. The central plaque is inscribed although some lettering has deteriorated and cannot be read. It commences 'The fear of the Lord is the beginning of wisdom...' a typical Victorian sentiment

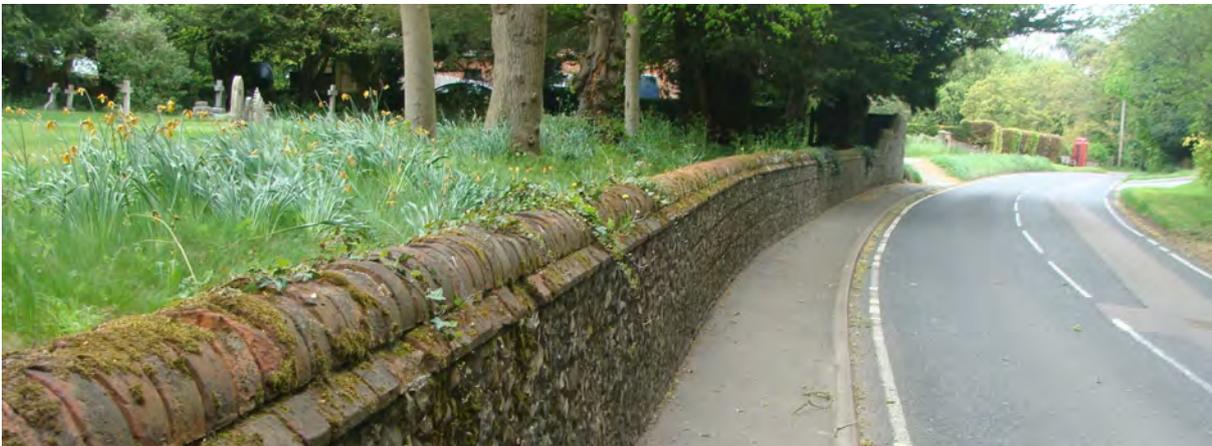
**1.75** Wall surrounding churchyard. 19th century boundary flint wall with rounded capping detailing.

Picture 1.14 The wall surrounding the churchyard is an important and strong feature in the street scene

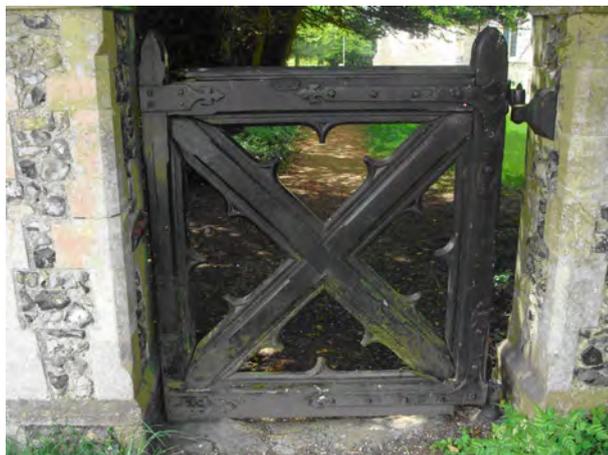
**1.76** Two wooden pedestrian gates forming part of the 19th century boundary wall to the churchyard. Design typical of their period. Both were noted as being in need of repair in the original survey. Repairs have recently been completed and the gates re-hung.

Picture 1.15 One of two fine pedestrian gates to the churchyard prior to repairs being undertaken

**1.87 Opportunities to secure improvements.** Undertake repairs to Houblon Tomb in churchyard. Repair both wooden pedestrian gates to churchyard.

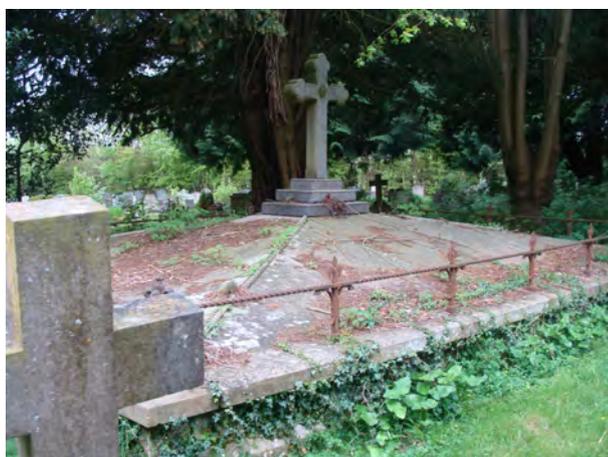
**1.77** Tombs in churchyard. Of particular note is the Houblon tomb which is in need of cleaning and minor restoration. The church was largely rebuilt by John Archer Houblon in 1874 who was then Lord of the Manor of Great Hallingbury. The latter was descendant of Protestant merchants fleeing the continent and settling in London. John Houblon was first governor of the Bank of England in 1694, whose image appears on the back of the series E £50 notes issued in 1994.

Picture 1.16 The Houblon tomb in need of minor repair and restoration. The churchwarden advised the fieldworker that contact had been made with the family in this respect

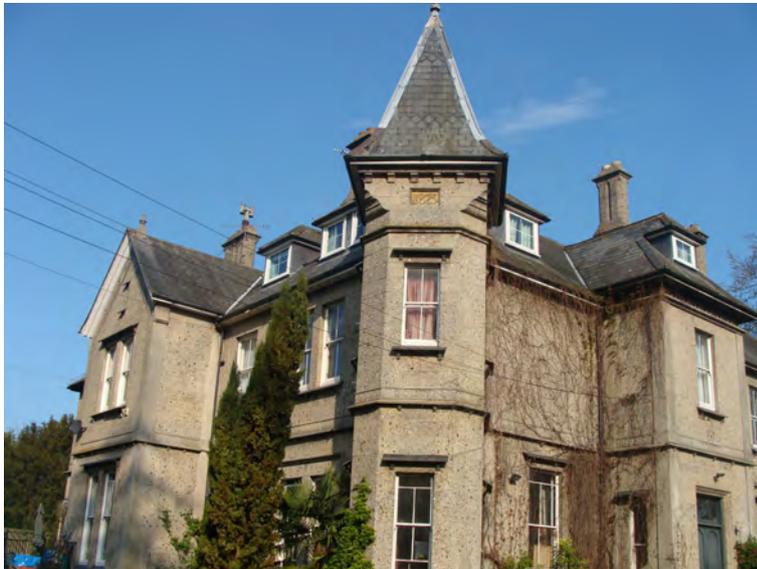
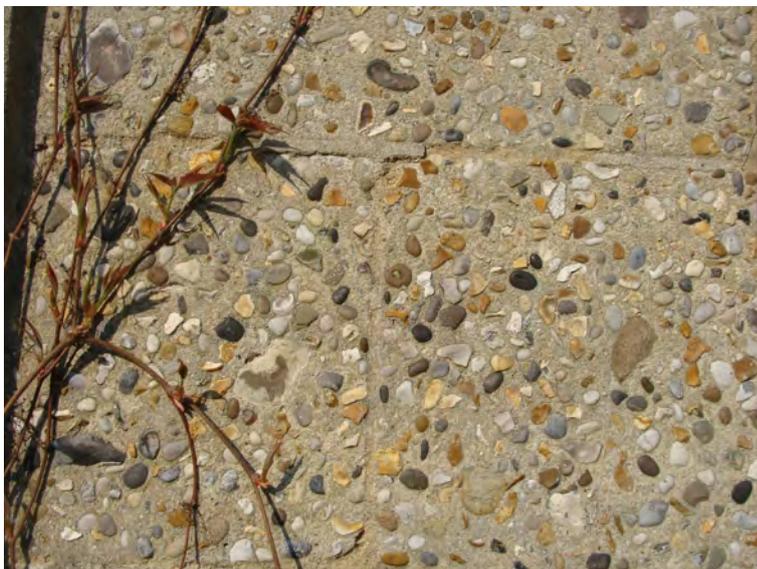
Picture 1.17

**1.79 Other buildings that make an important architectural or historic contribution.** Glebe House, Church Road. A large tall 19th century residential building, formerly a Rectory, now divided into flats. Constructed of or faced with aggregate blocks with decorative horizontal detailing. Slate roof with dormers and chimney ranges with pots. Some original sliding sash windows and door detailing. Tower folly to south west corner with date plaque 1875. In large grounds with mature trees and homestead moated site. A most unusual building with the features described worthy of retention.

**1.80** One resident advised the fieldworker that the building was erected by a Rector previously living in Scotland who desired to replicate the stone appearance of a Scottish mansion. However as natural stone proved too expensive he elected to use the emerging concrete/aggregate technology.

Picture 1.18 Glebe House, Church Road. An unusual late 19th century building constructed of or faced with concrete and exposed aggregate block detailing. Unusual and most worthy of retention

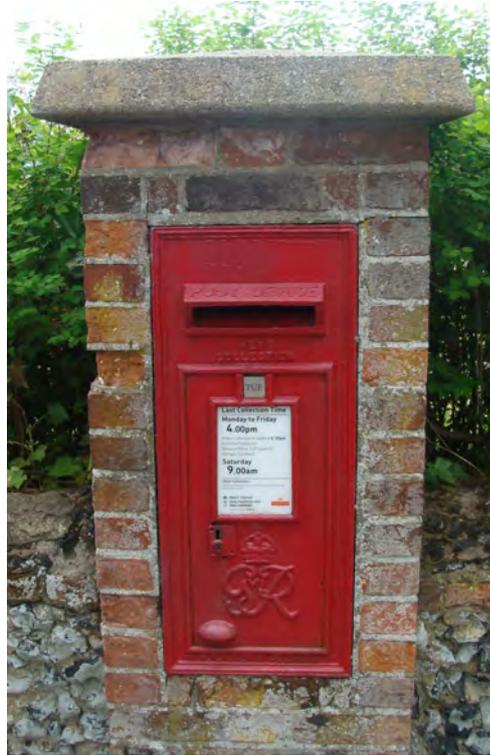
**1.81 Other distinctive features that make an important architectural or historic contribution.** Mid-20th century George VI Post Office Box in brick pier inserted in 19th century wall. Motif reads G VI R surmounted by Crown.

Picture 1.19 Mid-20th century letter box

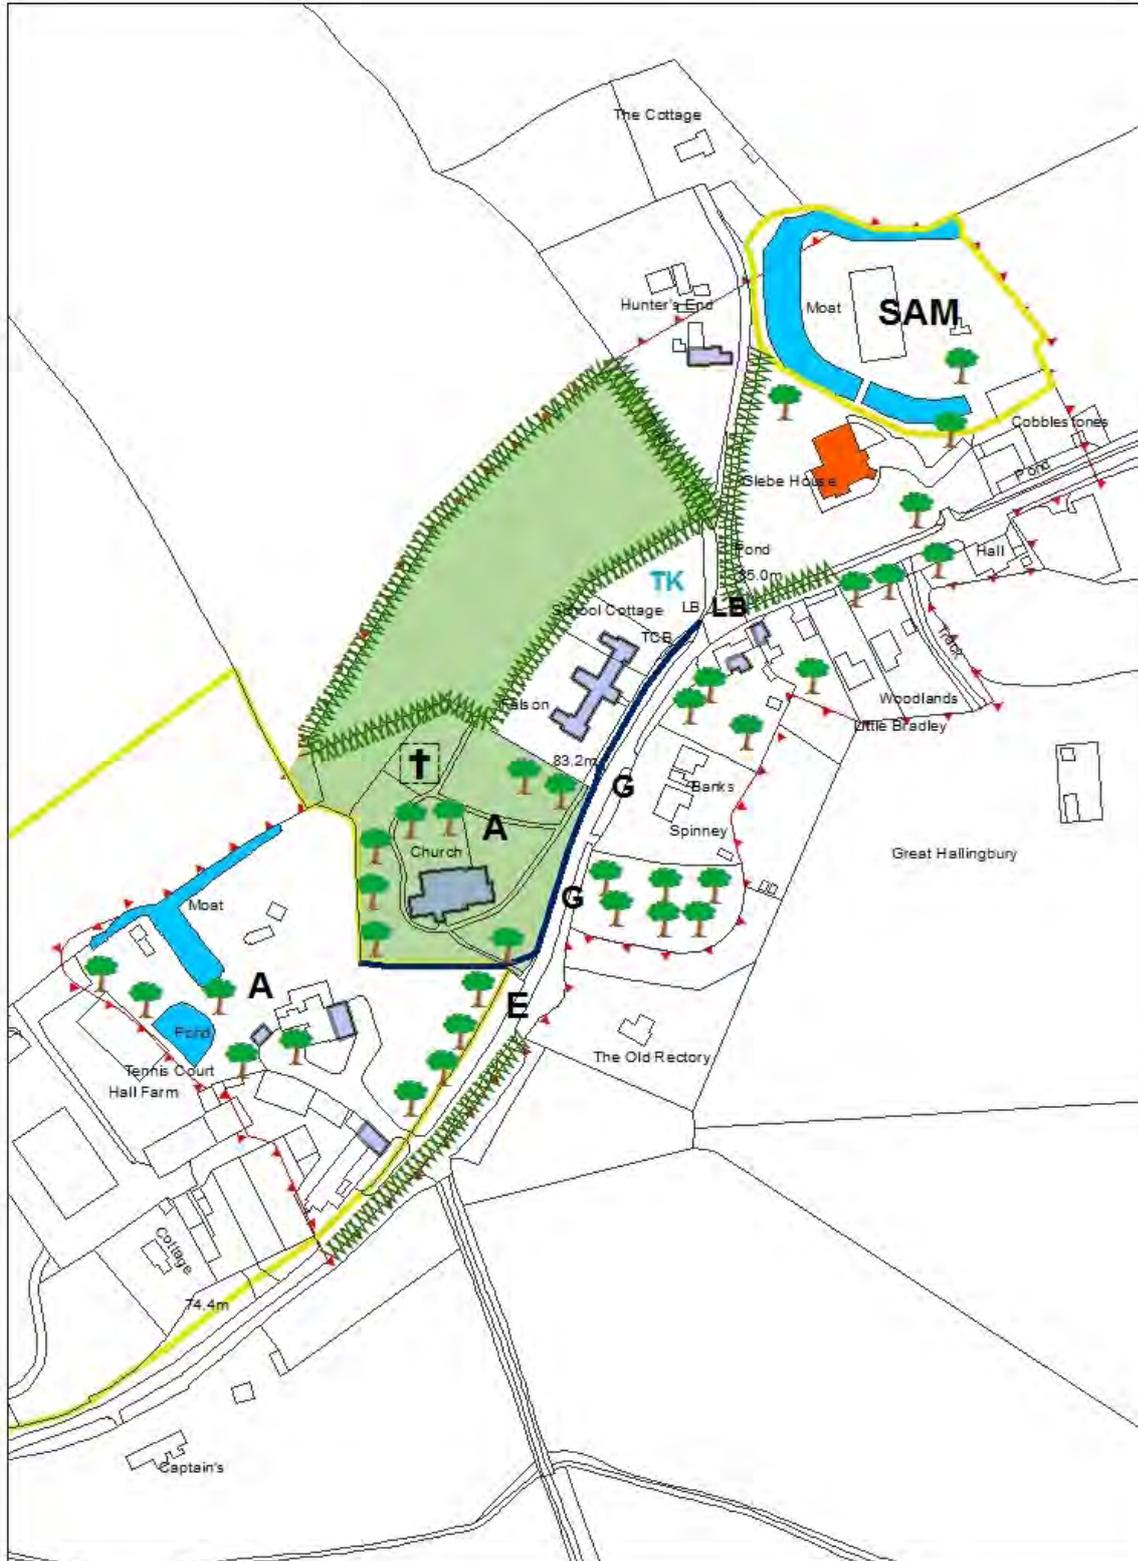
**Figure 3 - Management Plan**

Great Hallingbury Conservation Area Appraisal - Management Plan
