**Elmdon Conservation Area Appraisal and Management  
Proposals, Approved December 2014**

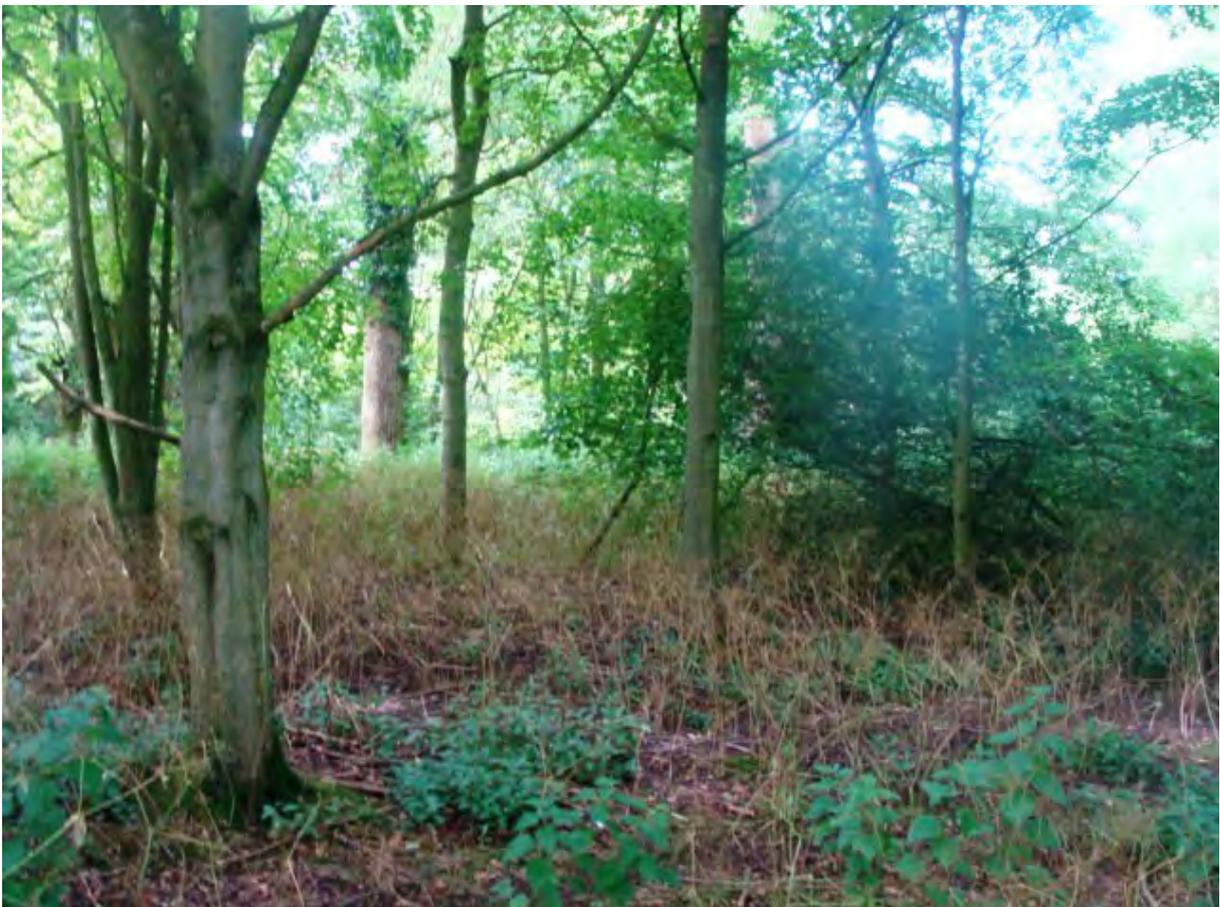
**1.62** Castle Grove, north west of Elmdonbury. Castle Grove survives well as an essentially undisturbed example of a ringwork and will retain archaeological information. The monument consists of a ringwork situated on the crest of a north-east facing slope. Ringworks are medieval fortifications built and occupied from the late Anglo-Saxon period to the later 12th century. They comprised a small defended area containing buildings surrounded or partly surrounded by a substantial ditch and a bank surmounted by a timber palisade or, rarely, a stone wall. Ringworks acted as strongholds for military operations and in some cases as defended aristocratic or manorial settlements. They are rare nationally with only 200 recorded examples. As such ringworks are of particular significance to an understanding of the period.

Picture 1.4 Castle Grove Ringwork, being the remains of a rare medieval fortification, located to the north west of Elmdonbury.

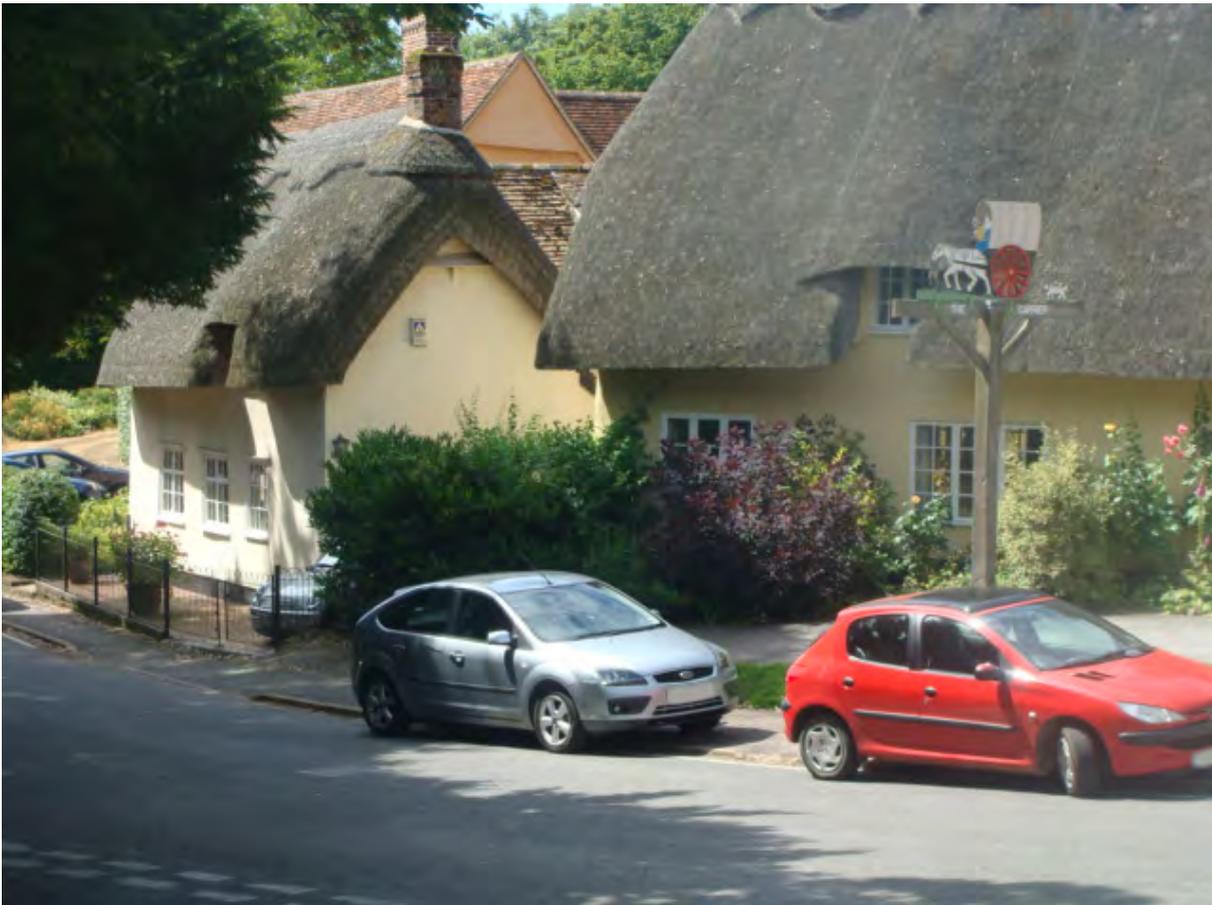
**1.66** Carrier - Grade II. Formerly the Carrier Inn, 18th century timber-framed and plastered building. One storey and attics. Casement windows. Roof thatched, half hipped at the north and south ends, with a central chimney stack and 2 dormers.

Picture 1.5 The importance of thatch in the centre of the Conservation Area. Building to right is Carrier, a former PH whilst the thatched building to the left is the old bakery.

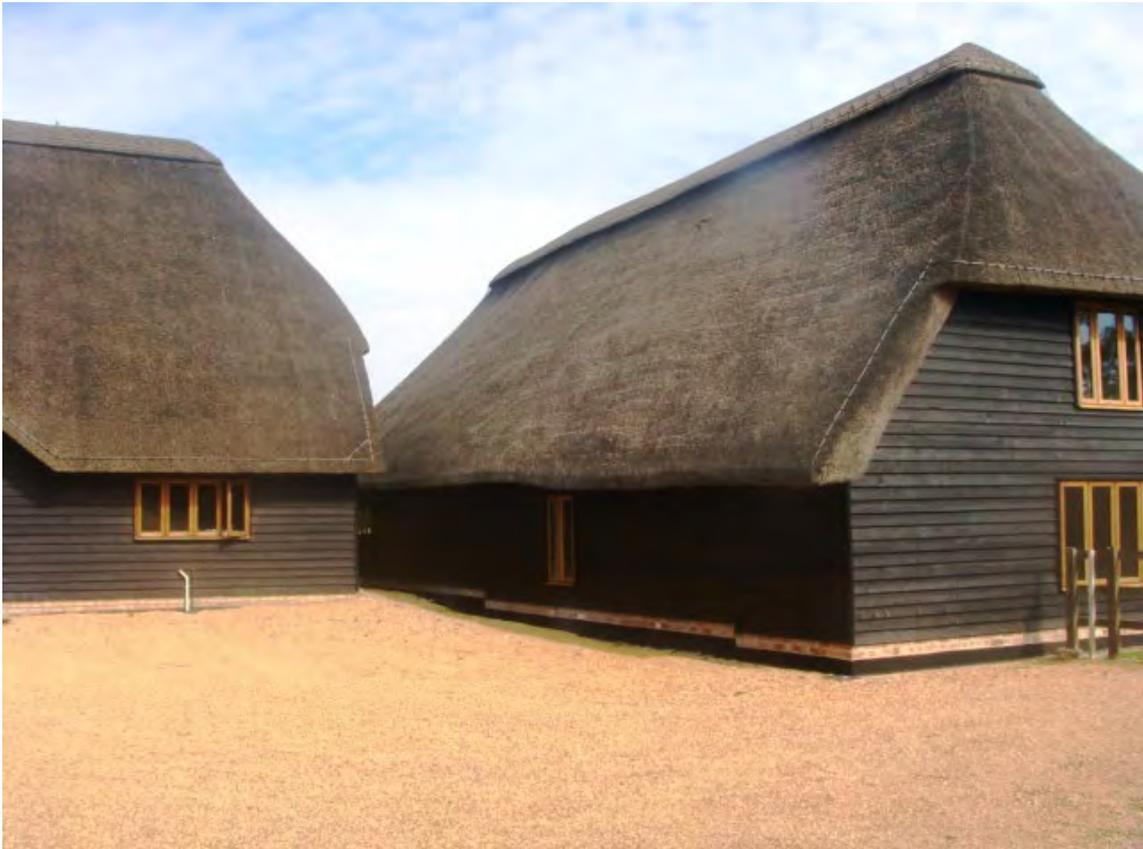
**1.67** South barn to east of Elmdonbury - Grade II. At right angles to north barn. The south barn which extends to the south-west is a later 16th or 17th century aisled barn of 5 bays with 2 entrances. The roof is thatched and half-hipped at the ends. *The barn has been successfully converted although painting inserted window frames black would result in further visual improvements.*

Picture 1.6 - North and South barns at Elmdonbury, restored and successfully converted. The principle of such conversion is debated in some quarters but without this enterprise there is a risk of such buildings falling into disrepair and neglect. Painting the window frames black would further improve their general appearance.

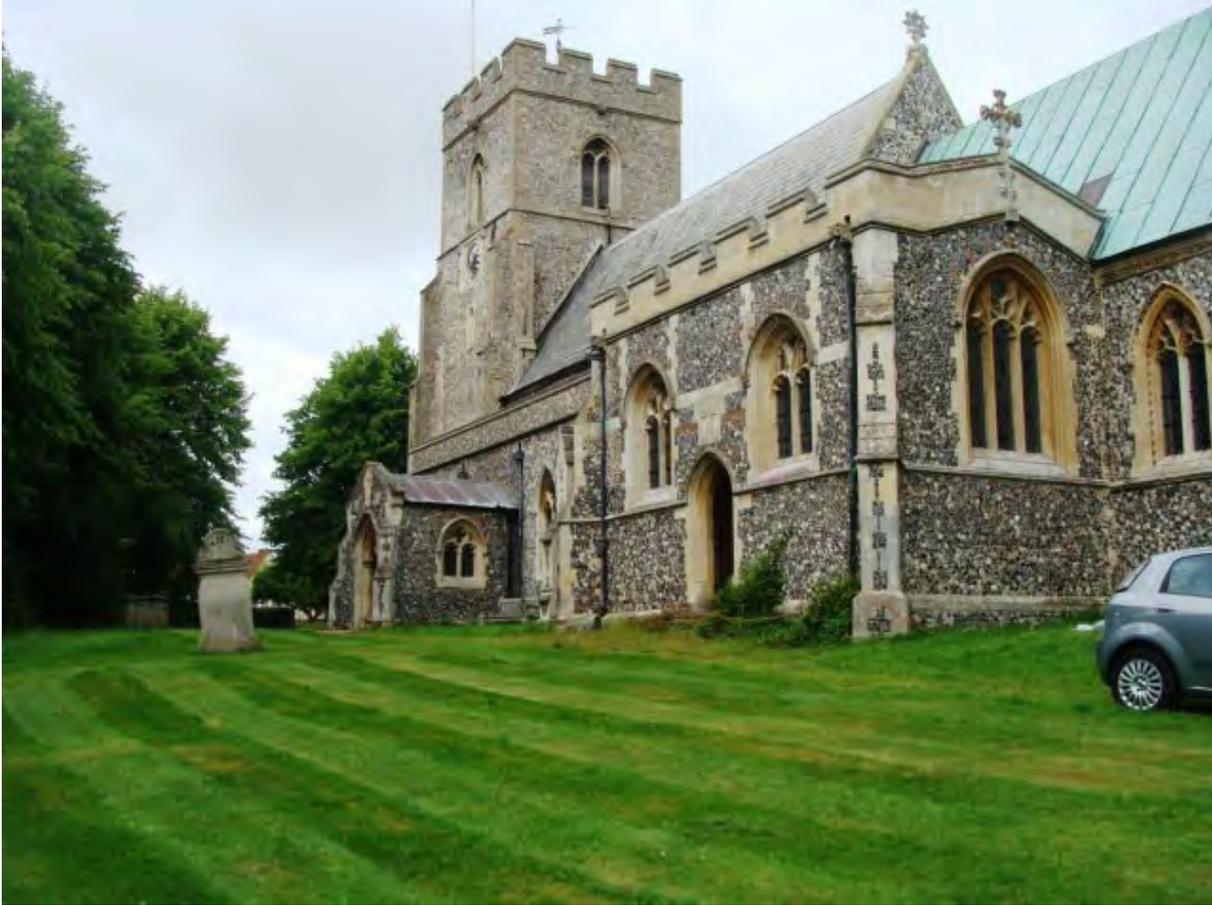
**1.68** Church of St Nicholas - Grade II\*. A flint and rubble church with a 15th century west tower, the rest of the building was rebuilt, probably on the old foundations in 1852 and 1879 and restored in the early 20th century. It was rebuilt in the 14th -15th century style. The west tower has a modern parapet top and has been considerably restored. The fittings include a good late 16th century marble altar tomb with a panelled canopy and an inscription to Thomas Meade, Justice of Common Pleas 1585. The church forms the central feature of the village.

Picture 1.8 The church of St Nicolas dominates the centre of the village. It has been substantially rebuilt in the late 19th century.

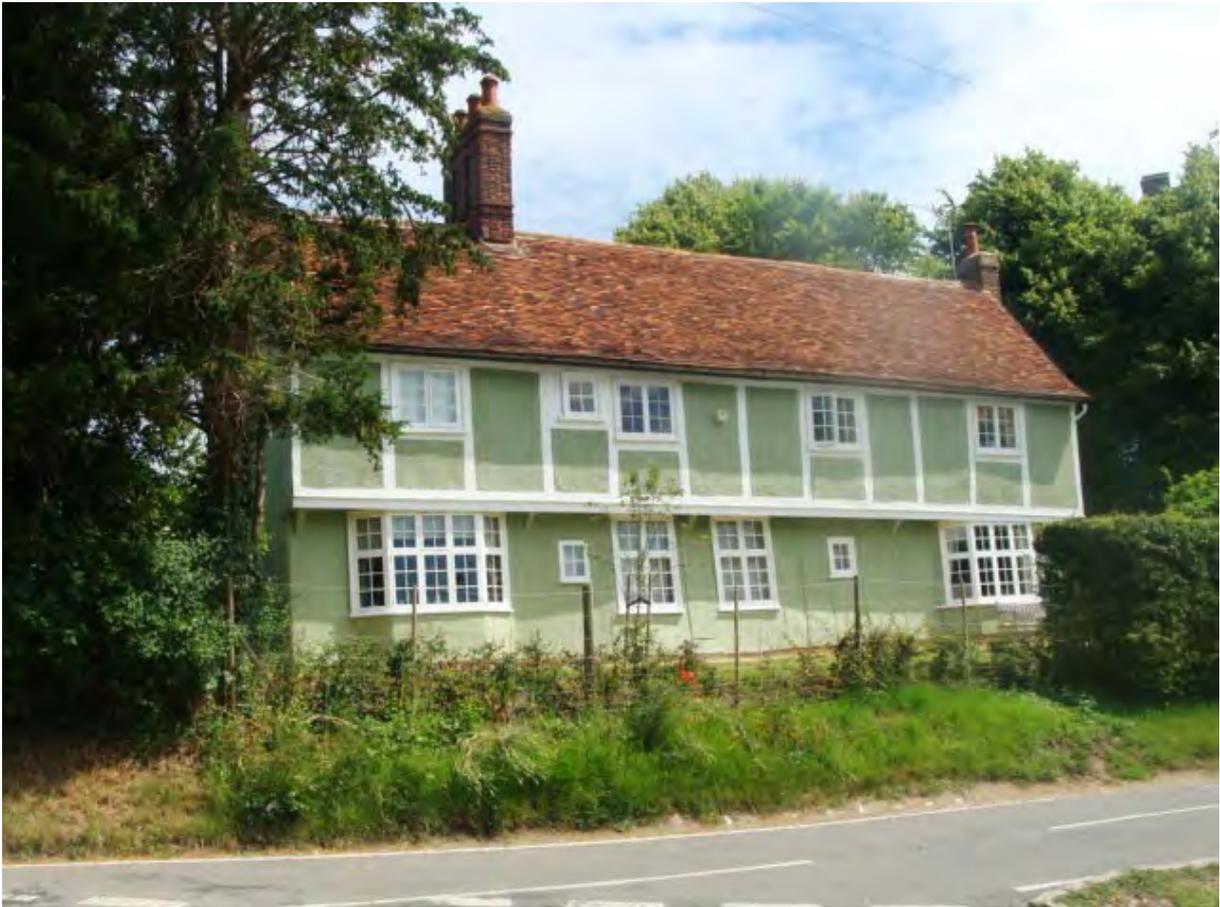
**1.70** Crawley House - Grade II. Timber-framed and plastered house built circa 1600. Two storeys. The upper storey is jettied on the whole front, with panelled plaster. Four window range of casements. The ground storey has 2 shallow bay windows. Roof tiled, with an original central chimney stack with 3 attached square shafts and an external stack at the east end. *In a book 'Elmdon Schools' by John Mills 2012 the writer advises the building was known formerly known as Le Yeldhall and was a village guild for the purposes of prayer as opposed to being associated with craft or industry. The building was sold in the mid 1500's to a Thomas Crawley who set out in his will of 1559 the foundations of a Grammar School. The latter use seems to have continued until the early 1800s.*

Picture 1.9 Crawley House. An imposing timber framed and plastered house described as dating from about 1600 by the Listed Building description, but may be earlier.

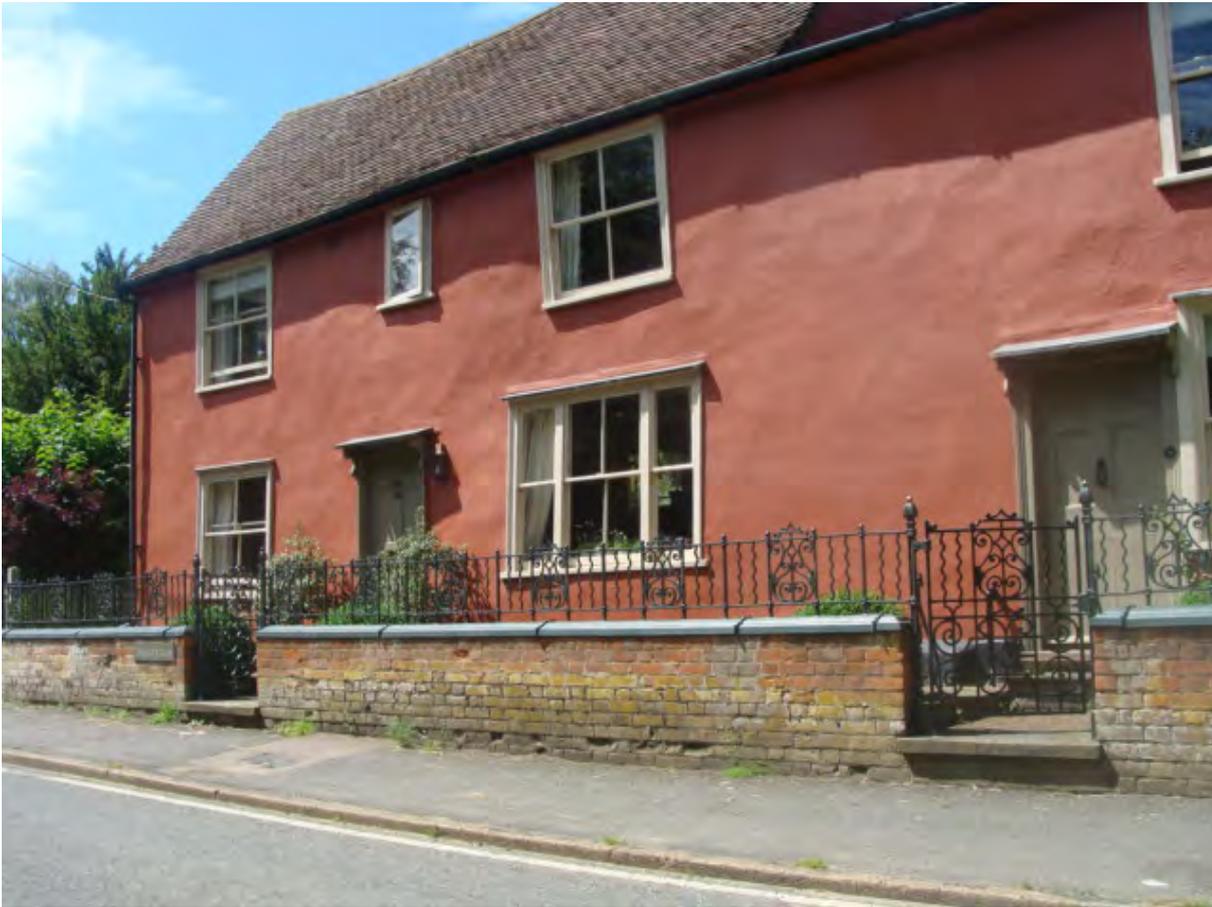
Picture 1.10 The Old Stores, High Street.

**1.72** The Old Stores - Grade II. 19th century timber-framed and plastered buildings, now one tenement. Two storeys. At the north end there is a 19th century double-fronted former shop front with glazing bars. The centre part sets back with one window range and the south block has 2 window range. The windows generally are double-hung sashes with single vertical glazing bars.

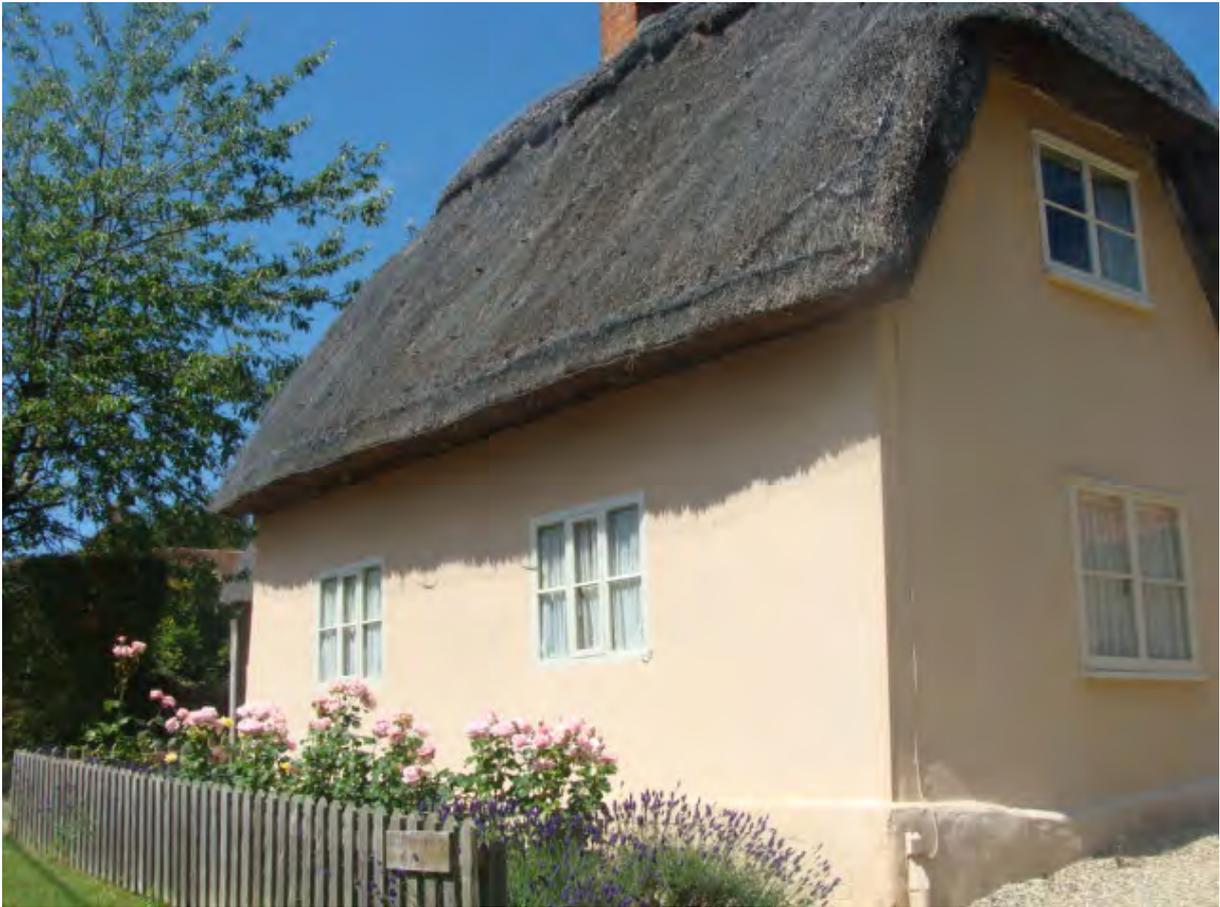
**1.74** Humphreys Green, King's Lane - Grade II. 18th/19th century timber-framed and plastered cottage. One storey and attics. Two window range of casements. Roof thatched, half hipped at the north-east and south-west ends, with a central chimney stack.

Picture 1.11 Humphreys Green, King's Lane. This area of the village in particular retains its rural characteristics that remain largely unchanged.

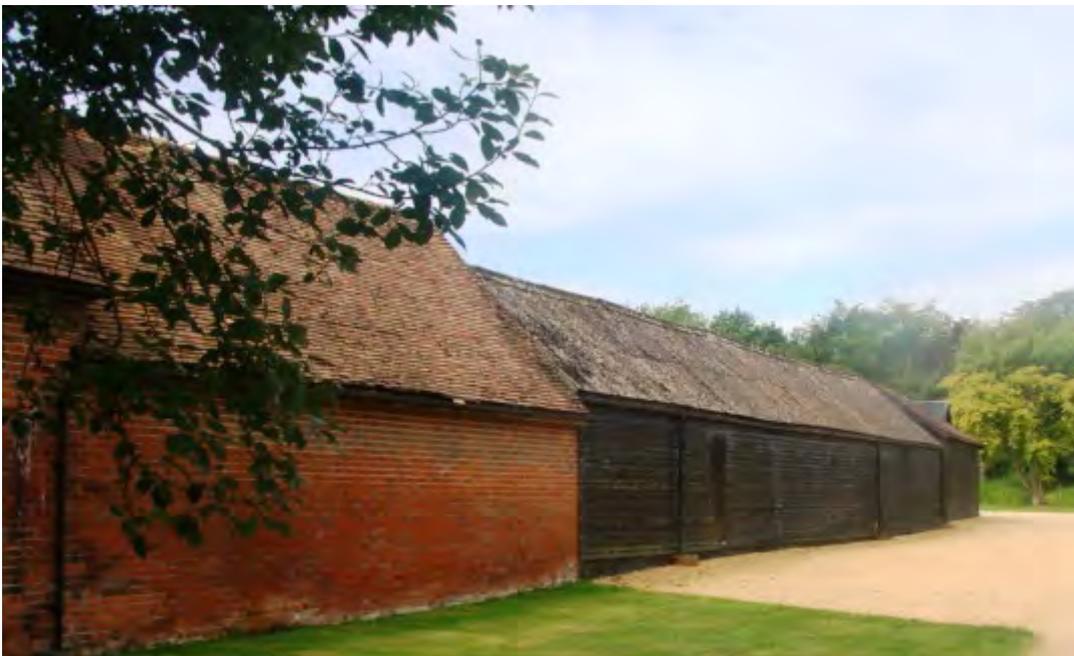
**1.80** Range of agricultural buildings and stabling to immediate north of listed thatched 'barns' at Elmdonbury. A long range in a continuous run variously of brick and weather boarding. Roofs also various, some being tiled others corrugated asbestos. Probably date from 19th/ early 20 century. These are considered to have had a functional relation with and ancillary to the listed barns and thus 'curtilage listed'.

Picture 1.12 Range of agricultural buildings interpreted as being curtilage listed to immediate north of listed barns at Elmdonbury. Their linear form encloses the built form of the site on its northern edge.

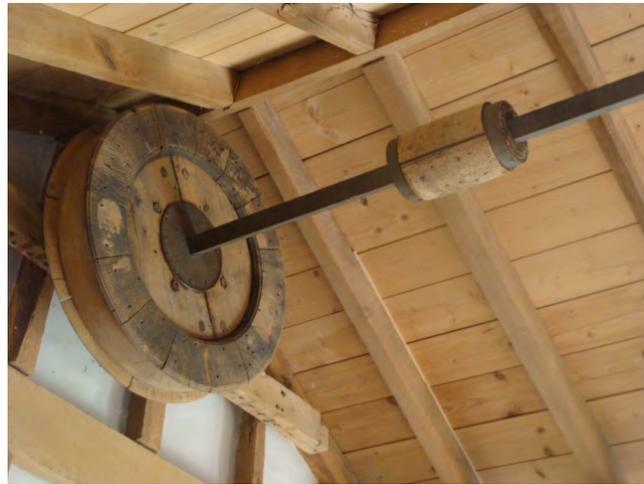
**1.81** Outbuildings to Elmdon Lodge. One raised above ground on metal staddle supports. Timber framed with slate roof. 19th century in appearance. Internally much renovated with remains of local milling (?) equipment restored in situ. At the time of listing of nearby barns in 1983 these outbuildings had a functional and ancillary relation with the listed barns and thus can reasonably be regarded as 'curtilage listed' despite now being in different ownership. Recommended for inclusion in the Conservation Area because of their historical and architectural interest.

Picture 1.13 Interior detail of restored outbuilding to Elmdon Lodge showing equipment of what is believed to once having been a local milling process. Building raised off ground by metal staddle supports to prevent rodent entrance and to keep stored produce dry. An interesting local historical association. Is there any local information?

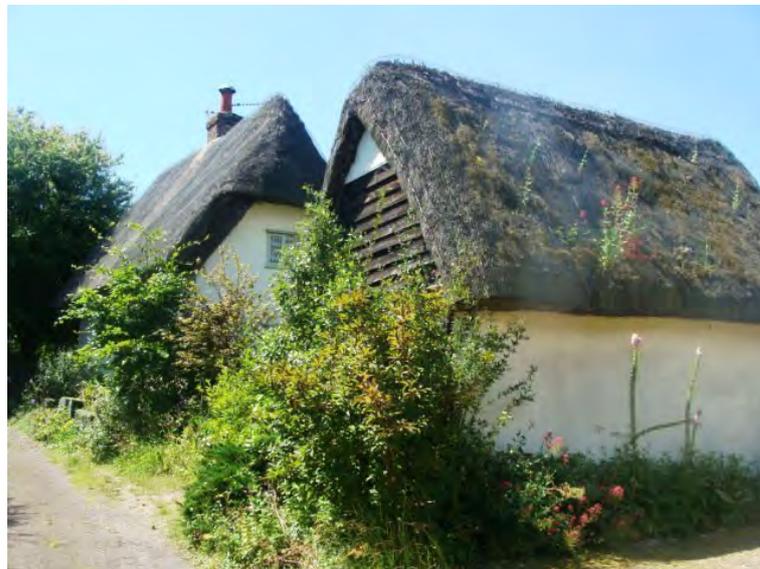
**1.82** Outbuilding to Barn Cottage, Kings Lane. Thatched building ancillary to main listed property. In due course its roof will need re-thatching.

Picture 1.14 Outbuilding to Barn Cottage in future need of re-thatching. Delightful historic group of buildings in a quintessentially English rural setting.

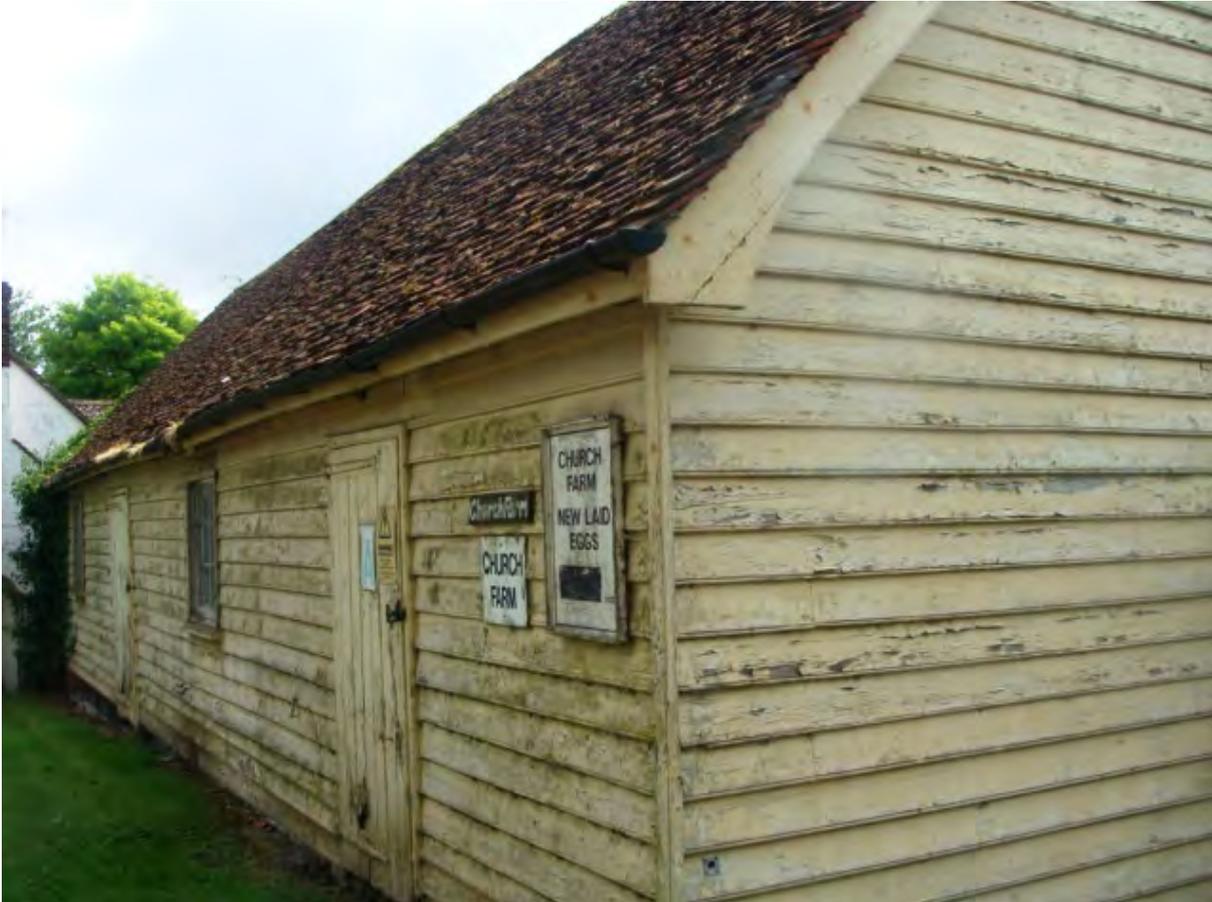
20th century date. Many original/early features. Buildings generally appear in fair condition although barn to road frontage would benefit from repairs to tiled roof and repainting.

Picture 1.15 Group of barns associated with Church Farmhouse date from the 19/20th century and are in general good condition. Modest repairs to the one on the road frontage would improve the street scene.

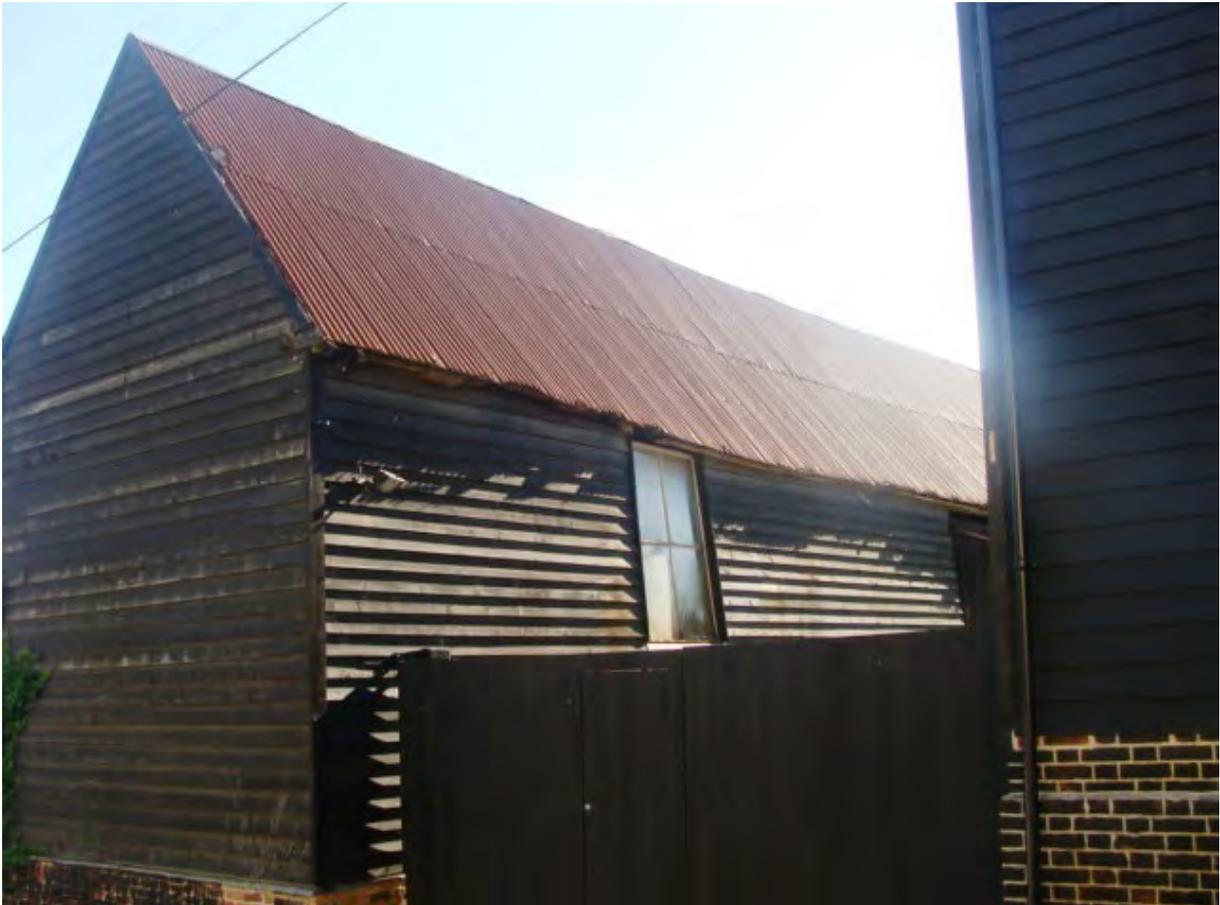
**1.84** Barn ancillary to north of Hill Farmhouse. A traditional agricultural barn at right angles to the road in deteriorating condition with corrugated iron roof. The restoration of this building would be most beneficial. (Another barn to the front of Hill Farmhouse has been restored and is in active use.) Similarly, there is a restored barn between the Forge and Hillside on the opposite side of the road. These barns now in active economic use retain agricultural characteristics such as extensive areas of weather boarding and thus continue to contribute to Elmdon's rural character.

Picture 1.16 The renovation of this ancillary listed barn at Hill Farmhouse would be most beneficial.

Other actions
Contact owner of Pigots and discuss the future of this important Grade II* building. If appropriate add to the Buildings at Risk Register.
Advise English Heritage of plotting errors on their database mapping information in respect of Church Farmhouse and The Cottage, Ickleton Road and Hill Farmhouse, High Street.
Amend Uttlesford District Council mapping that wrongly identifies the Coach house to the west of Elmdonbury as being individually listed.
It is hoped the church authorities will continue with their important initiative of repairing tombstones in St Nicolas's churchyard.
It is suggested the Elmdon Parish Council contact Essex County Council regarding restoration of the three way directional sign on the central village green.
Discuss potential with owner of initiating repairs to roof and repainting barn to frontage of Church Farmhouse.
Discuss potential with owner of initiating repairs particularly to roof of ancillary barn at Hill Farmhouse.

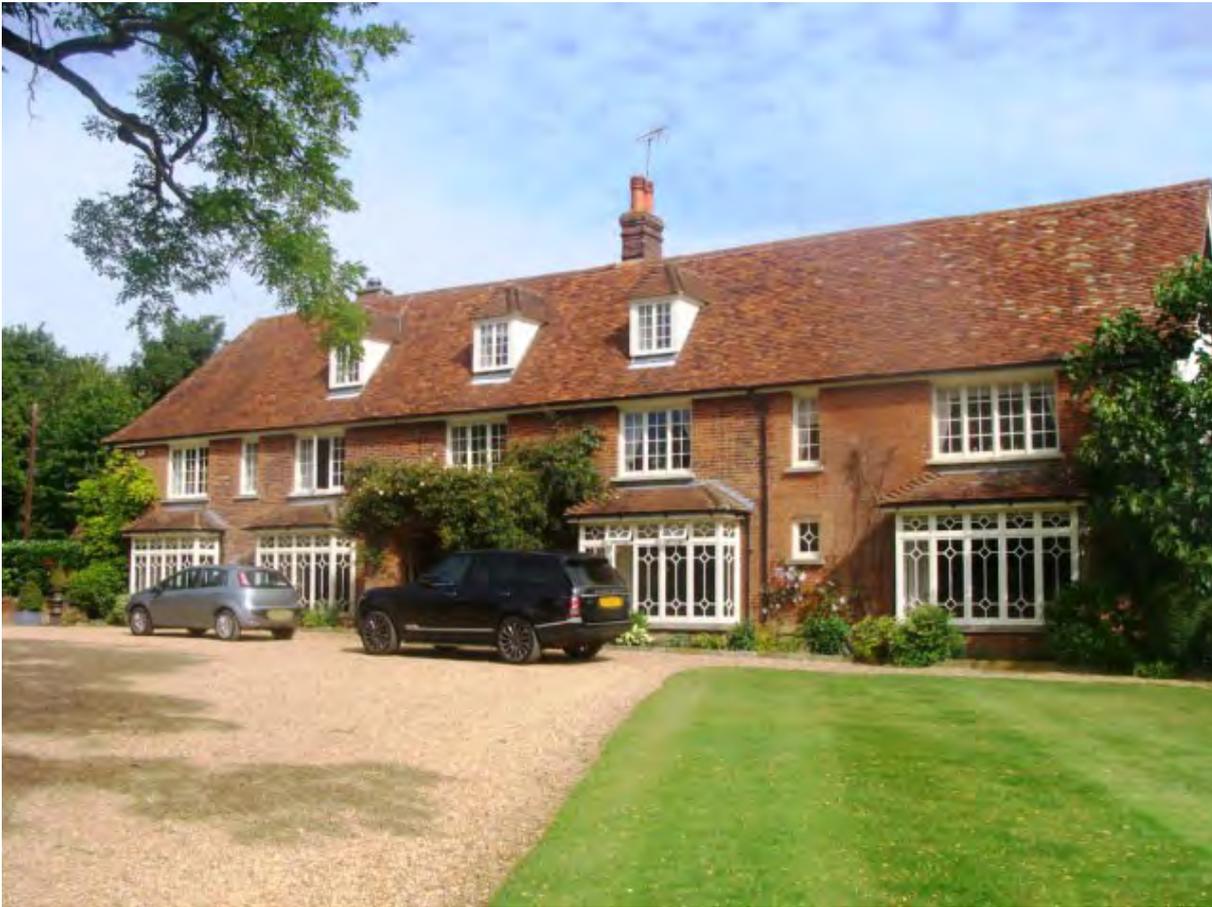
**1.87** Main house at Elmdonbury. Large two storey brick house with steeply pitched roof, 3 no. dormers and central chimney. Distinctive window range. Probably of 19th century date and earlier. Imposing building of similar proportions is identified on late 19th century mapping. It is not considered to be ancillary to the nearby listed barns and therefore not 'curtilage listed'. An Article 4 Direction to provide protection for selected architectural features may be appropriate subject to further consideration and notification.

Picture 1.17 Main house at Elmdonbury. This whole site is important historically being the location of medieval ring works. The main house probably has components representing various periods. The front elevation makes a significant visual contribution and is most worthy of retention.

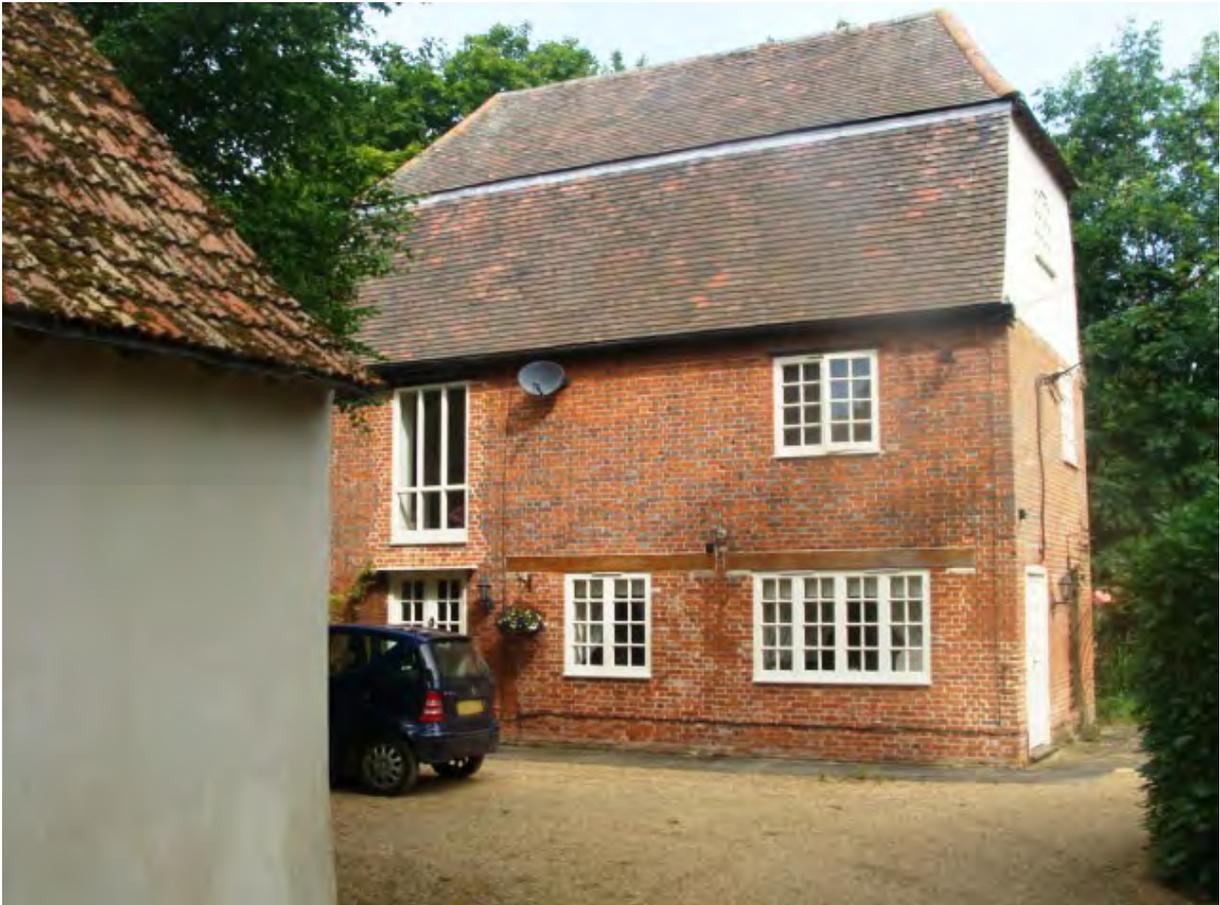
Picture 1.18 The Coach House to the west of Elmdonbury. Note wooden lintel interpreted as once having provided support for original entrance point.

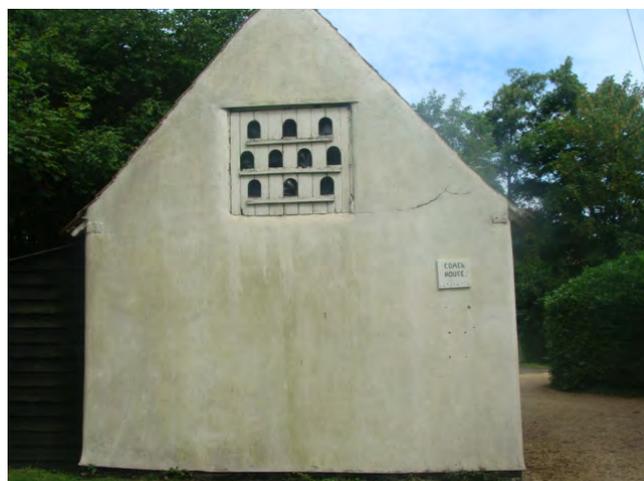
Picture 1.19 - Building to south of Coach House.

**1.89** Building to south of the Coach House. Small rendered agricultural building with pantiled roof worthy of retention. It is not considered to be ancillary to or have a functional relation with the listed barns on site and therefore not 'curtilage listed'. An Article 4 Direction to provide protection for selected architectural features may be appropriate subject to further consideration and notification.

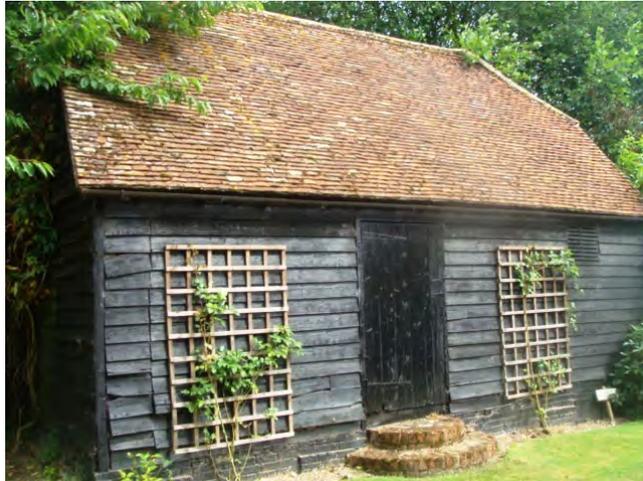
**1.90** Barn to the east of the Coach House. A small weather boarded agricultural building with tiled roof worthy of retention. It is not considered to be ancillary to or have a functional relation with the listed barns on site and therefore not 'curtilage listed'.

Picture 1.20 Small weather boarded barn to east of the Coach House worthy of retention.

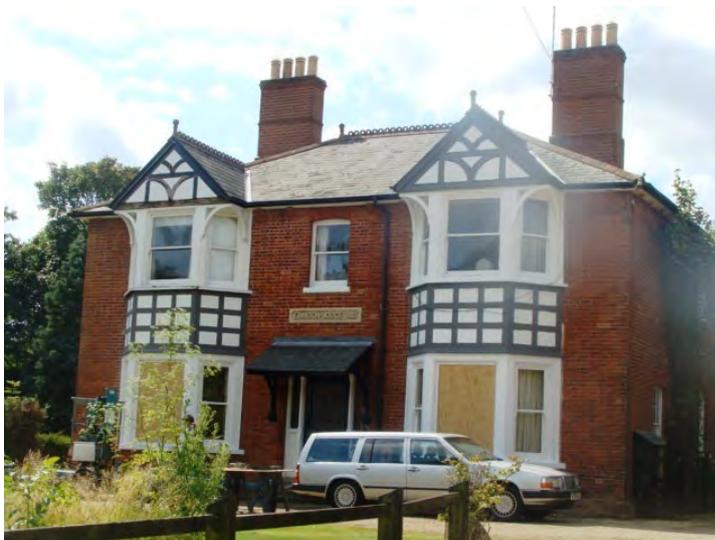
**1.91** Elmdon Lodge. Large detached residence constructed of brick with hipped slate roof. 2 no. prominent brick chimney stacks (rebuilt) with pots; finials and decorative ridge tiles to roof. Central doorway with typical coloured glass detailing with slate canopy on decorative supports above. 2 no. bay windows to both floors with decorative wooden detailing. Central stone plaque inscribed Elmdon Lodge 1883. At the time of listing this whole group was in a single ownership. However Elmdon Lodge cannot be considered to have been ancillary to the listed barns at this time and thus is not 'curtilage listed'. An Article 4 Direction to provide protection for selected architectural features may be appropriate subject to further consideration and notification.

Picture 1.21 Elmdon Lodge - a fine Victorian building unusual in the Elmdon context and most worthy of retention.

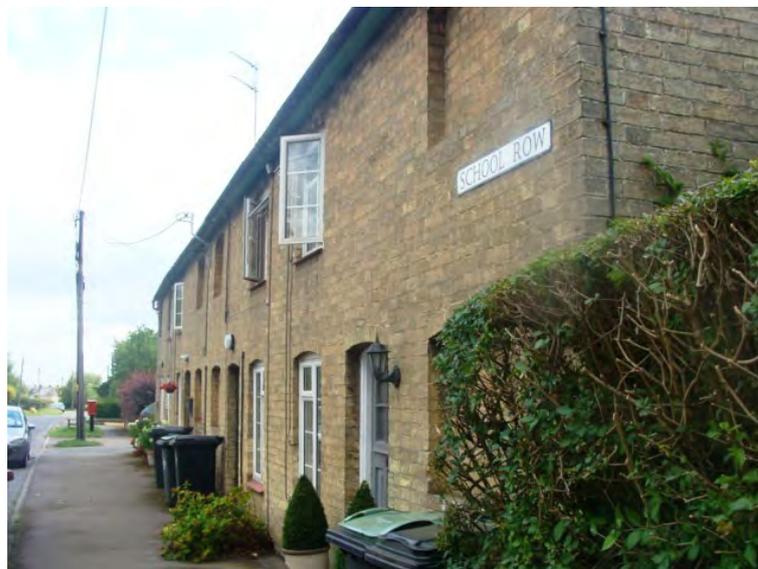
**1.95** School Row. Interesting terrace of four 19th century cottages on opposite side of road to school. Of yellow brick construction with slate roof and 2 no. chimneys with pots. A number of blocked window openings. This work was presumably undertaken in reaction to the unpopular 'window tax' seen at the time as a tax on 'light and air'. This tax was repealed in 1851. Modern windows detract to a degree but impact reduced by common detailing having being applied throughout. An Article 4 Direction to provide protection for selected architectural features may be appropriate subject to further consideration and notification.

Picture 1.22 School Row - an interesting 19th century terrace with some properties having window openings blocked up, presumably in response to the deeply unpopular window tax that was repealed in 1851.

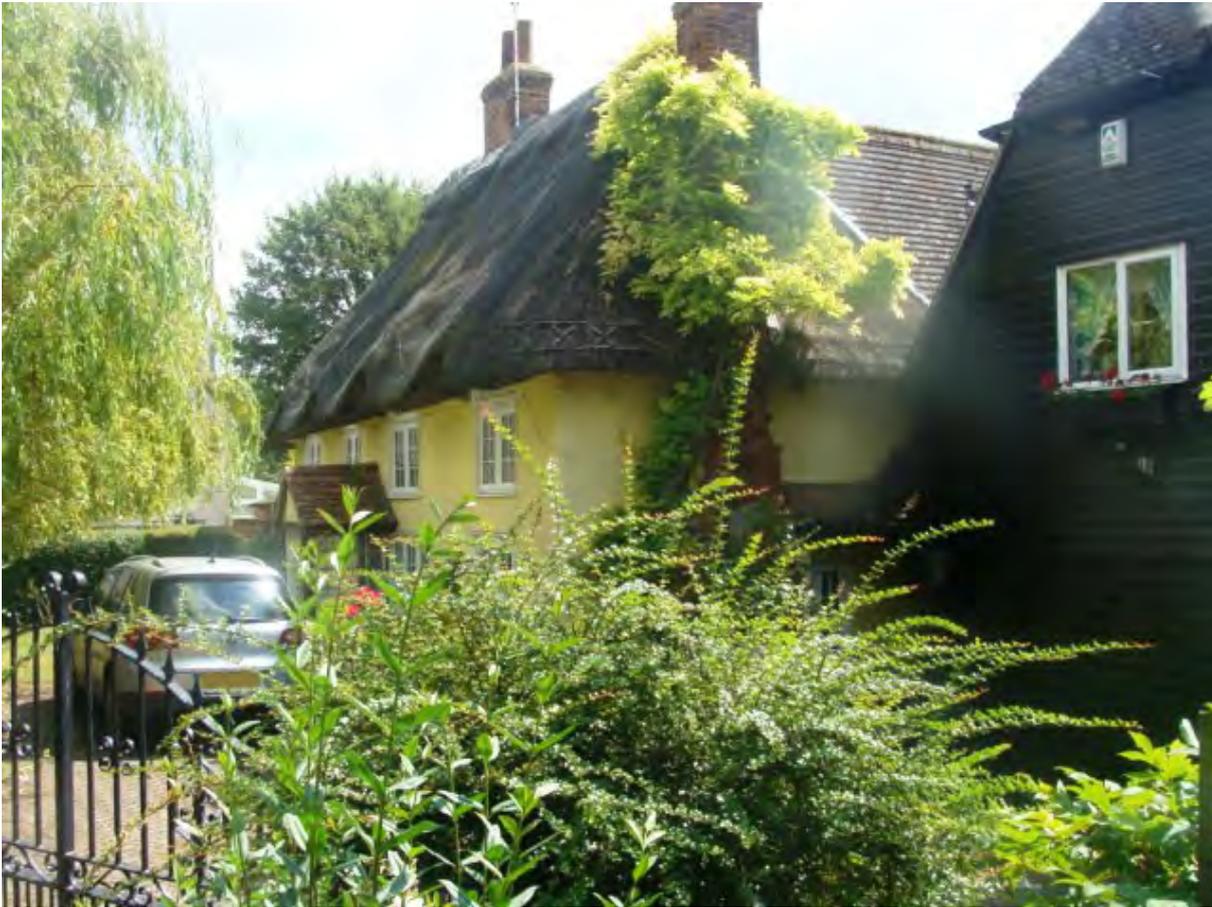
**1.96** Violet Cottage in part. From external observation only the eastern thatched element of Violet Cottage may be contemporary with other thatched properties in Elmdon dating from the 17/18th centuries. Render and later window detailing; thatched roof and 2 no. chimneys, later extensions. An Article 4 Direction to provide protection for selected architectural features may be appropriate subject to further consideration and notification.

Picture 1.23 Violet Cottage. The thatched element is believed to be early and contributes to the local street scene and is worthy of retention.

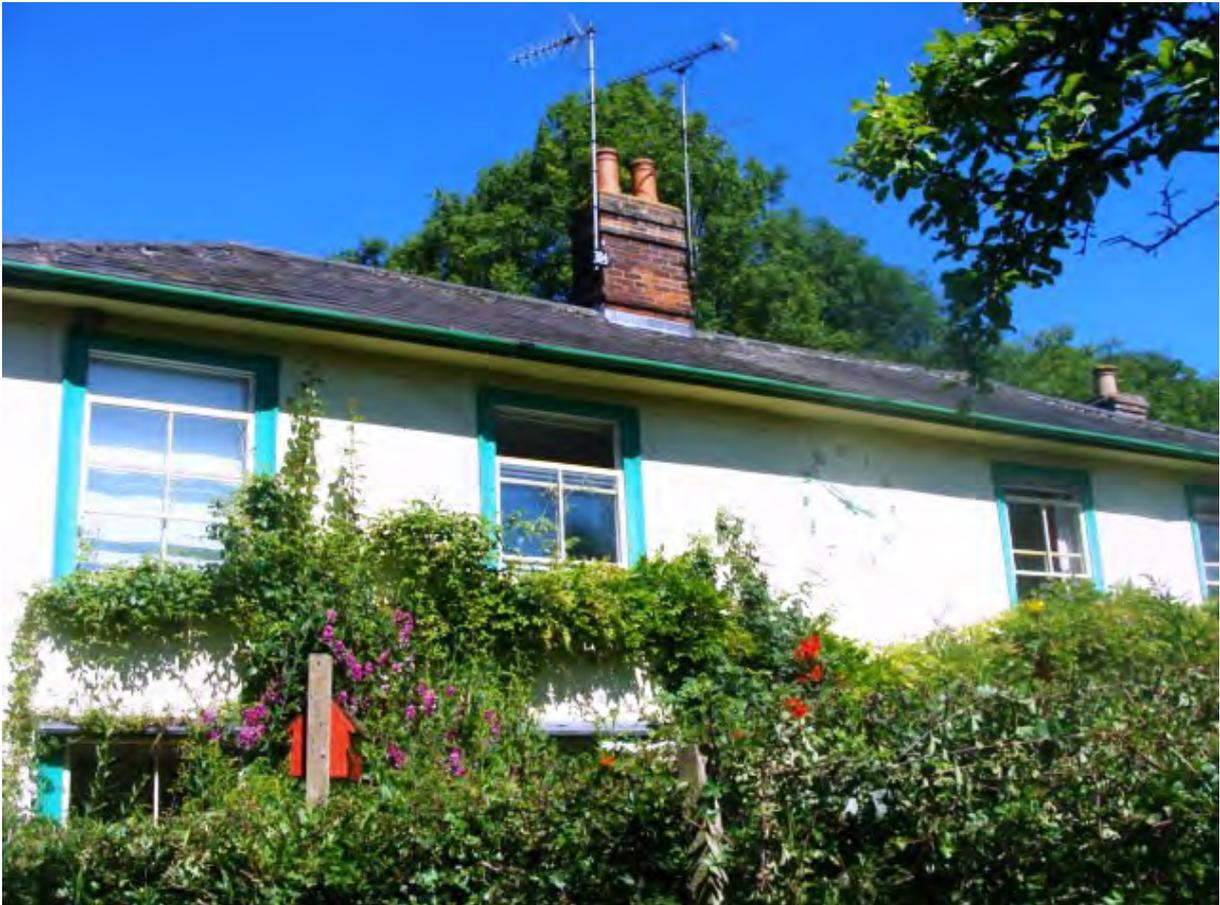
**1.97** Pilgrims, High Street, southern junction with King's Lane. 19th century rendered property with hipped slate roof and 2 no. chimneys with pots. Original/early vertical sliding sash windows. An interesting building whose front elevation contributes to the local street scene despite later additions. An Article 4 Direction to provide protection for selected architectural features may be appropriate subject to further consideration and notification.

Picture 1.24 Pilgrims, a 19th century property whose front elevation contributes to this part of the Conservation Area.

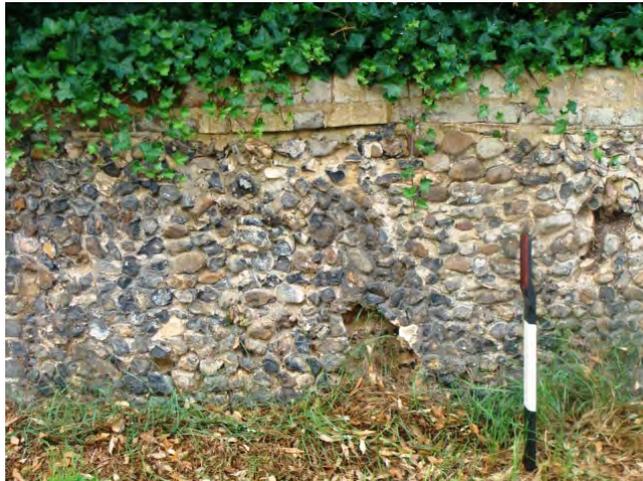
**1.102** An important long length of brick and flint wall to front of the Old Vicarage on both the Ickleton Road and High Street frontages. Height varies 1-1.5m. Curtilage listed. Some repairs necessary.

Picture 1.25 Selected areas of important wall to boundary of the Old Vicarage are in need of repair.

Discuss potential with owner of initiating repairs to wall on High Street frontage of the Old Vicarage.
Source owner and consider potential of initiating selected repairs to 19th century pump on the Ickleton Road.

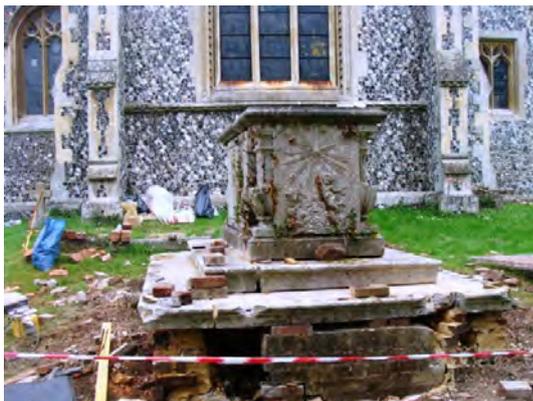
**1.105** Tombs and gravestones in St Nicholas churchyard. There are a number of good quality tombs and gravestones in the churchyard. One chest tomb was being restored at the time of survey and those responsible for this positive action are to be applauded.

Picture 1.26 Chest tomb in churchyard being repaired.

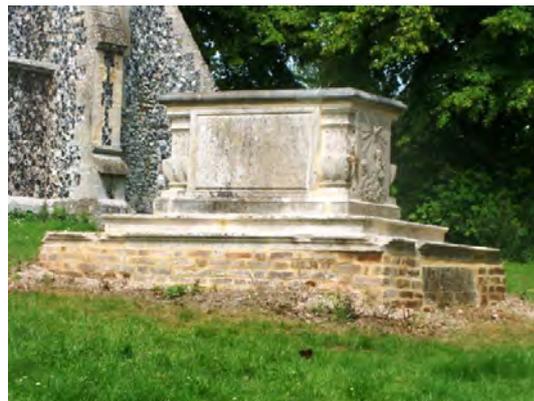
Picture 1.27 The same tomb following restoration. Those responsible for this positive action are to be congratulated.

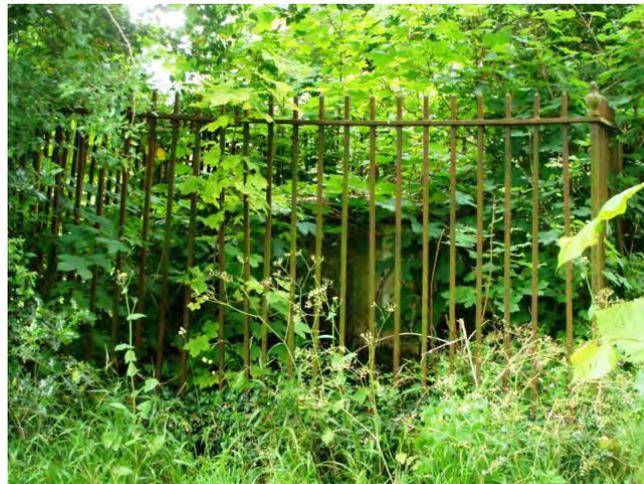
**1.107** Early discussions have indicated that the local church authorities are aware of these issues and it is hoped a programme of restoration can continue. Such tombs are a key source of architectural interest and local historical importance.

Picture 1.28 Another chest tomb in the churchyard in need of restoration. Early removal of vegetation, particularly Sycamore saplings would be most beneficial and cost effective.

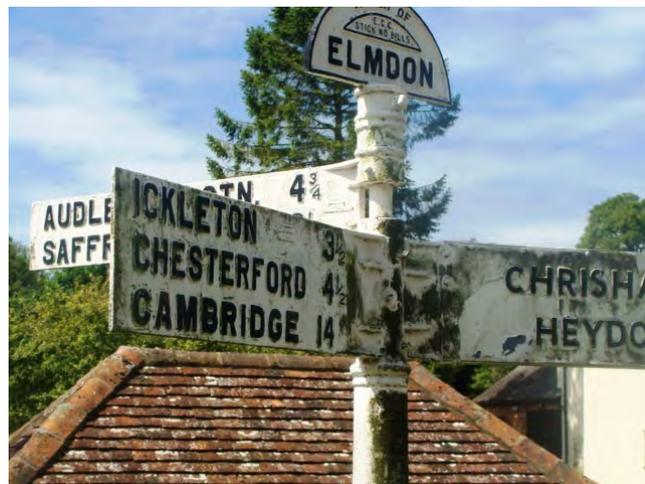
**1.108** Directional sign on central green. Fine traditional metal signpost with inscribed finial that reads: PARISH OF ELMDON E.C.C. STICK NO BILLS. This traditional sign post and its fingers should be retained, cleaned and renovated.

Picture 1.29 Traditional directional sign that adds to the character of the centre of Elmdon but is in need of cleansing and renovation.

**1.118 Opportunities to secure improvements.** Continue with restoration programme of initiating repairs to tombstones in the churchyard. It is suggested the PC contact ECC regarding retention, cleansing and restoration of the three way directional sign on the central village green. Barn to frontage of Church Farmhouse would benefit by initiating repairs to roof and repainting. Similar suggestion in respect of ancillary barn at Hill Farmhouse. Small areas of wall to High Street frontage of the Old Vicarage would benefit from repair works being carried out. Ideally removal of selected utility poles. Restoration of village pump. Ickleton Road within limits of financial resources.
