**Elmdon Conservation Area Appraisal and Management  
Proposals, Approved December 2014**

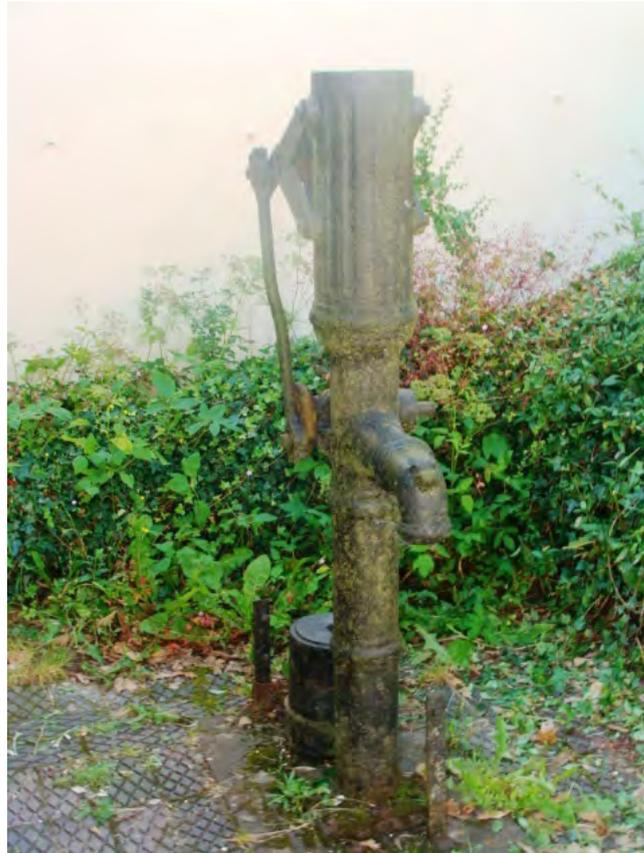
**1.110** 19th century pump, Ickleton Road. Remains of a large village pump with slate pavior base. Regrettably important elements missing including decorative finial. Structure and base needs renovation. Suggested minimum recommended works relate to removal weed growth. A very worth while long term restoration project would be to renovate this important feature and element of local history.

Picture 1.30 Traditional village pump that is very much part of the local history and in need of some restoration. Various levels of restoration possible but an immediate improvement could be achieved by removing weed growth and re setting slate paviours.

Discuss potential with owner of initiating repairs to wall on High Street frontage of the Old Vicarage.
Source owner and consider potential of initiating selected repairs to 19th century pump on the Ickleton Road.

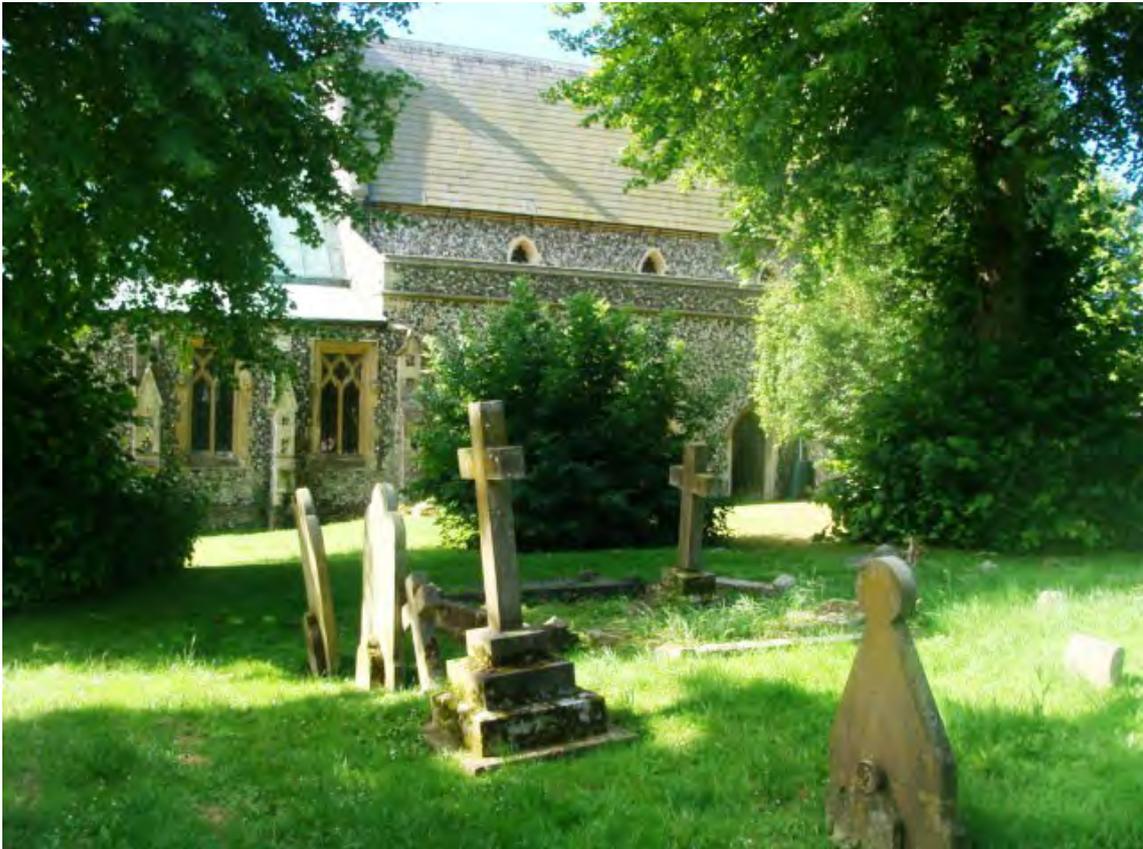
**1.112 Important open spaces.** Elmdon churchyard is a large important space in the centre of the village that is well kept with many good quality trees of traditional churchyard species and a rich variety of tombstones.

Picture 1.31 Elmdon Churchyard, a verdant open space in the centre of the village of considerable visual and historic importance.

**1.118 Opportunities to secure improvements.** Continue with restoration programme of initiating repairs to tombstones in the churchyard. It is suggested the PC contact ECC regarding retention, cleansing and restoration of the three way directional sign on the central village green. Barn to frontage of Church Farmhouse would benefit by initiating repairs to roof and repainting. Similar suggestion in respect of ancillary barn at Hill Farmhouse. Small areas of wall to High Street frontage of the Old Vicarage would benefit from repair works being carried out. Ideally removal of selected utility poles. Restoration of village pump. Ickleton Road within limits of financial resources.

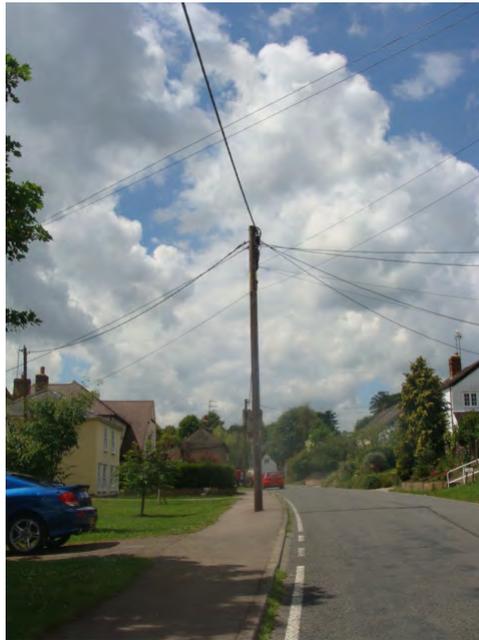
**1.117 Elements that are out of character with the Conservation Area.** There are a large number of utility poles in the Conservation Area whose appearance and overhead services detract to varying degrees. The practicalities and associated cost of achieving such improvements, particularly in this difficult economic climate, is recognised. However it is considered appropriate to draw attention to the visual damage caused and for the Parish Council to discuss the matter with the relevant utility company to explore the potential of achieving selected improvements now or in the longer term of those considered at local level to be in the more sensitive locations. The principle individual and groups of poles are shown diagrammatically.

Picture 1.33 The impact of utility poles on views into the Conservation Area.
