Quendon and Rickling Conservation Area Appraisal and
Management Proposals, Approved June 2015

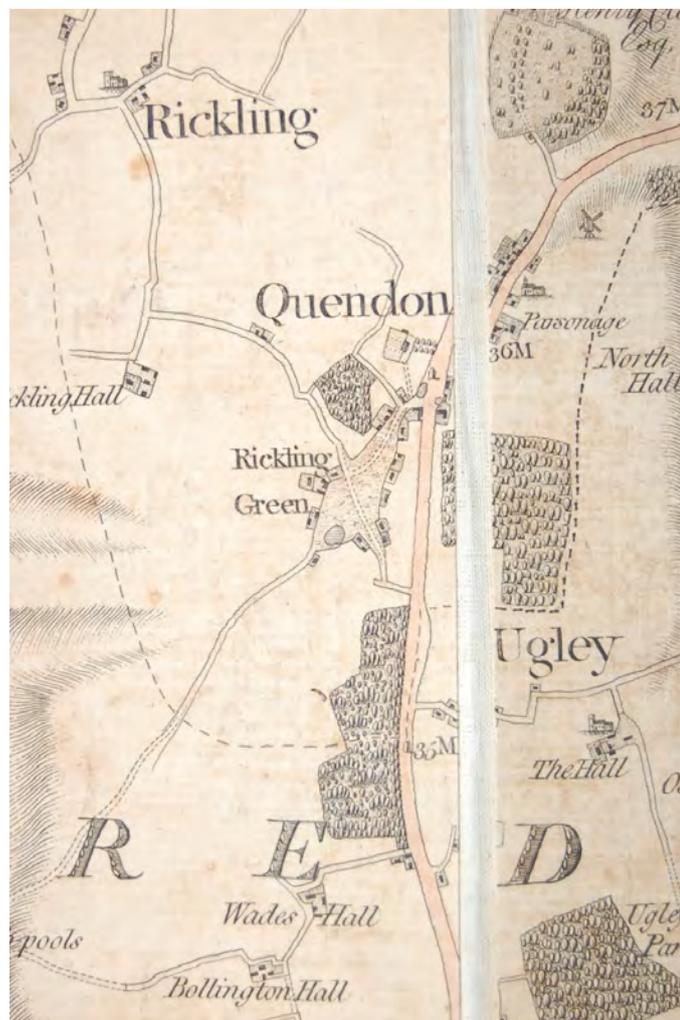
Picture 1.1 Quendon and Rickling as shown on the Chapman and Andre map of 1777 (Reproduced courtesy of a private collection)

1.59 The Chapman and Andre survey of 1773-5, published in 1777, and the 1783 Christ's Hospital plan of the farms in the parish of Rickling⁽²⁰⁾ both give a good idea of the area at this period. The focus of Rickling Green is on the large central open space, whilst in Quendon properties are starting to spread out along the course of the Cambridge to London road.

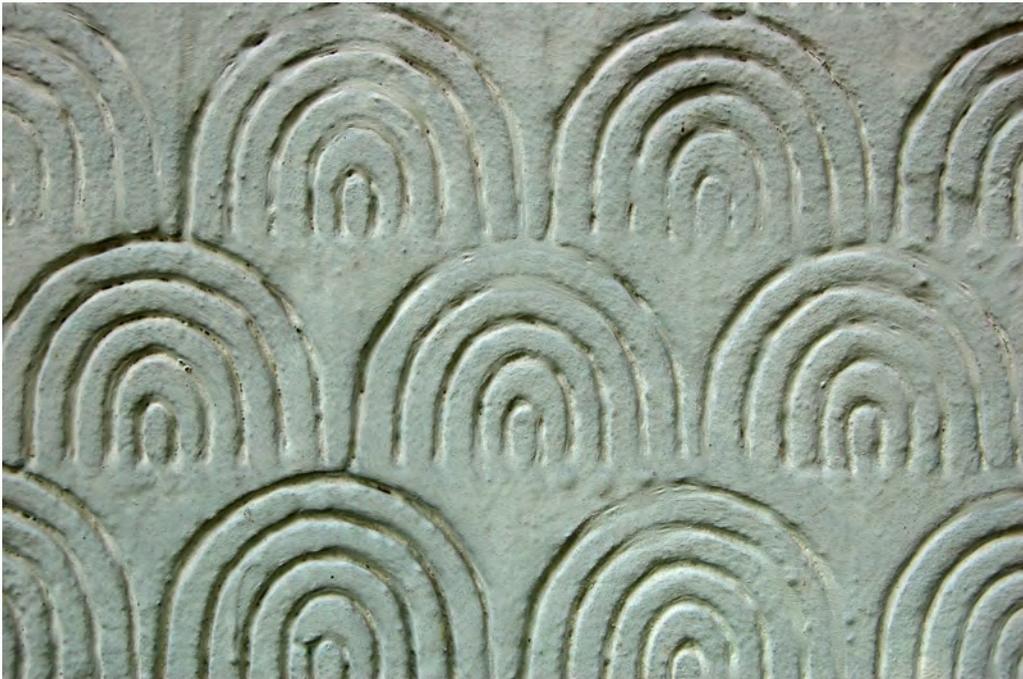
Picture 1.2 Traditional Essex combed pargetting of an unusual almost horseshoe shape on the wall of one of the Rickling Corner Cottages.

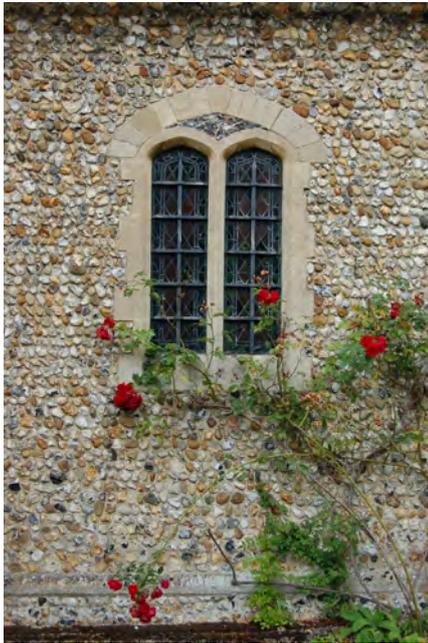
Picture 1.3 Local flint and imported stone contrast on the windows to the church of St Simon and St Jude, Quendon.

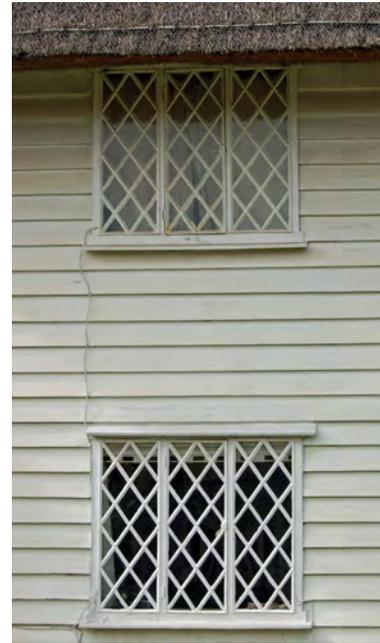
Picture 1.4 Elegant diamond pane form windows are employed to dramatic effect within the weatherboard exterior of Rickling House Cottages.

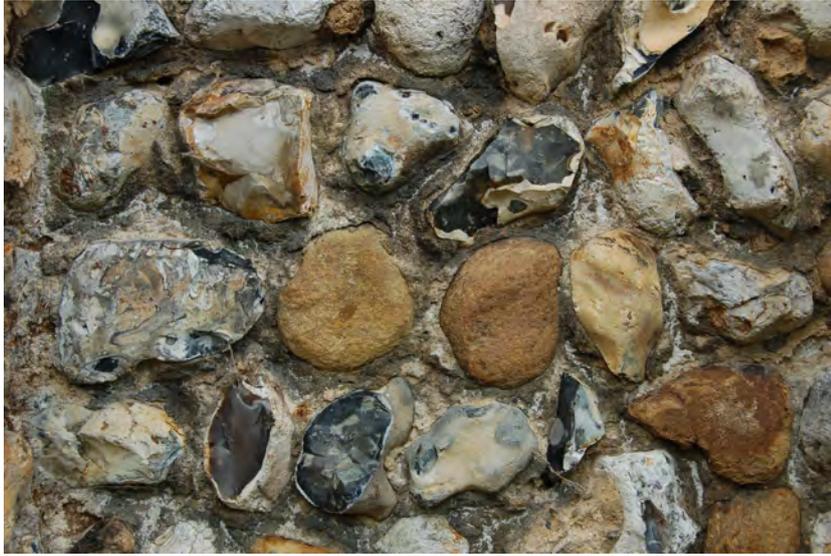
Picture 1.5 Local flint used to good effect in the boundary wall to the church of St Simon and St Jude in Quendon.

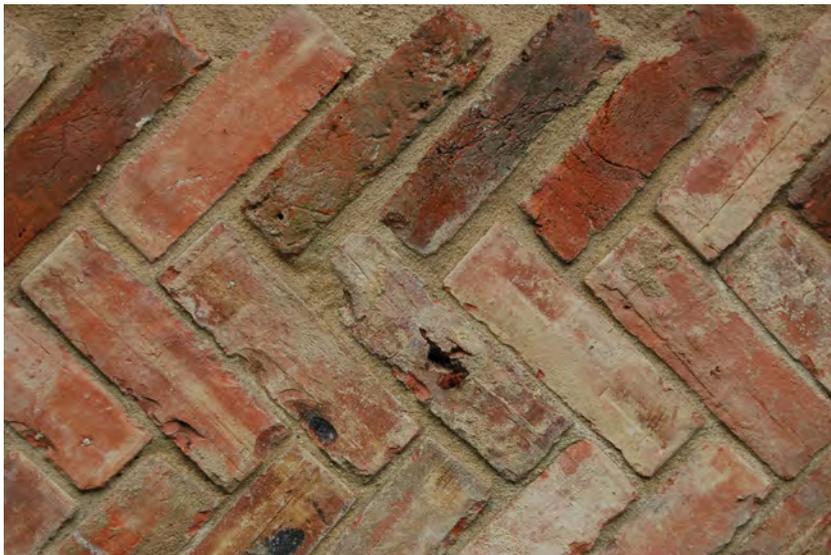
Picture 1.6 Modern brickwork laid in a herringbone pattern is used to good effect in a wall abutting the east side of the Cambridge Road.

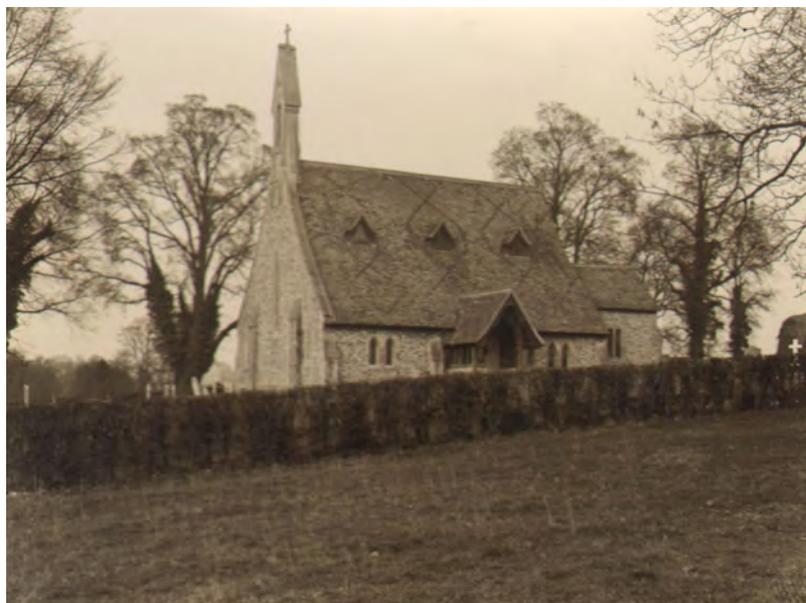
Picture 1.8 Church of St. Simon and St. Jude in 1920 prior to the addition of the timber bell tower. (Reproduced courtesy of Saffron Walden Museum).

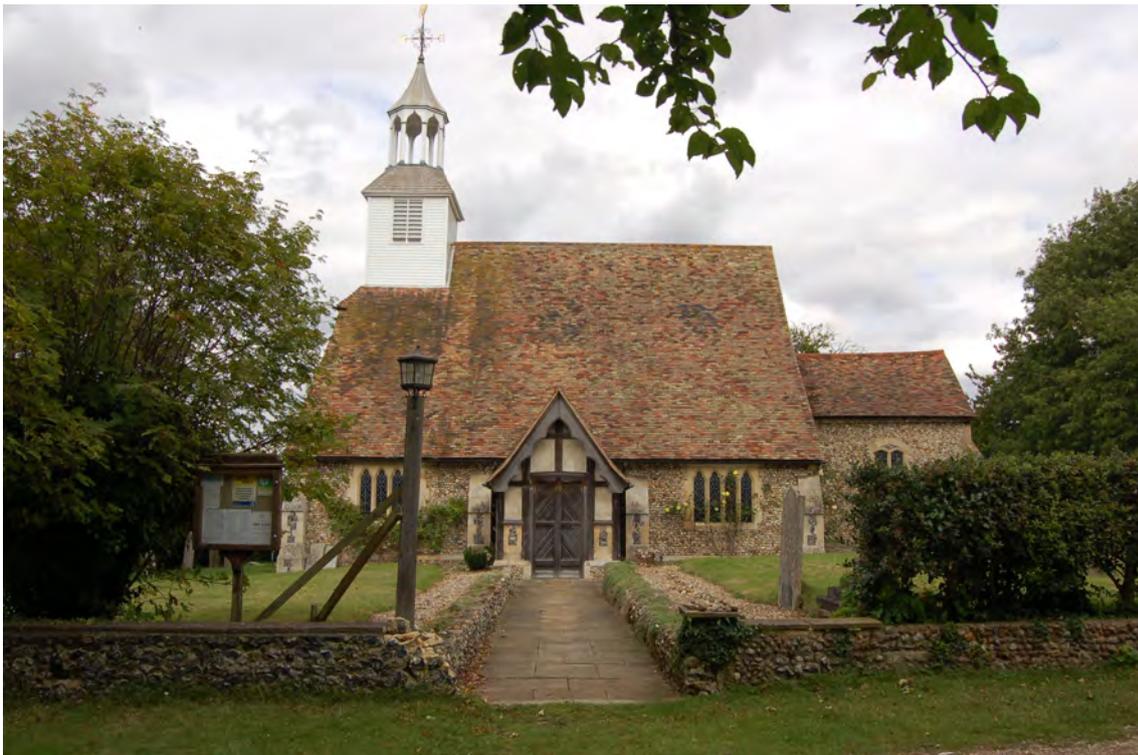
1.97 Church of St. Simon and St. Jude, Grade II*. Positioned somewhat discretely up a small track and on the sloping ground as it rises away from the road, is the small 13th century flint church with its distinctive white weather boarded bellcote giving it just a hint of a New England chapel. Bettley and Pevsner consider it a "curious looking but attractive building"⁽³³⁾ notable for three distinctive features, namely the "nave roof which covers the aisles in a single sweep; the conspicuously small chancel ... And the timber bellcote by Stephen Dykes Bower"⁽³⁴⁾. The chancel arch and the north and south arcades are each of 3 bays and date from the earliest period of construction in the 13th century but were restored, as was much of the church, by George Perry of Bishop's Stortford in 1861. At the same time a small vestry was added at the north end. Further restorations of the aisle windows, south porch and roof were undertaken in 1965-8 by Dykes Bower, who was then a resident of Quendon Court, just a few hundred yards down the road. Other notable features are the original windows in the north and south walls, a screen commissioned in memory of the architect A. Winter Rose, who died in 1918, and the 18th century organ case, said to have come from the chapel of Jesus College, Cambridge. Following an appeal the bellcote was extensively restored in 2013.

Picture 1.9 Quendon church today with the addition of the timber bell tower which was restored in 2013.

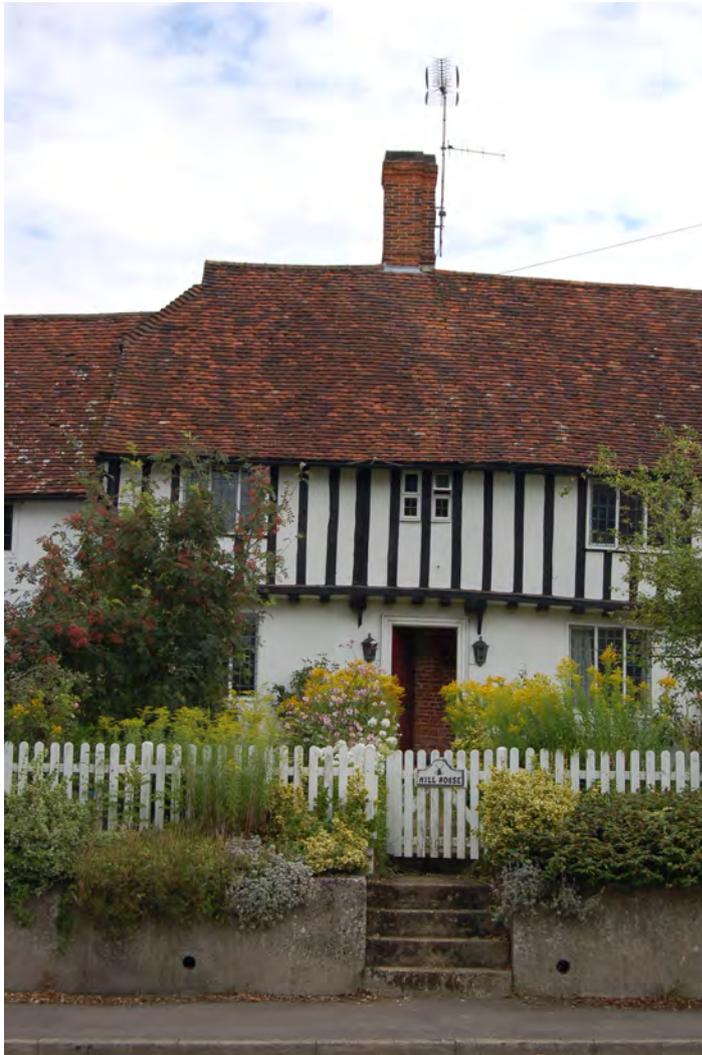
Picture 1.11 The varied roof heights, contrasting joinery against the whitewashed plaster and addition of the low picket fence contribute to the rural atmosphere of Mill House and Cottages, even though they abut the busy Cambridge Road.

1.100 Mill House and Mill Cottages comprise principally a 17th century timber-framed and plastered house of circa 1640, with later additions extending to the north and south. The main central block is jettied on the upper storey. At the lower edge of the jettied storey there is part of a plaster band with leaf ornamentation. A two window range in the centre part and one window range in the additions is made up of small 2 and 3-light leaded casements. Roofs are tiled, half hipped at the north and south ends, with a central square chimney stack to the centre block and an end external stack at the north end.

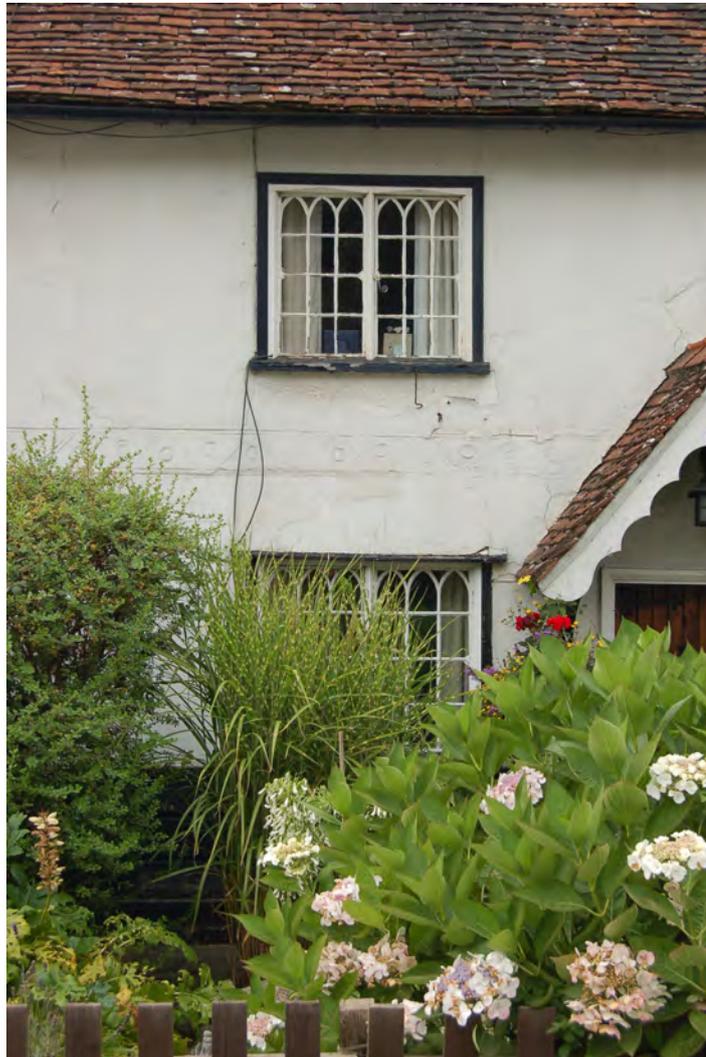
Picture 1.12 Rickling Corner Cottages, some of the most distinctive and visually arresting of all the buildings in the area.

1.104 Perhaps, some of the most distinctive and visually arresting of all the buildings in the area are Rickling Corner Cottages (Grade II), situated prominently on the junction of the road down to Rickling Green. In all there are five terraced properties here

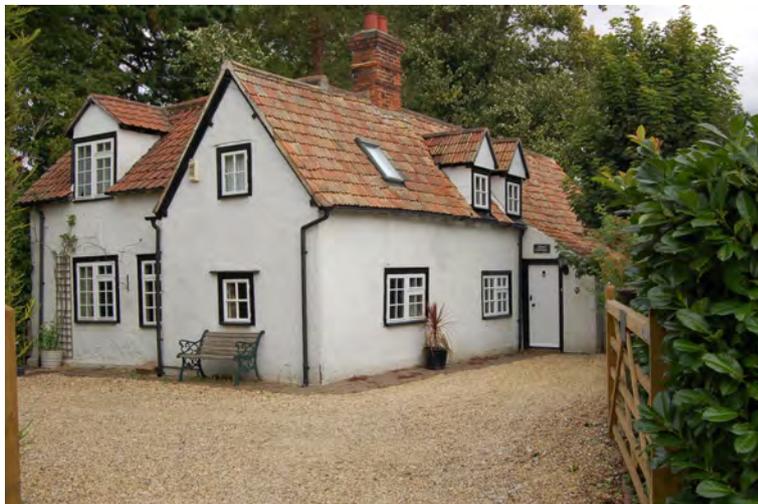
Picture 1.13 Pond Cottage, a pleasing, probably 18th century, building of one and a half storeys, much extended from its original form, but still worthy of note.

1.108 Pond Cottage is a timber-framed and plastered house of probable 18th century origin. Renovated in the 20th century it is now one storey high with attics. The casement windows are all modern replacements with wide glazing bars. Roof tiled with a central chimney stack and three dormer windows. A modern porch (in old style) is built out to the south. Article 4 Directions to provide protection for roofing materials and selected architectural detailing may be appropriate subject to further consideration and notification.

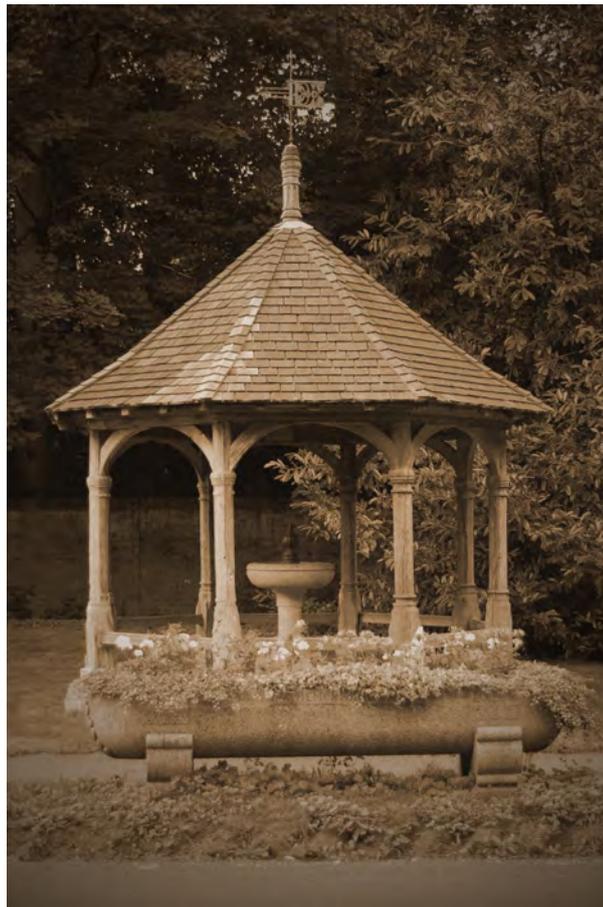
1.109 The 19th century village fountain under its octagonal pagoda-like roof supported on eight decorated oak posts with braces, is one of the most distinctive structures in the village. The roof is shingled with a large central turned finial supporting a small iron weather vane. A plaque records that the fountain and nearby drinking trough were donated to the people of Quendon in 1887 by Henry Tufnell Esq. in memory of Col. Cranmer-Byng of Quendon Hall. Article 4 Directions to provide protection for selected architectural detailing may be appropriate subject to further consideration and notification.

Picture 1.14 The 19th century village fountain, a most distinctive feature that should be preserved.

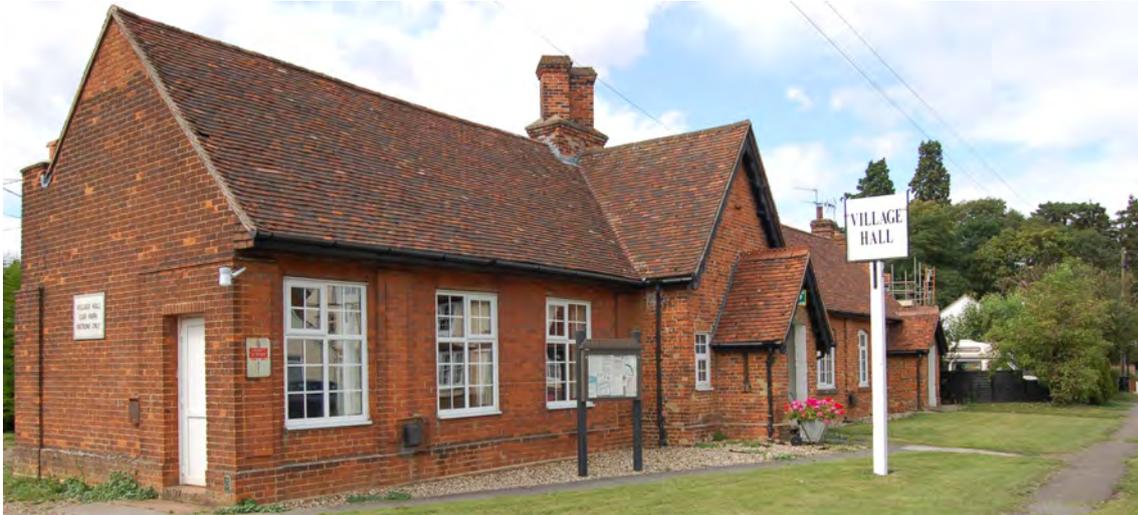
Picture 1.15 Quendon and Rickling Village Hall. One of the most prominent buildings in the village and most worthy of retention.

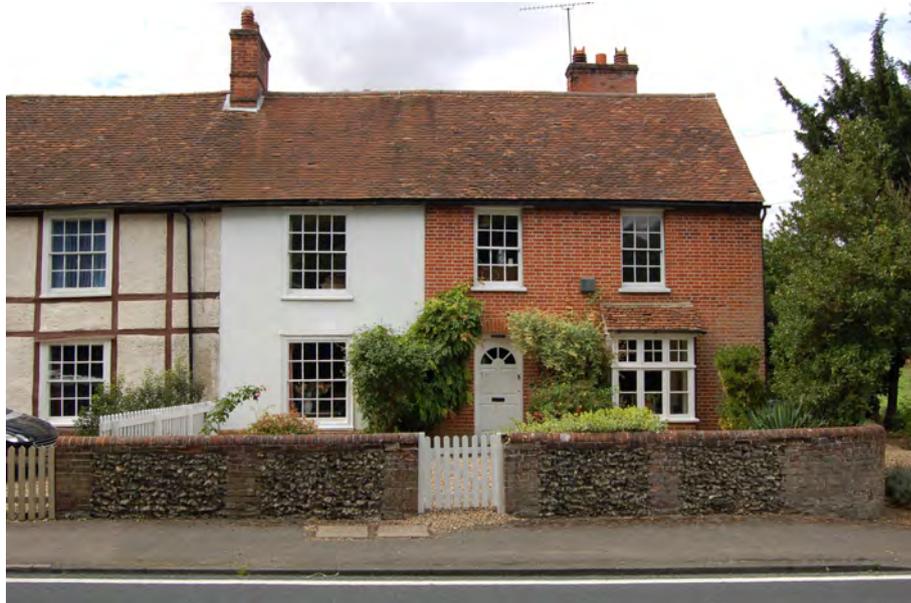
Picture 1.16 Fine flint and brick walling and a white painted picket style gate gives access to Norbury Cottage.

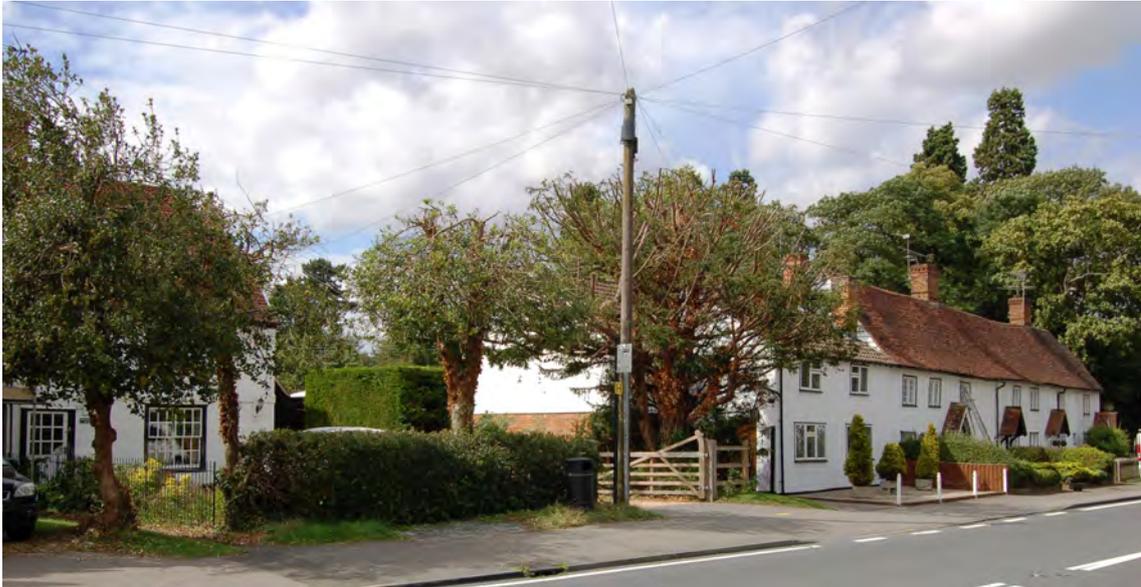
1.119 Elements that are out of character with the Conservation Area. A number of telephone utility poles and their overhead services detract from the quality of the streetscene, particularly along the Cambridge Road. It is considered appropriate to draw attention to the level of visual damage, particularly where these services intrude in proximity to Listed Buildings. It is recognised that in the current economic climate it may be difficult to achieve any real improvements, though, it will still be worth while exploring the potential for the under grounding of services with the telephone utility companies should the opportunity arise.

Picture 1.19 Utility poles, particularly in close proximity to quality listed buildings, introduce a discordant element into the street scene. If at all practicable, their replacement with underground services would be a significant improvement.

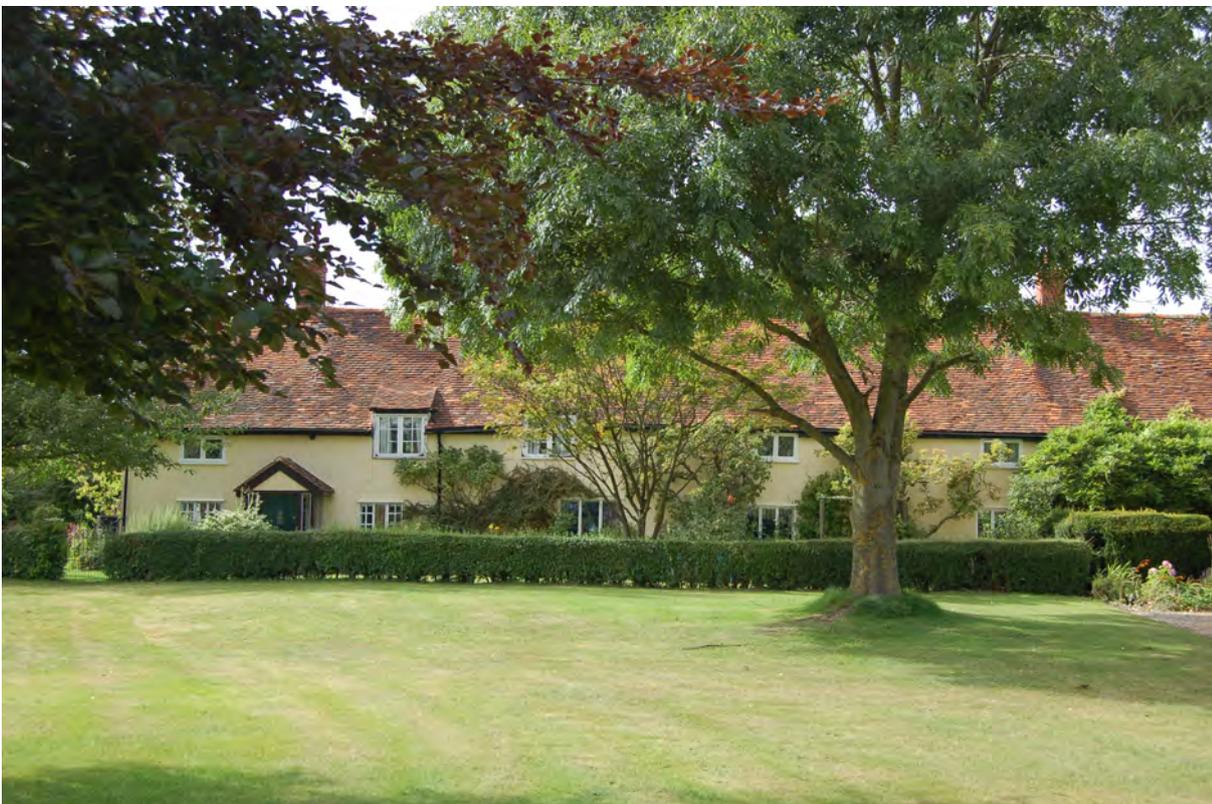
Picture 1.21 Yew Tree Cottage: A designated heritage asset positioned to the north of the Green and largely screened by mature vegetation and trees.

1.134 Yew Tree Cottage - Grade II, Yew Tree Cottage is located in a prominent position within the village, and occupies a corner plot at the southern end of Rickling Green Road which is framed by a boundary of mature vegetation forming a buffer between the openness of the Village Green and the more built-up area to the north-west. The cottage is believed to date from the 17th century and is timber framed with render externally. Formerly 3 cottages, now one tenement, it is two storeys with a five windows on the upper floor and 6 window range to the ground floor. Both storeys comprise mostly leaded casement windows. The roof is tiled with 3 central brick chimney stacks.

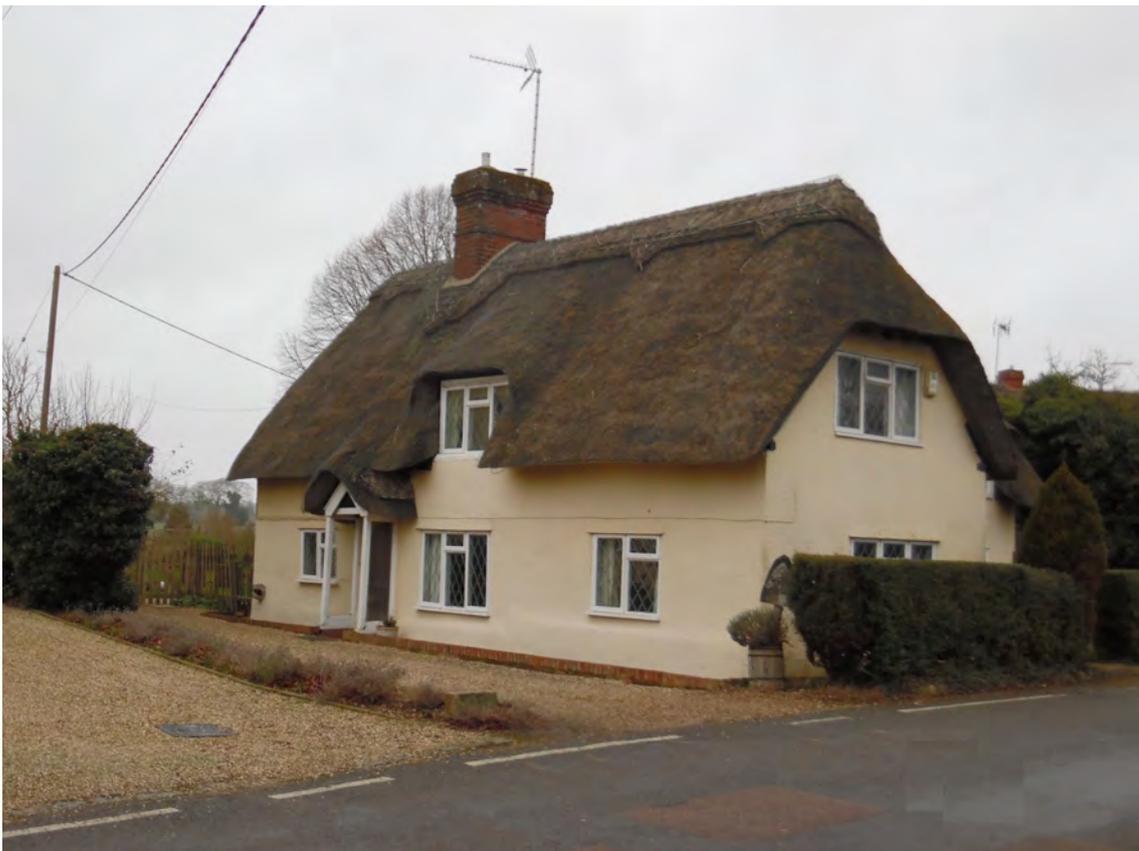
1.135 Well Cottage - Grade II, Believed to date from between the 17th and 18th century, Well Cottage is a timber-framed and plastered dwelling which was later renovated in the 20th century. The structure is one storey with attic and features casement windows with lattice leaded lights. The roof is thatched with a half hipped gable at the east end and a central chimney stack. The cottage also features a dormer window to the front elevation and there is a modern wing built out to the north, which has been designed in a similar style to the main cottage.

Picture 1.22 Well Cottage: A Grade II listed, thatched cottage on the outskirts of the Green.

1.136 Should the need to replace the existing windows to Well Cottage arise, a return to a more traditional casement style would be desirable, subject to the necessary consents.

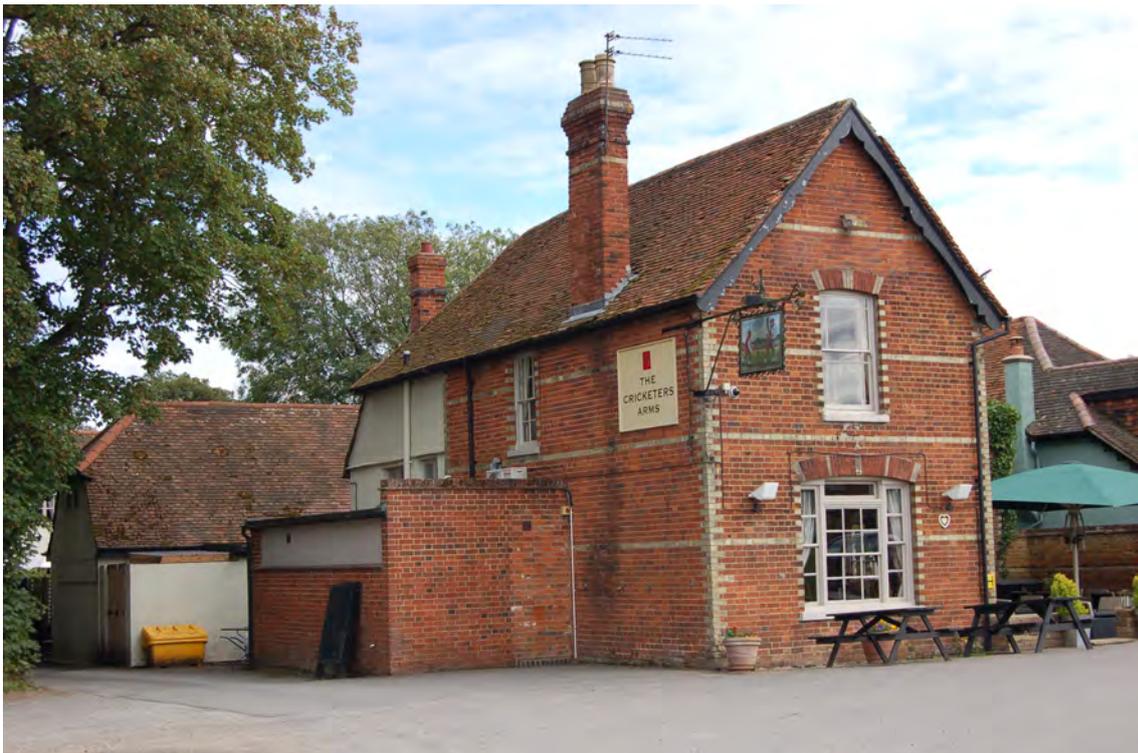
Picture 1.23 The Cricketers Arms public house: A fine 18th century structure with later 19th century alterations enjoying a prominent position overlooking the Green.

1.140 Cricketers Arms Public House - Grade II, Located in a highly prominent position overlooking the Green, the inn comprises an 18th century-early 19th century block, with a later 19th century wing extending to the west. The older block was re-fronted when the later wing was built. Constructed in red brick with yellow brick quoins and dressings, the later wing features a pitched roof, with gable elevation fronting onto the green and decorative bargeboard. The inn is two storeys. The older block has a parapet and 2 window range comprising horizontal sliding sash windows with glazing bars. The 19th century wing has double-hung sashes with glazing bars. The roofs are tiled with a central chimney stack on the older block and further brick stack to the new wing.

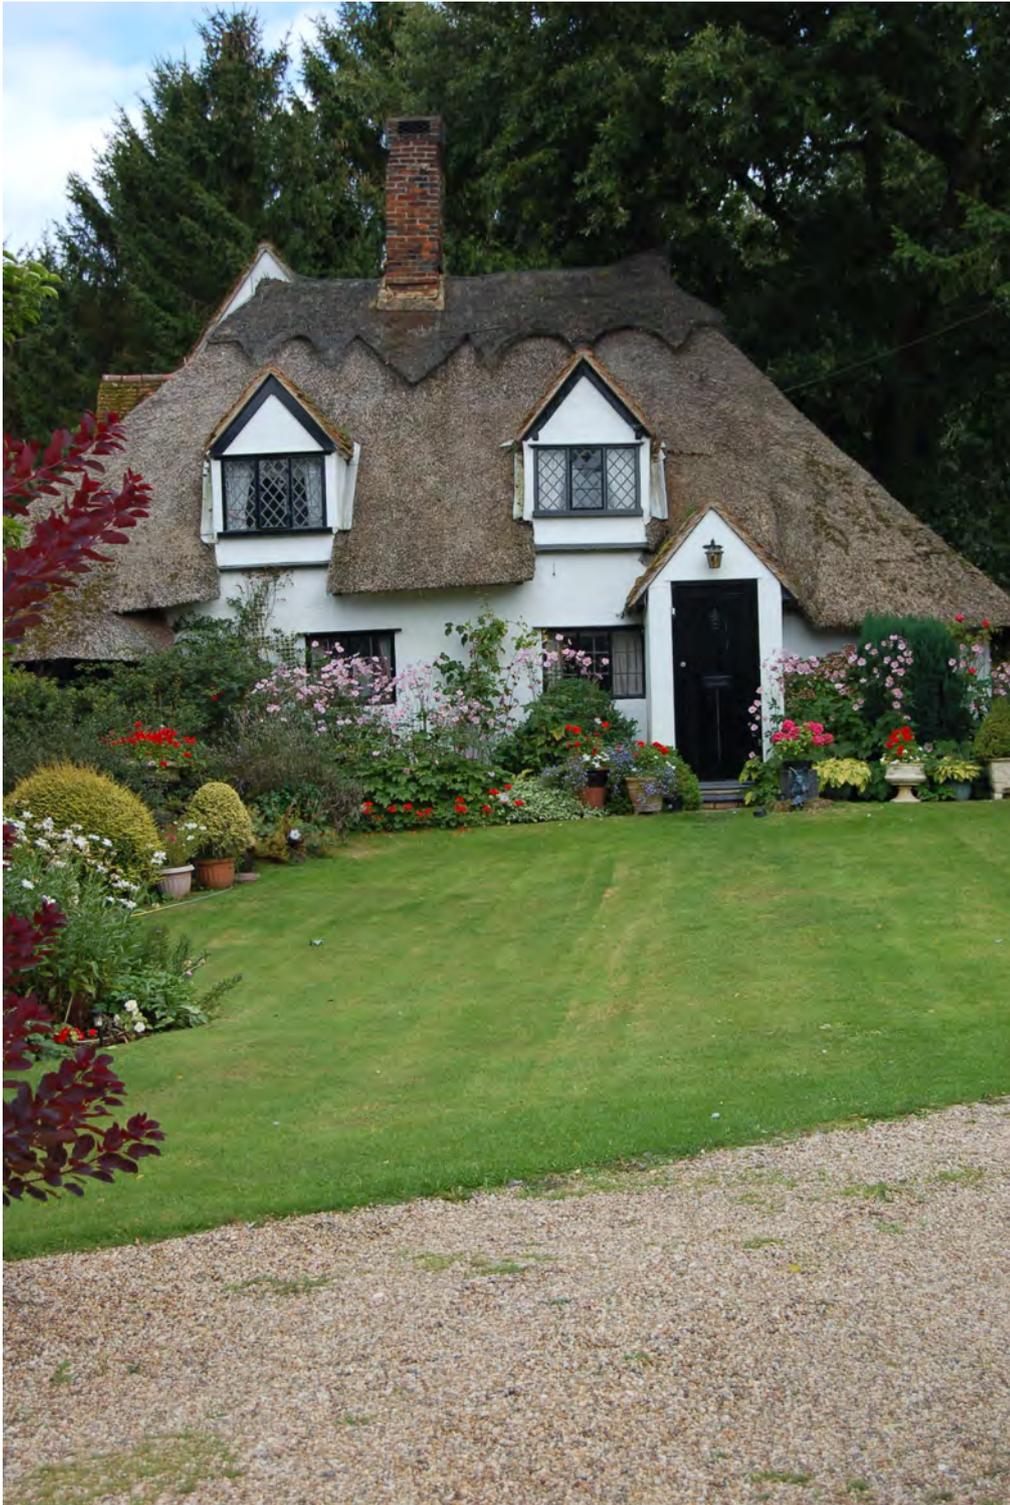
1.142 Thatch - Grade II, Believed to date from the 17th-18th centuries, Thatch is a small, timber-framed and plastered cottage. It is one storey with attic and features small leaded casement windows. As the name suggests, the roof is thatched and today, the primary elevation features two gabled dormer windows with lattice leaded lights and an internal brick chimney stack.

Picture 1.24 Thatch: A fine example of a 17th-18th century thatched cottage which makes a significant contribution to the character of the Conservation Area.

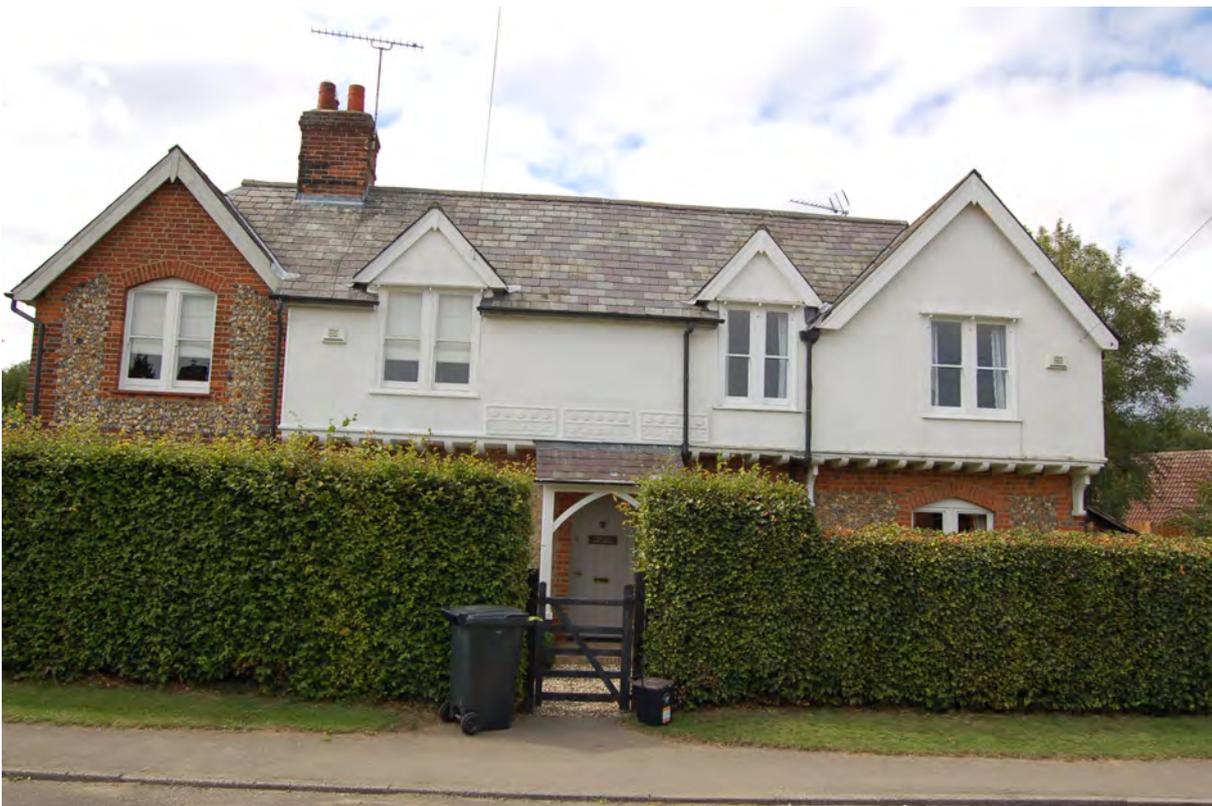
Picture 1.25 Flint Cottage to the right and The Old Post Office to the left. Good examples of modern infill development which reflects local architectural styles and materials.

1.145 Flint Cottage and The Old Post Office - These modern dwellings, whilst recent additions to the Rickling Green Road Street scene, make a positive contribution to the character and appearance of the Conservation Area by reason of their form, materials and detailing. A pair of semi-detached, brick and flint houses with east facing gables, gabled dormer windows comprising 2-light timber sliding sash units, with slate pitched roof and brick chimney stack. Both dwellings feature an array of traditional architectural features including jetty to the front elevation and plaster to the first floor with some pargetting. Article 4 Directions to provide protection for windows and selected architectural detailing may be appropriate subject to further consideration and notification.

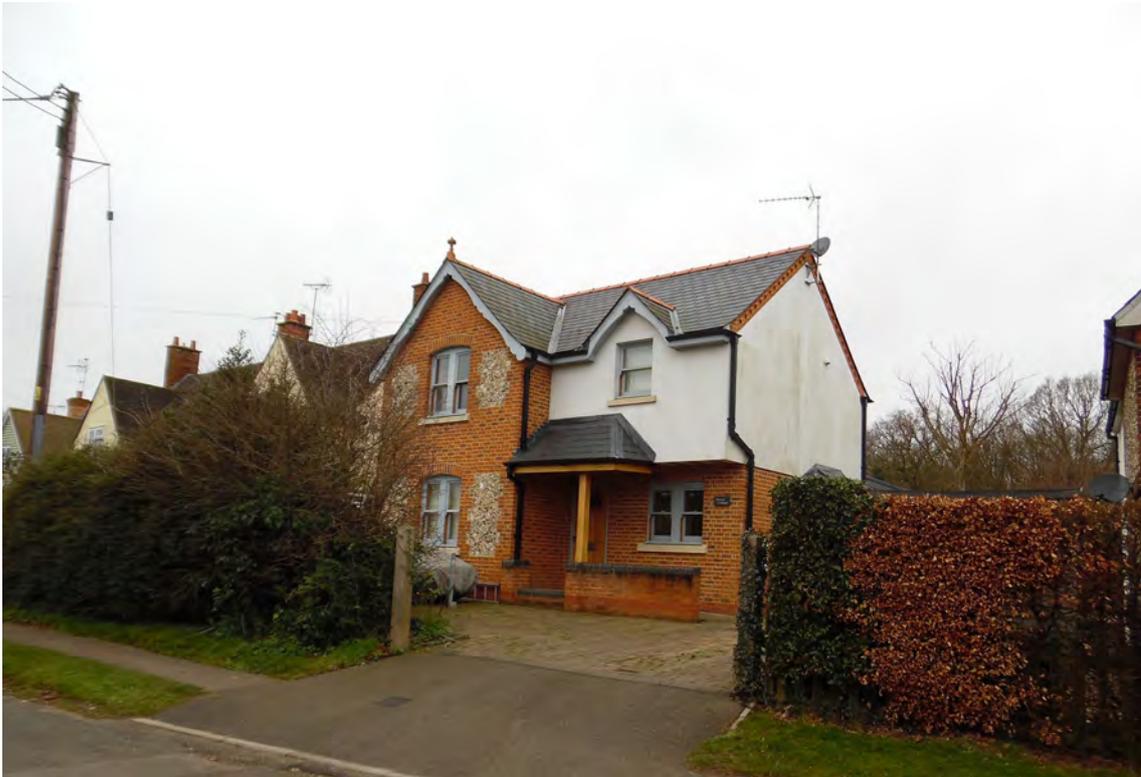
Picture 1.26 Snowy Cottage: Another example of a recent addition to the Rickling Green Road street scene which positively contributes to the character and appearance of the Conservation Area.

1.146 Snowy Cottage - A recent 21st century addition to the street scene; a detached two storey dwelling with slate roof, predominantly brick with flint panels and render to the first floor. It references local architectural styles with a projecting gable featuring decorative bargeboard detailing, finial and vertically sliding sash windows with segmented arches. Article 4 Directions to provide protection for windows and selected architectural detailing may be appropriate subject to further consideration and notification.

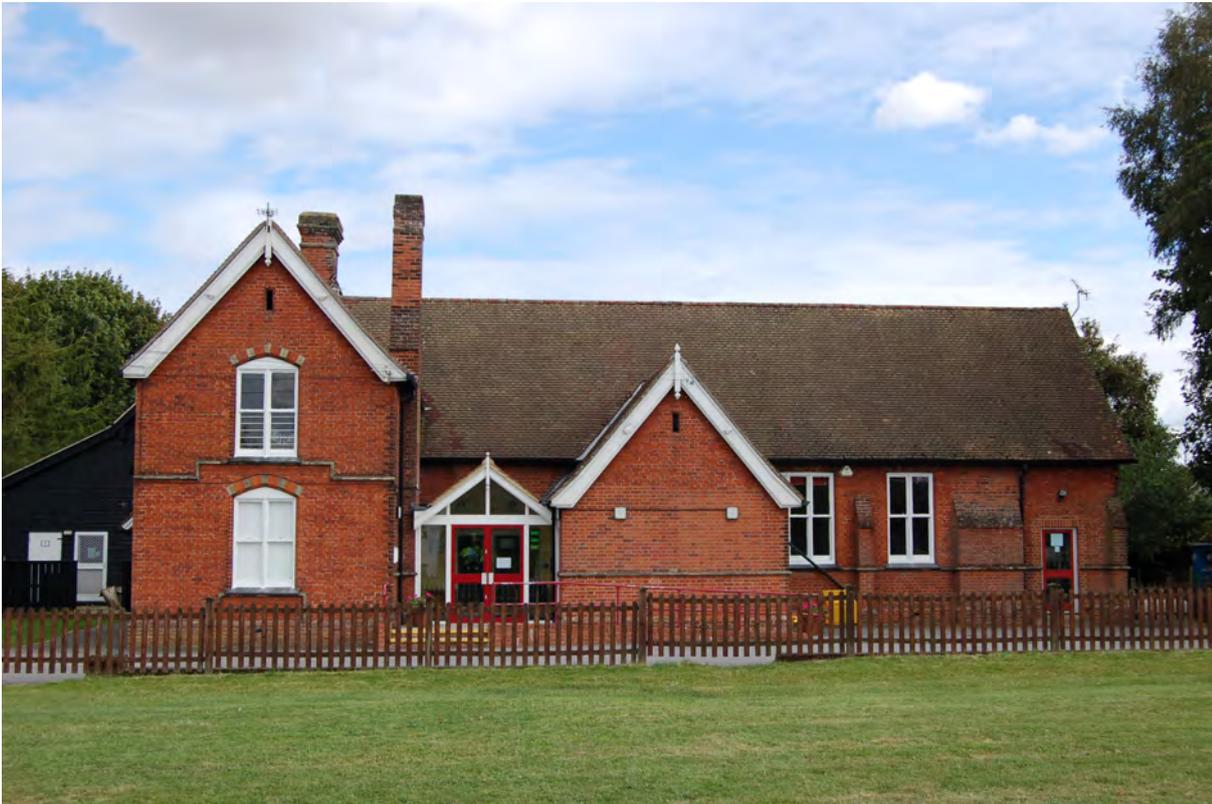
Picture 1.27 A 19th century school, still very much at the centre of village life and a principle feature on the outskirts of The Green.

1.148 Rickling Church of England School - A red brick structure located in a prominent position to the north-east of the Green, with tiled roof and brick end chimney stack. Constructed in Flemish bond, with brick buttresses of varying widths, the primary west facing elevation features a 2-light sash window with mullions under a flat brick arch, and a similar 2-light window to the right hand side. Two brick gables project to the west, the wing on the left-hand side being two storeys and featuring a decorative bargeboard with finial and pendant detail, and 2-light sash windows under pointed brick arches. The right-hand side gable is single storey and features the same bargeboard detailing. There is a stepped string course running along the elevation. A further glazed, gabled porch has been erected between the western wings, whilst there are further 21st century timber clad extensions to the east. Article 4 Directions to provide protection for windows and selected architectural detailing may be appropriate subject to further consideration and notification.

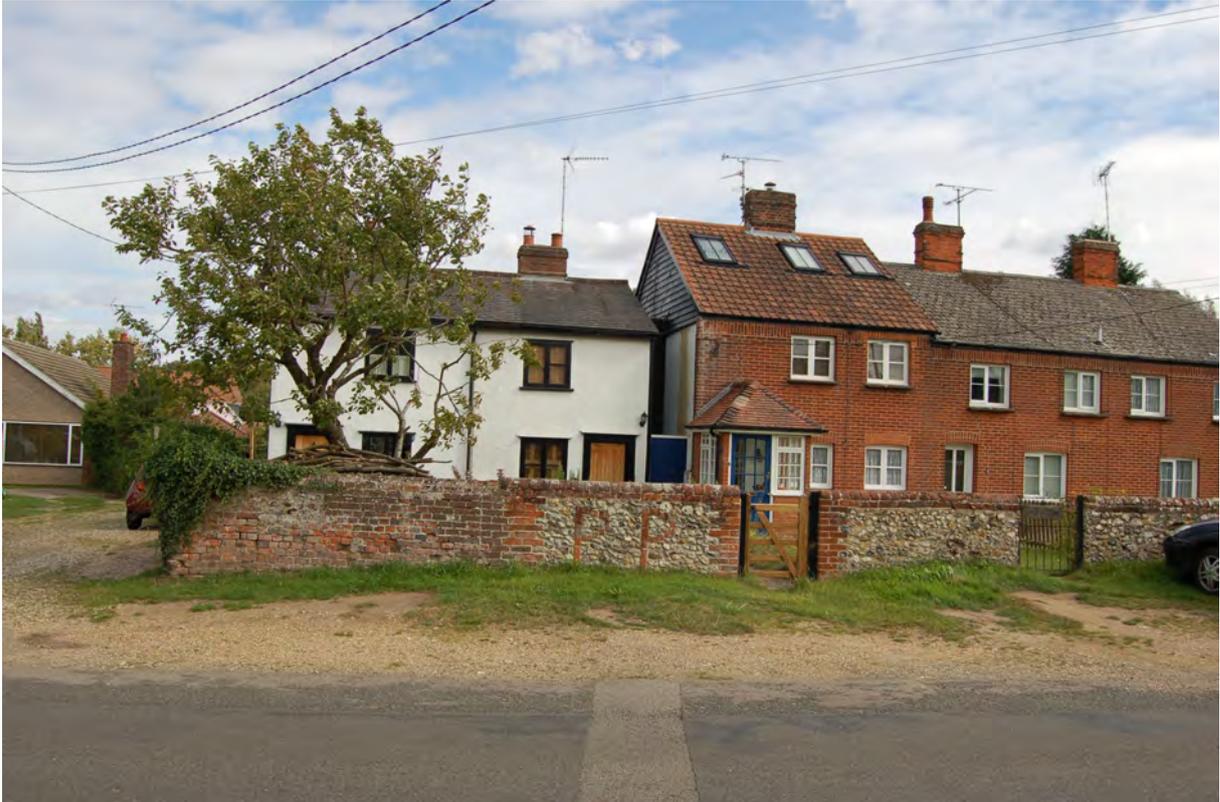
Picture 1.28 Nos. 1, 2 and 3 Lacey Cottages. These 19th century cottages are located in a prominent position along Rickling Green Road.

1.150 Nos. 1, 2 and 3 Lacey Cottages - Nos. 1 and 2 are a pair of rendered, semi-detached cottages with slate roofs and central brick stacks. Both cottages feature timber 2-light casement windows with central, horizontal glazing bar and timber ledge and brace doors. No. 3 is a semi-detached and adjoins No. 1 Rickling Green Road. It features a brick facade with part rendered and part weather boarded gable to the north. It has a clay tile roof and central brick chimney stack. The windows are 2-light casements with horizontal glazing bars. Article 4 Directions to provide protection for windows and selected architectural detailing may be appropriate subject to further consideration and notification.

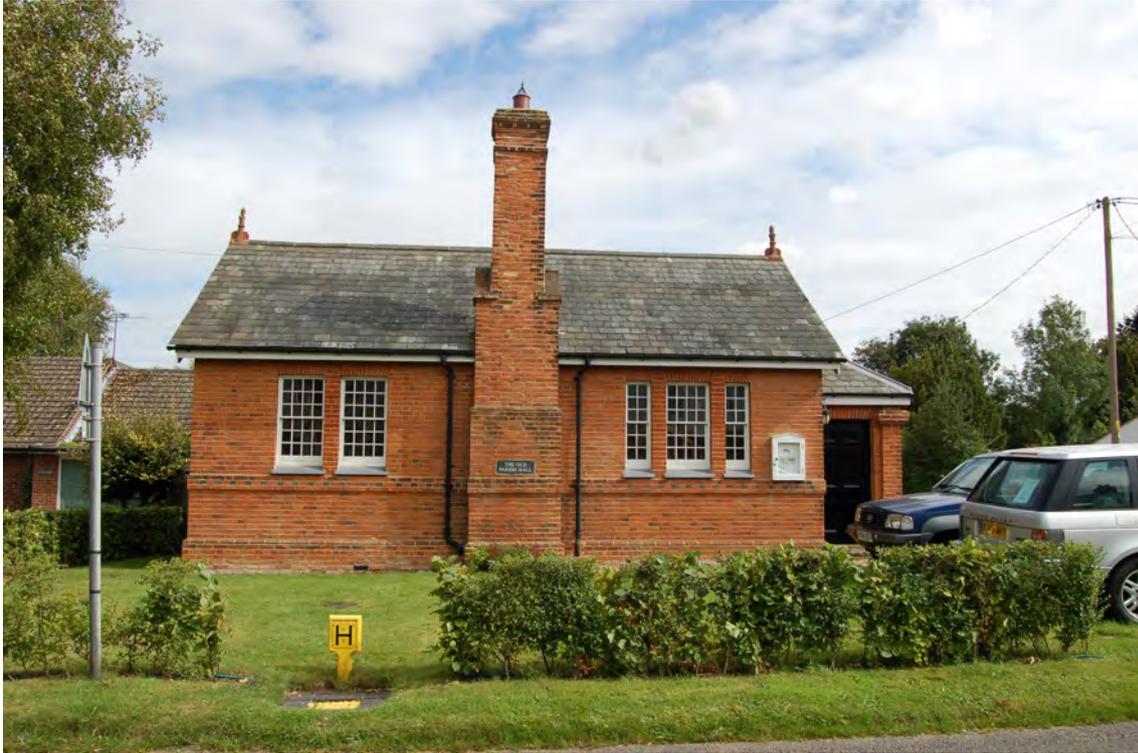
Picture 1.29 The former Rickling Parish Hall, now converted to residential use. A most pleasing 19th century building worthy of retention.

1.151 The Old Parish Hall - Located in a highly prominent position along Rickling Green Road the Old Parish Hall, believed to date from the 19th century, is a red brick structure in Flemish bond with a single storey porch to the south elevation, featuring a 6-panel door with flat brick arch. At the centre of the western elevation is an imposing external brick chimney stack featuring triangular brick detailing to the shoulders. The roof is slate, with plain bargeboards to the gables, and clay finials.

1.152 The fenestration is irregular comprising two 24-pane sash windows with glazing bars to the left-hand side of the chimney stack, and an identical window on the right-hand side which is flanked by 2 narrow sash windows; one on either side. All windows feature flat brick arches. There is a brick string course which runs below the sill level, featuring 3 courses in Flemish bond; the central brick course featuring contrasting header bricks. Article 4 Directions to provide protection for windows and selected architectural detailing may be appropriate subject to further consideration and notification.

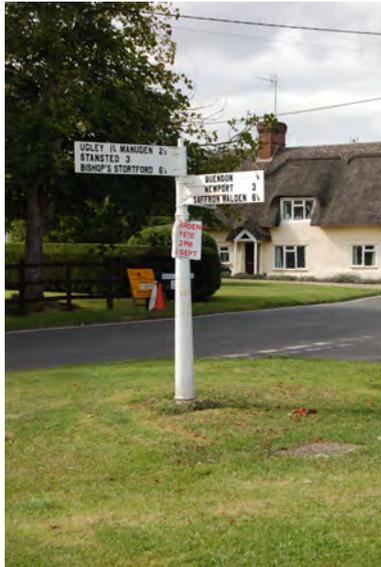
1.155 There are also two historic, cast-iron finger-posts located on the grass verges to the west of the green, which are historically important pieces of street furniture, understood to have been made by the Maldon Iron Works in 1934, which are worthy of retention and make a positive contribution to the Conservation Area⁽³⁶⁾.

Picture 1.30 Made by Maldon Iron Works in 1934, this signpost was partially restored in 2003 and continues to be an important feature of the village scene.

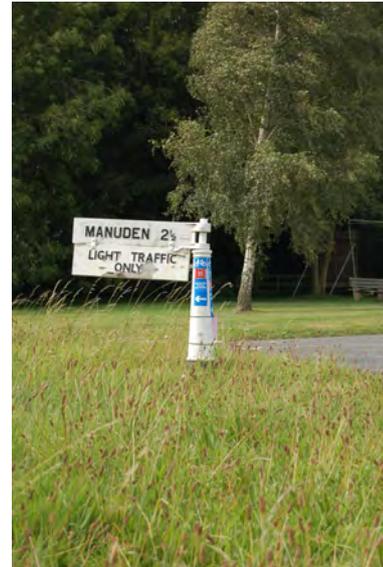
Picture 1.31 Also made by Maldon Iron Works, this sign was set no. 4 of order R/301, dating from 1934.

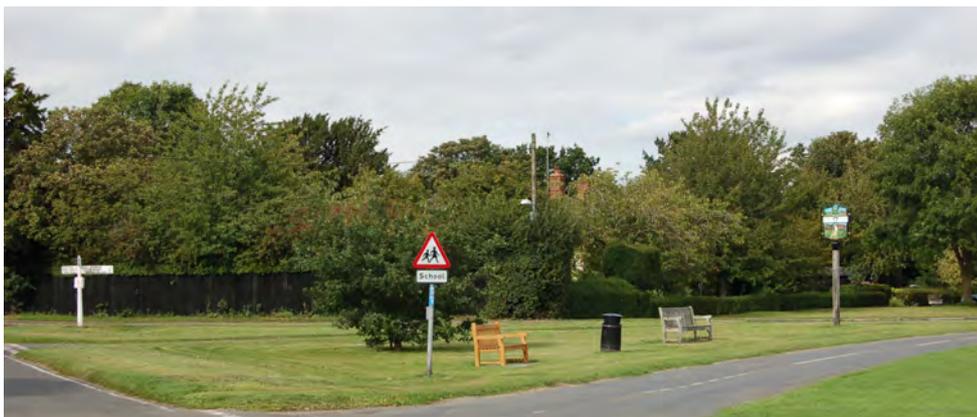
1.168 There is also an excess of street furniture on the grassed island to the west of the Green, consisting of signage, benches and a bin. The array of features detracts from the modest and generally uncluttered character of the Conservation Area and its historic features such as the village signpost and historic finger-posts.

Picture 1.35 It is regrettable that several new items of street furniture have been located in such close proximity, detracting from the relatively sparse and uncluttered appearance and character of this part of the Green.

1.170 Should the opportunity arise, the relocation of the School warning post would be beneficial in reducing the clutter on the grass island to the west of the Green. The repositioning of the litter bin may also reduce the visual impact of these items of modern street furniture.
