Quendon and Rickling Conservation Area Appraisal and
Management Proposals, Approved June 2015

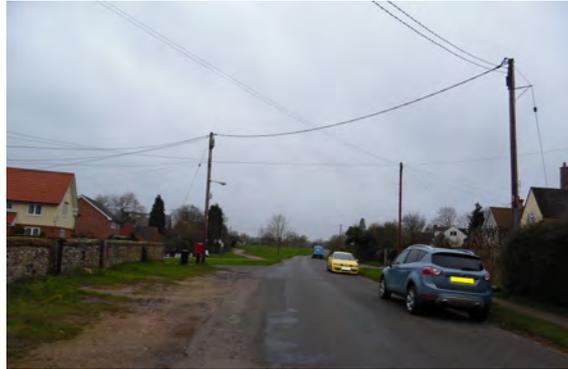
Picture 1.36 The prominent telegraph poles and cables detract from the Rickling Green Road street scene.
