Roothers Farm, Debden Green, Henham Road, Debden

LB at Risk
Roothers, Debden Green, Henham Road, Debden

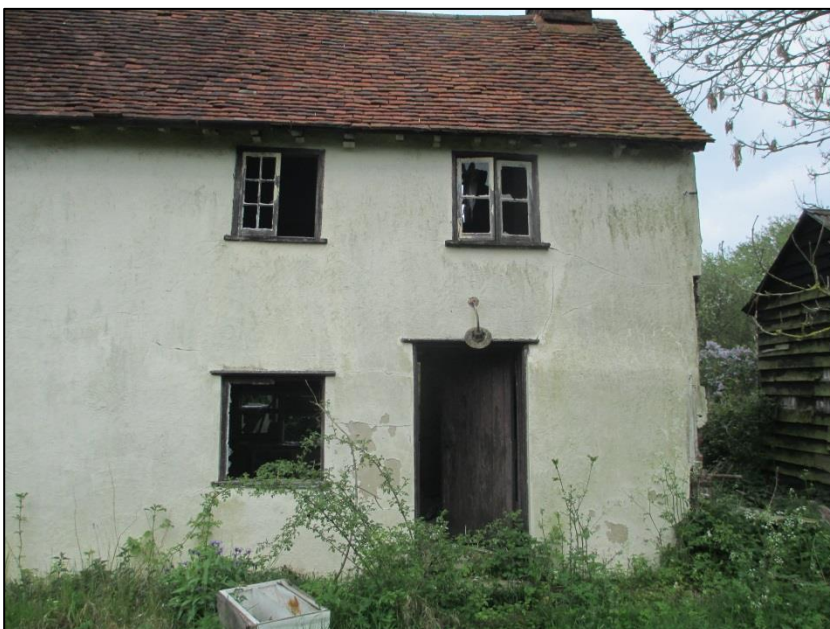
C17 timber-framed and plastered building with a C18 addition at the rear. Two storeys. The upper storey is jettied at the south-west end of the front. The windows are partly double-hung sashes and partly casements. Roof tiled, with one external chimney stack.

House is vacant and in a dilapidated condition with the openings unprotected, leaving the building vulnerable to further deterioration.

- Openings to be secured allowing for adequate ventilation
