# **Donald Insall Associates**

Uttlesford District Council Heritage Impact Assessments

Draft 11th May 2018

Commissioned by **Uttlesford District Council**

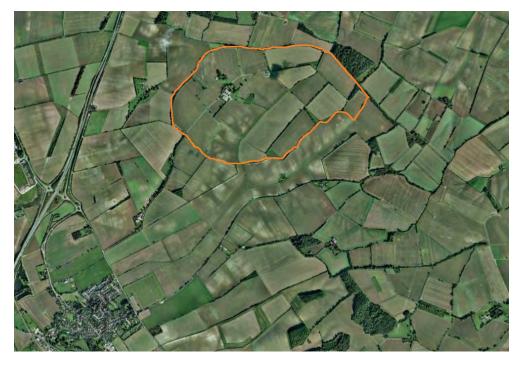
Fig.6: Aerial photograph of development site with Deer Park boundaries (orange outline)

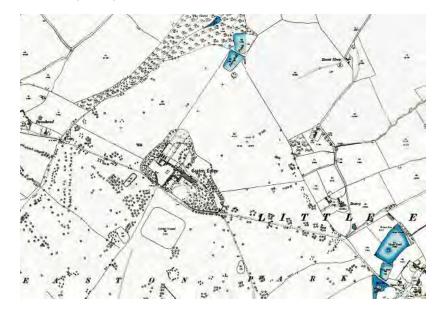
Fig. 7: Easton Lodge on OS 25" to 1 Mile map of 1898 showing the extent of the gardens around the main house.

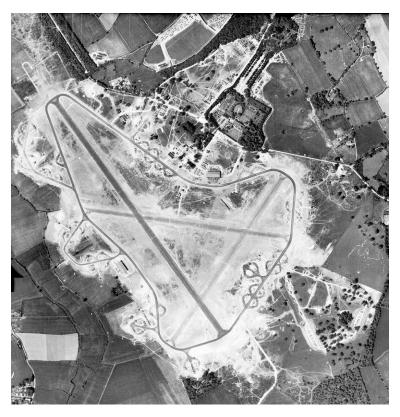
Fig 10: Aerial photograph of RAF Great Dunmow aerodrome in May 1944. The Lodge with Peto's gardens is clearly visible top centre of the photograph. With the end of the war in 1945, the aerodrome was used for Care and Maintainance (Fig. 11).

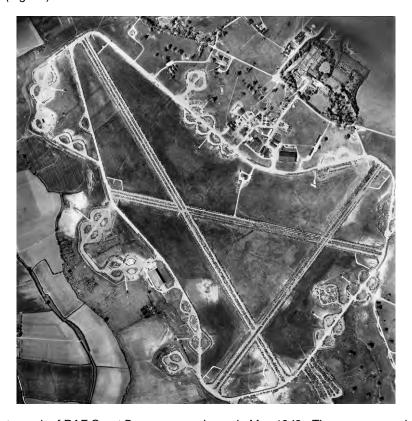
Fig 11: Aerial photograph of RAF Great Dunmow aerodrome in May 1948. The runways, perimeter track and hard standings are being used for storage of now redundant military vehicles

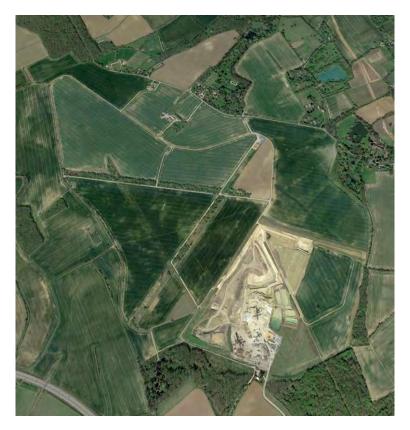
Fig 12: Aerial photograph of RAF Great Dunmow aerodrome in 2017 showing the remains of the runways and the perimeter track. The location of the runways is clearly visible as crop marks in the fields. The south -east corner of the site has been lost to quarrying.

- 8.3.9 In April 1958 the aerodrome ceased to be required for military purposes and was sold for agricultural use, with farming operations commencing in 1960 and in 1965/66 the concrete areas were broken up for aggregates for use in the construction as part of the new A12 road.
- Very little of the aerodrome still exists except some single track agricultural roads remaining from the 8.3.10 perimeter track and a blister hangar with a four Nissen huts and electrical generator shed near Easton Lodge. Although the runways have been removed their locations are still discernible. The north-eastern end of runway 04-22 still exists and is currently used for manure storage. From 2012 the south-east corner of the aerodrome has been the site of gravel extraction (Fig. 12).

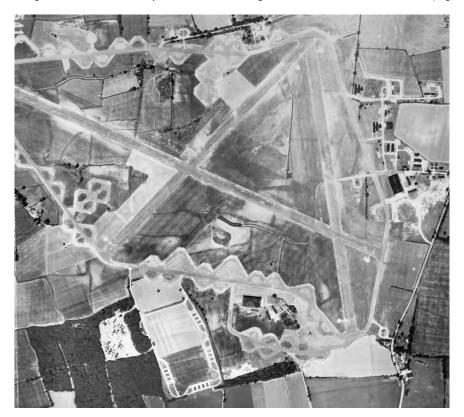
Fig. 8: Aerial photograph of RAF Great Saling / Andrewsfield in August 1949. Although longer an operational aerodrome the runways, perimeter track, hard standings, hangers, buildings and munitions dumps are still intact.

9.3.7 At the end of the war the aerodrome was closed in November 1945 and the site returned to agricultural use although the concrete runways and hard standings remained until the late 1960s (Fig 8.)

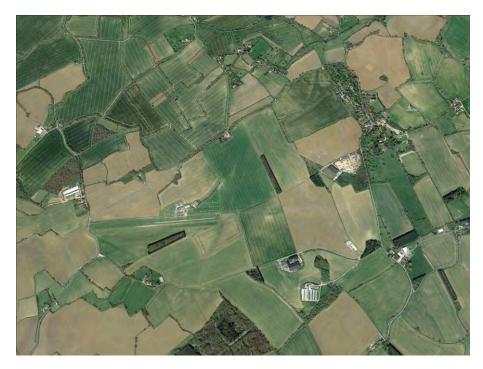
Fig 9: Aerial photograph of RAF Great Dunmow / Andrewsfield aerodrome in 2017 showing the remains of the runways and the perimeter track. The location of the runways are clearly visible as crop marks in the fields. The runway and associated buildings of the small airfield are visible centre left of the photo.

- 9.3.10 The outline of the original runways are still visible as crop marks in the fields, however the southern end of the concrete 15-33 runway still survives and is used as an agricultural hard standing (Fig. 9).

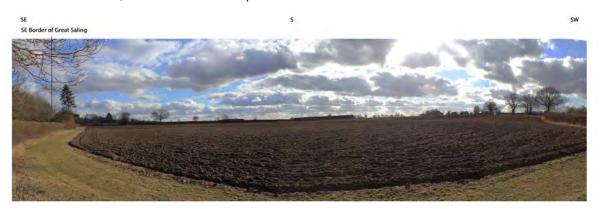
With potential future development of the site there will be a **moderate to major change** to the setting of the conservation area, and there will be an impact on the wider rural character of the area.

View south, Great Saling on the left

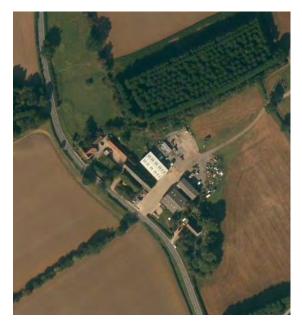
Aerial view of Onchor's Farm

Onchor's Farmhouse is located within the central northern area of the proposed site. It is Grade II listed (List Entry No. 1122779).

The farmhouse is dated C17 or earlier with C18 facade, timber framed and panel pargetted with red plain tile roof. There are additional non-designated buildings related to the farmhouse within its curtilage (not accessible to asses if NDAs).

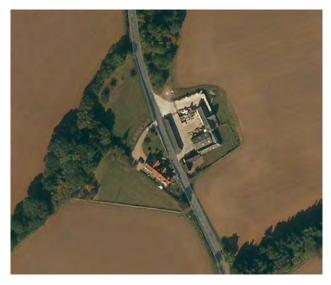
Aerial view of Mounts Farm

Mounts Farmhouse is located within the north east area of the proposed site. It is Grade II listed (List Entry No. 1122787)

The farmhouse is dated C17 or earlier with later alterations, timber framed and plaster with red plain tile roof.

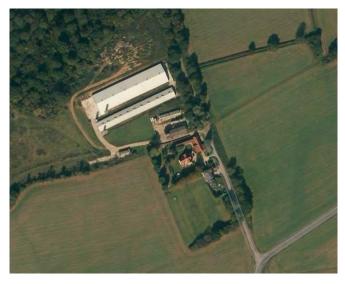
Aerial view of Badcocks Farm

The farmhouse is dated C17 recently restored with C20 additions, timber framed and plastered with C20 pargetting.

There are additional non-designated farm buildings within the curtilage of the farmhouse (not accessible to asses).
