**Radwinter Conservation Area Appraisal and Management
Proposals, Approved January 2013**

1.1 This appraisal has been produced by Officers of Uttlesford District Council to assess the current condition of the Radwinter Conservation Area, to identify where improvements can be made and to advise of any boundary changes that are appropriate. The document is in draft form and will be subject to public consultation and agreement by District Council Members.

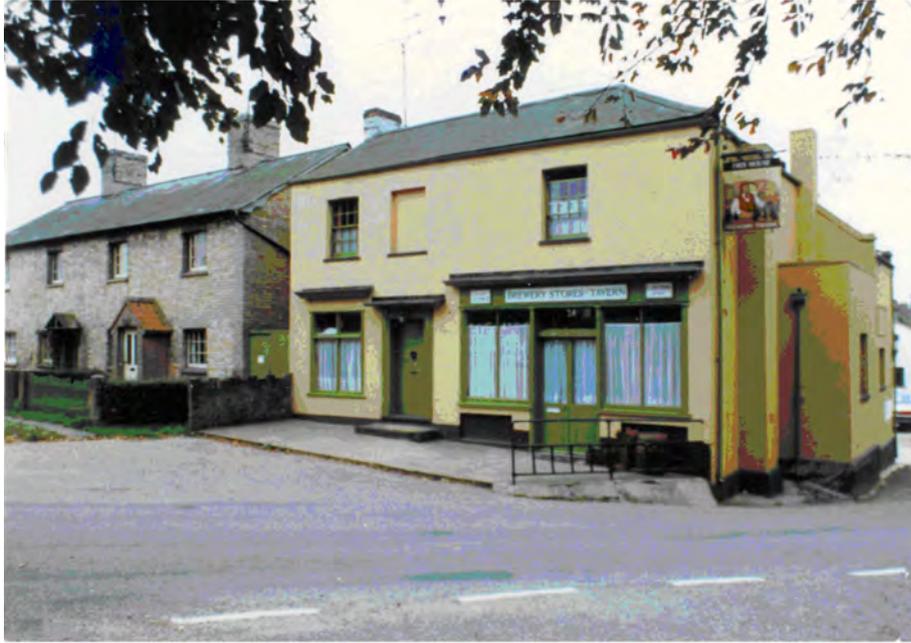
Picture 1.2 Traditional village shop and residence, mid/late 20th century, additional use as Brewery Tavern and enlarged window to left added. Also note porches of differing styles and scales added to adjoining 19th century terrace

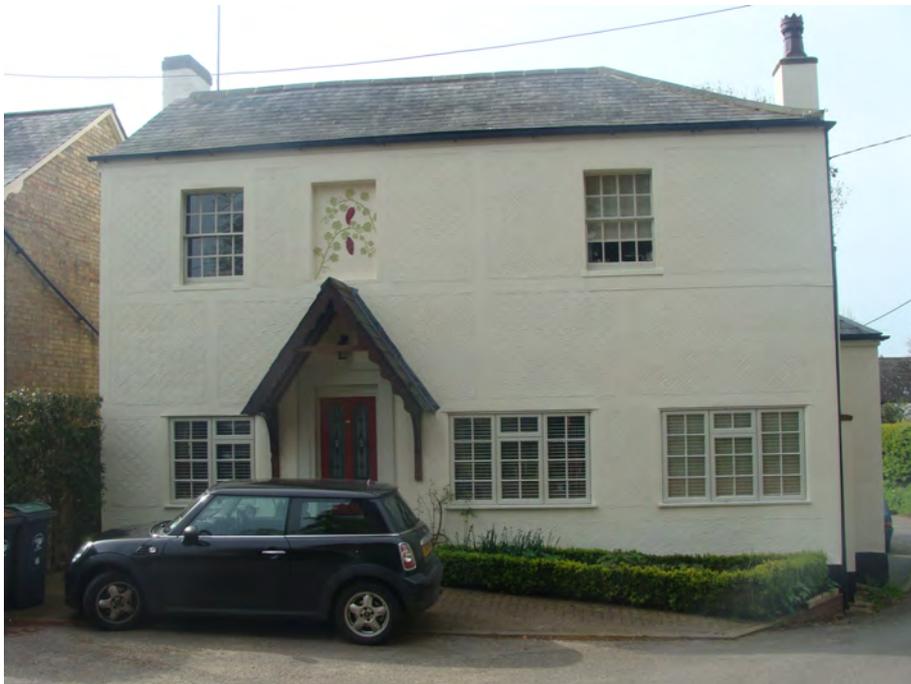
Picture 1.3 The building today, original commercial window detailing replaced and large central porch added. Change of use may have been inevitable but a more appropriate design solution retaining some original features would have been possible

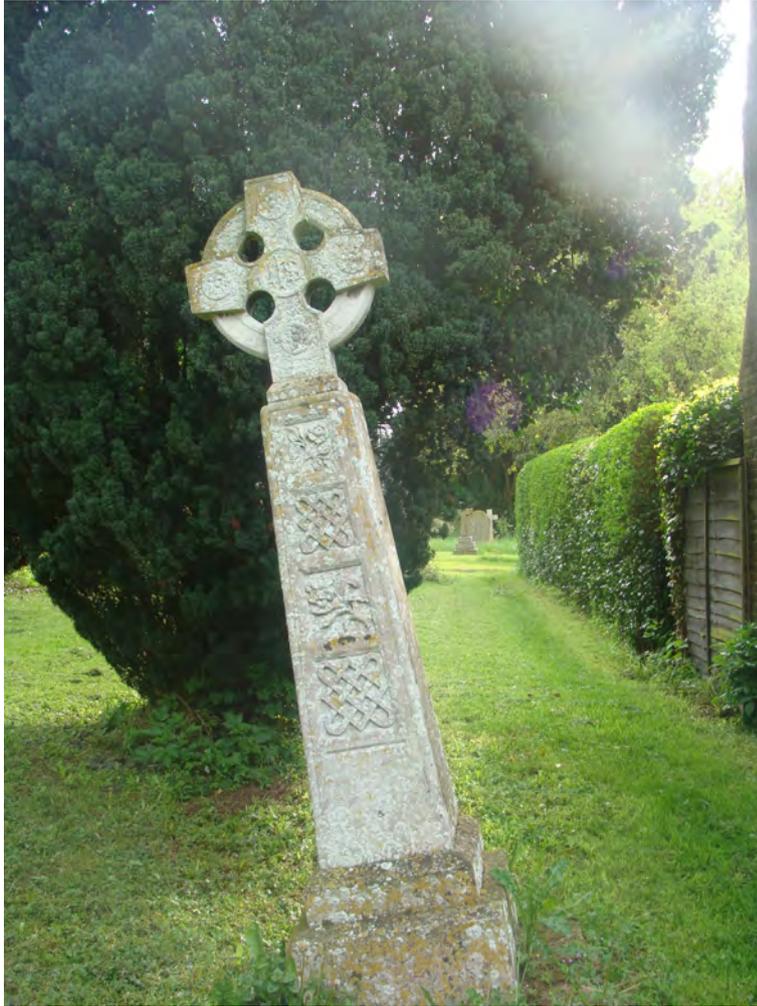
1.72 War Memorial commemorating the dead of both World Wars, tombstones and unusual metal grave markers within the churchyard. There are a wide range of such structures that add to the quality of the graveyard. Some are in need of resetting.

Picture 1.15 Within the churchyard there are many fine tombstones. Some may need re-setting

1.83 Opportunities to secure improvements. Seek owner's co-operation to replace decorative front boundary wall between Grove Cottage and the River Pant. Seek owner's co-operation to replace boundary between the Old Forge and churchyard with a hedge of native species. Consider re-setting selected leaning gravestones. Undertake a

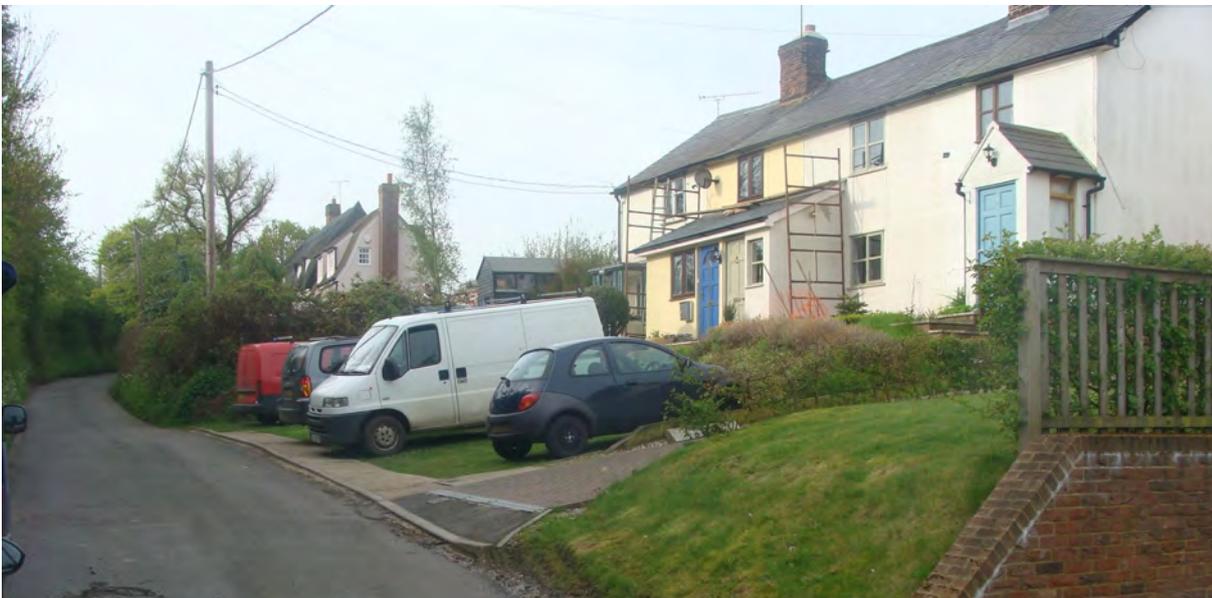
1.78 Elements that are out of character with the Conservation Area. The area to the south of the River Pant to the western side of the road consists of a grouping of late 19th/early 20th century properties whose historic and architectural qualities have been eroded by extensions and additions to the front elevations and by parking bays that detract from the quality of the street scene.

Picture 1.17 Late 19th/early 20th century terrace whose qualities have been eroded by porches to front and parking. The detail as to whether or not these developments represent 'permitted development' has not been checked in detail. However on the assumption that some developments fall into that category, the resultant detrimental impact on the local street scene certainly illustrates the value of the general principle of introducing Article 4 Directions within Conservation Areas in appropriate situations.
