Barn at Chickney Hall, Chickney

LB at Risk
Barn at Chickney Old Hall, Chickney

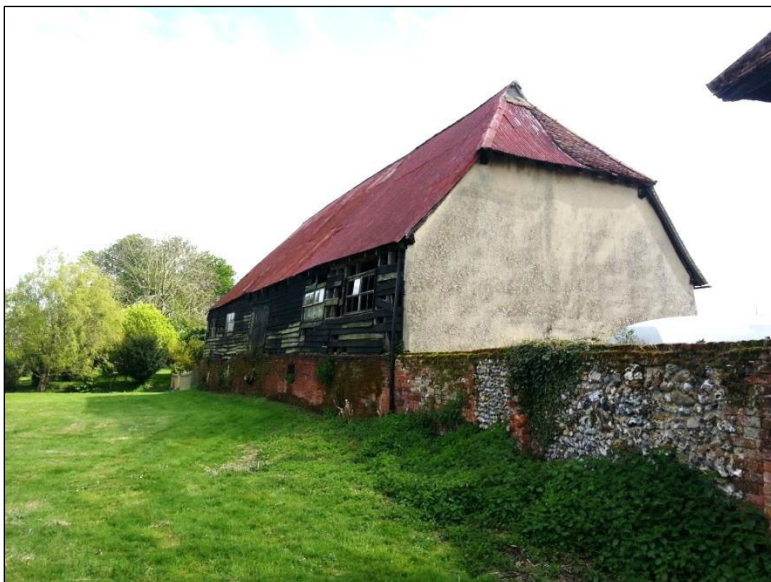
Barn. Mid C14, aisled. Timber framed and weatherboarded, with red plain tile hipped roof. 5 bays long with C17 half hipped midstrey. Arch braced tie beams, jowled arcade posts, and splayed and bridled arcade plate scarfs. Passing braces, and reversed assembly at eaves. Jowled aisle ties. Original Crown post roof rebuilt as side purlin in early C17.

Roof has now been 'mothballed' with new timbers inserted and corrugated sheeting to rear.

- Sections of missing weatherboarding to be replaced like-for-like
- Loose tiles to be reinstated or replaced like-for-like
- Windows to be boarded
- Tree stump in rear elevation to be removed and missing weatherboarding to be made good like-for-like
