# Gatehouse to Easton Lodge, Stortford Rd, Gt. Dunmow

## Description

LB at Risk  
Gatehouse to Easton Lodge, Gt Dunmow

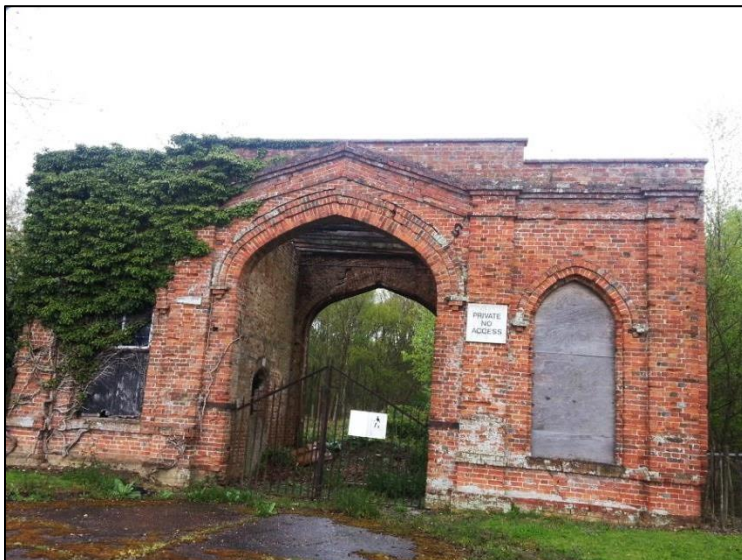
Gatehouse. C17, partly remodelled in C18. Red brick with central carriageway and flanking lodges. Carriageway has 4 centred arch, with 2 central arches to windows. Giant pilasters in brick. Central pediment with flat parapet above. Parapet at lower level above lodges, with projecting cornices below. Hood moulds. Y-traceried glazing bars. Arched doorways to lodges.

Missing most of roof covering and requiring removal of Ivy from brickwork. Planning Permission for one residential unit approved in 1992 but not yet implemented. Existing openings boarded up and temporary arch support installed.

- Vegetation to be removed
- Secure vulnerable areas of brickwork
