1 Silver Row, Mutlow Hill, Wedens Ambo

LB at Risk
1 Silver Row, Mutlow Hill, Wendens Ambo

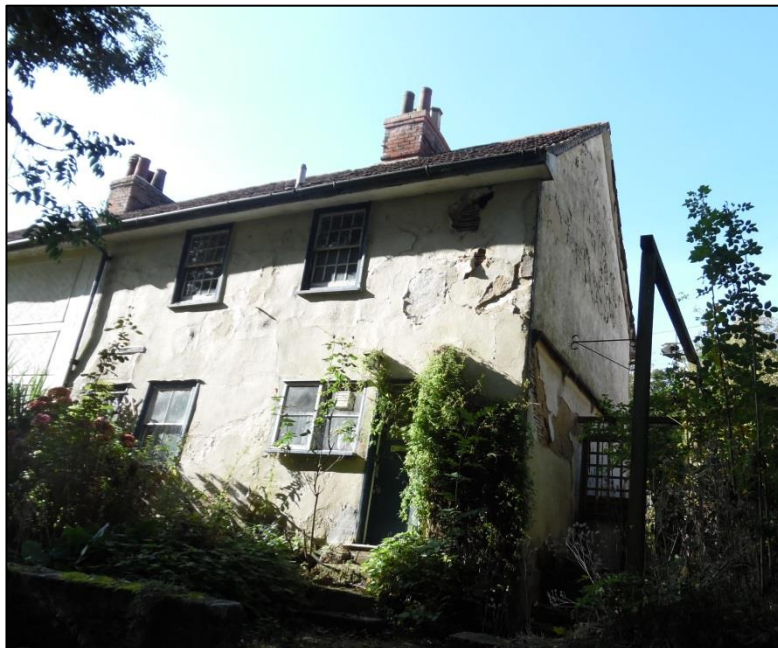
Missing render to front and side elevations with laths and timber frame exposed

- Localised repairs to the lime render in a like-for-like manner
- Openings to be secured allowing for adequate ventilation
